Asbestos Management Survey for Hendy Group Limited

Hendy, 18-22 Lottbridge Drove
East Sussex
BN23 6NS

Project Number: AS10788

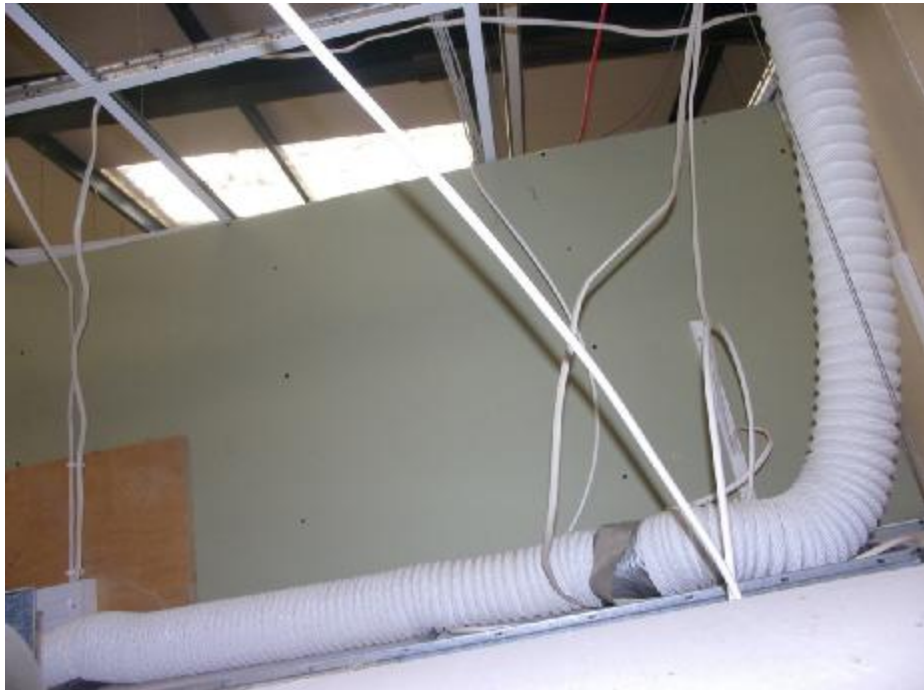
Void above low level suspended ceiling accessed in multiple areas. No ACM's present where inspected.

No Action Required

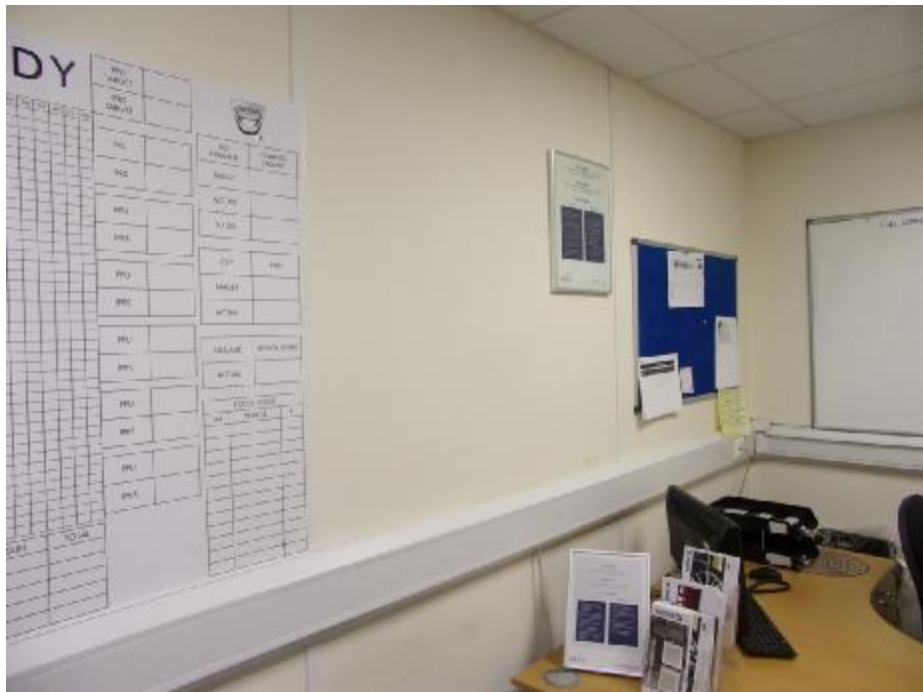
Material Comments: Non asbestos wall panels present in various areas throughout site.

Action: No Action Required

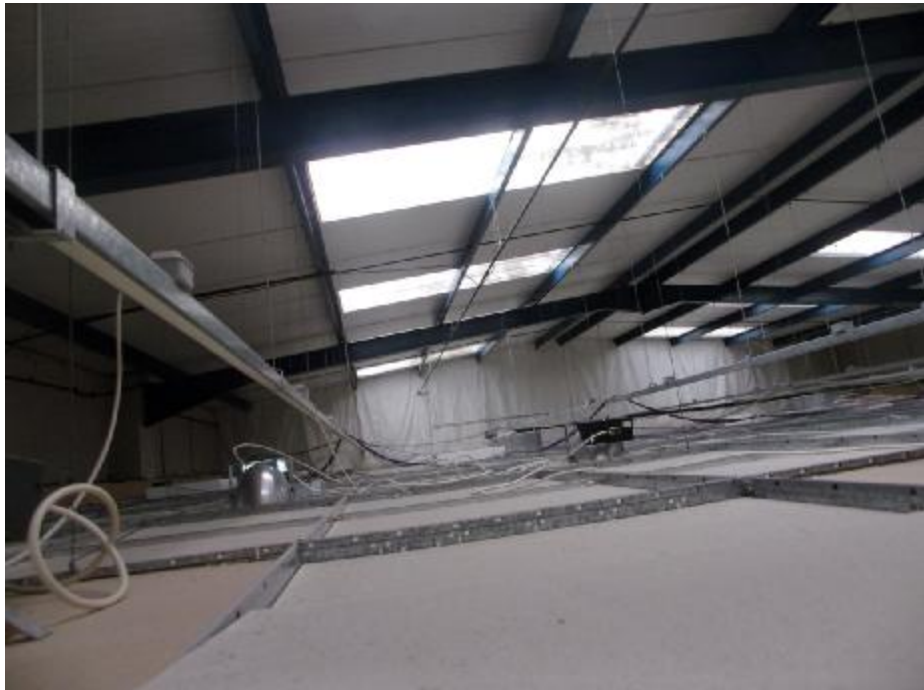
Limited access above high level suspended ceiling. No ACM's present where inspected.

Proceed With Caution

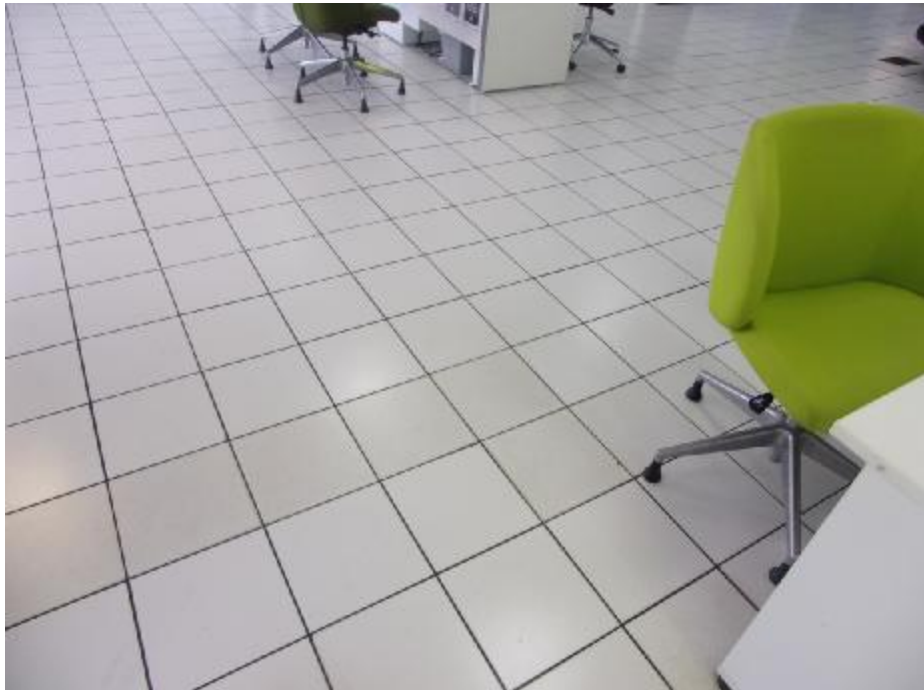
No access below tiled floor where present due to damage limitations.

Proceed With Caution

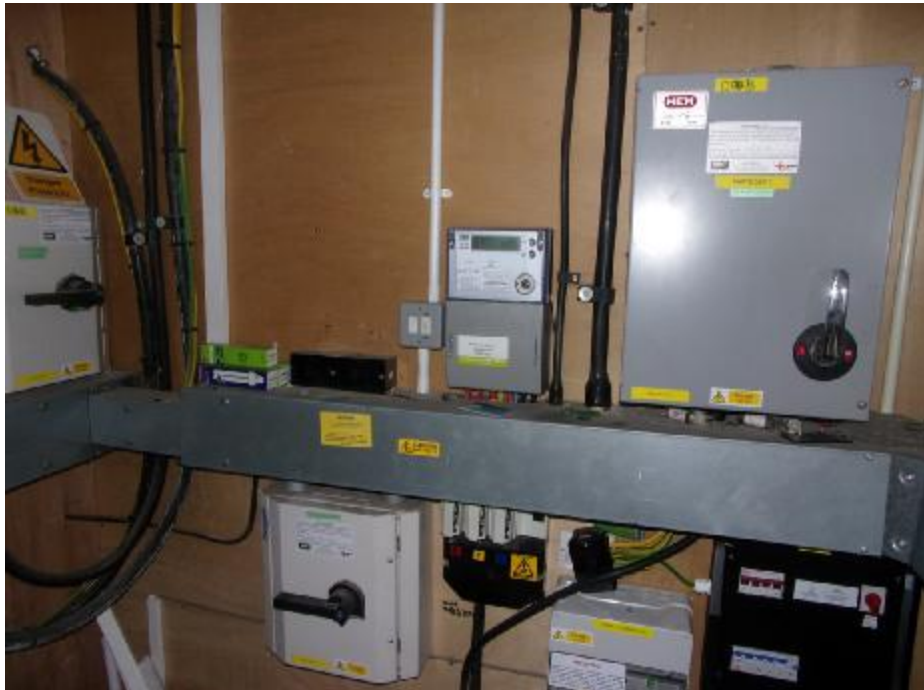
Material Risk Score:	4
Material Risk Band:	Very Low Risk
Priority Risk Score:	3

No access gained within electrical fuses due to live status. Presumed asbestos containing flash guards/rope lining within.
Anything outside of the fuse board needs the local electricity board's permission to isolate & remove.

Action: Annually Re-Inspect

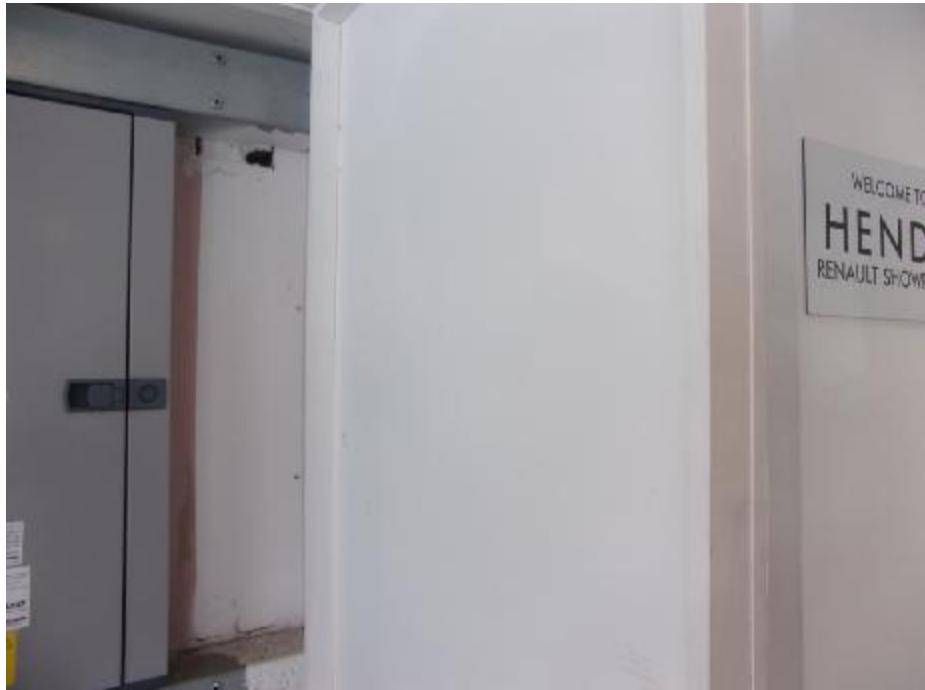
Material Comments: Timber panel to electric cupboard door.

Action: No Action Required

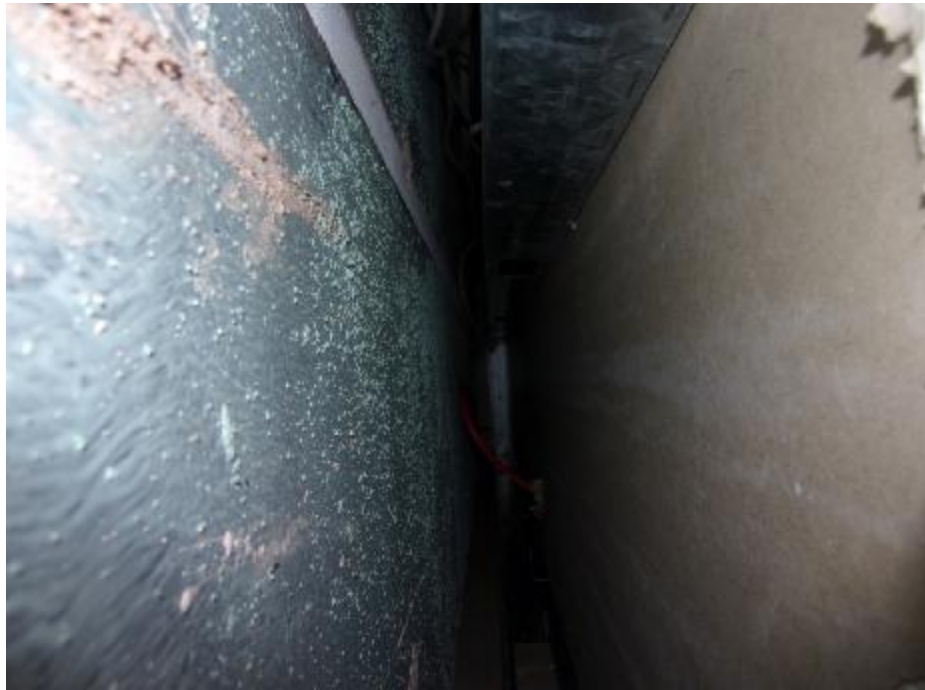
Material Comments: Riser panel accessed. No ACM's present where inspected.

Action: No Action Required

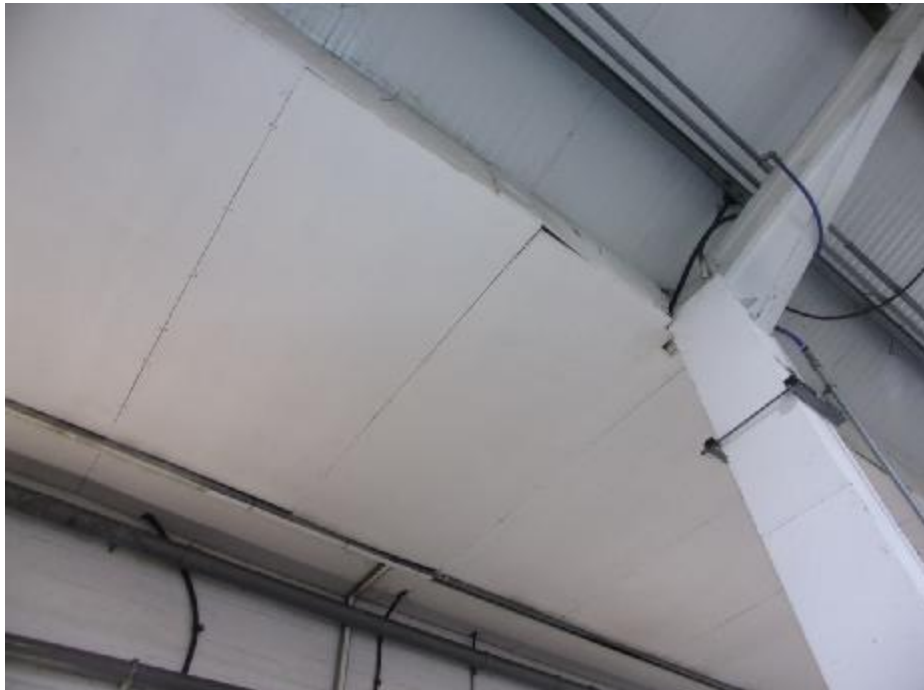
Material Comments: High level timber boxing. No access above due to damage limitations.

Action: Proceed With Caution

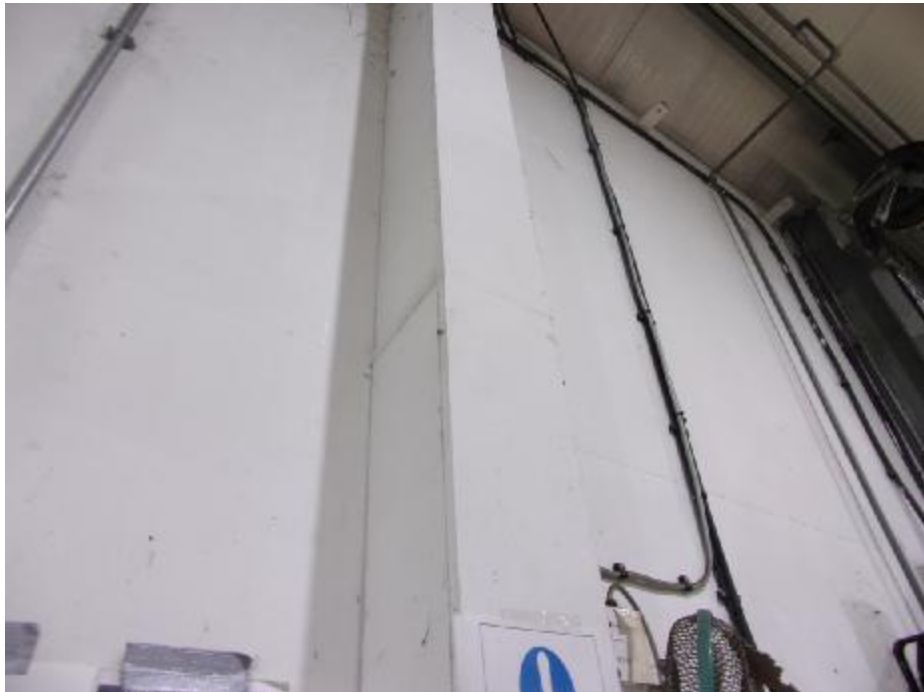
Material Comments: Non asbestos cladding to pillars throughout workshop.

Action: No Action Required

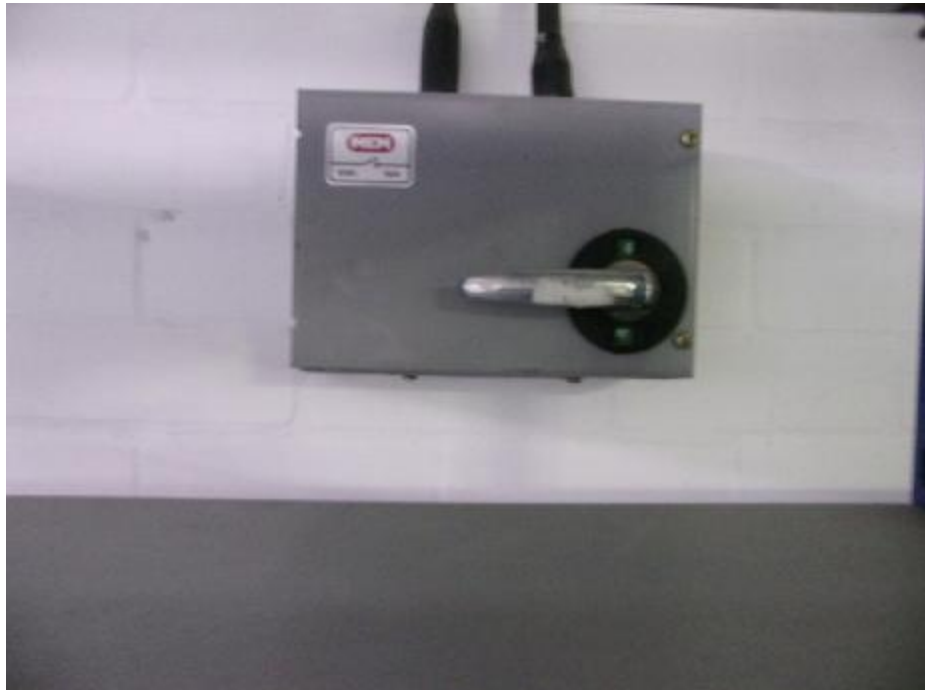
Material Risk Score:	4
Material Risk Band:	Very Low Risk
Priority Risk Score:	3

Material Comments: No access gained within electrical fuses to external wall due to live status. Presumed asbestos containing flash guards/rope lining within.

Action: Annually Re-Inspect

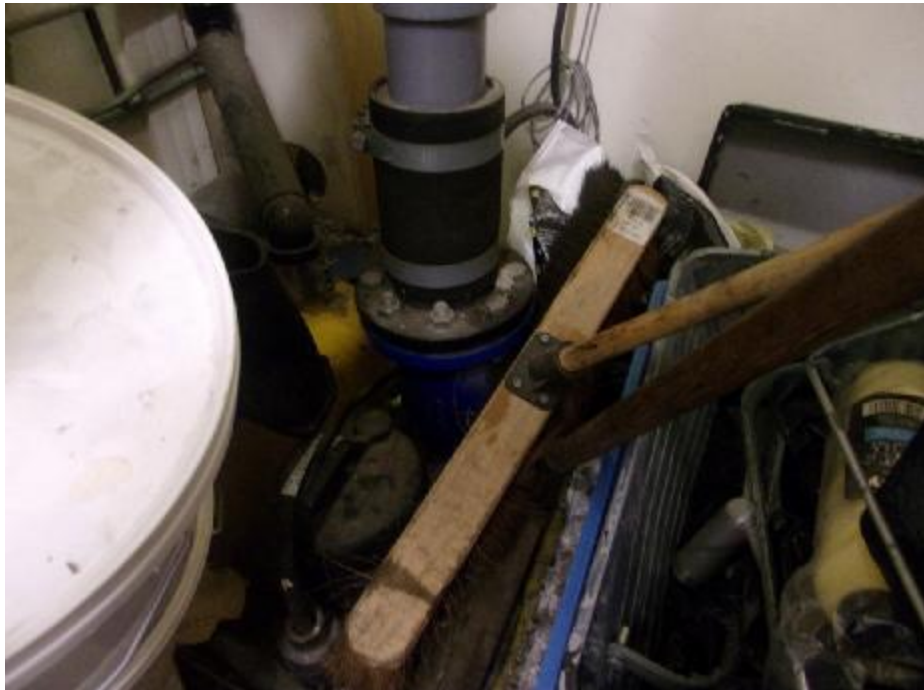
Material Comments: No access gained to flange gaskets for sampling. Presumed asbestos containing until proved otherwise.

Action: Annually Re-Inspect

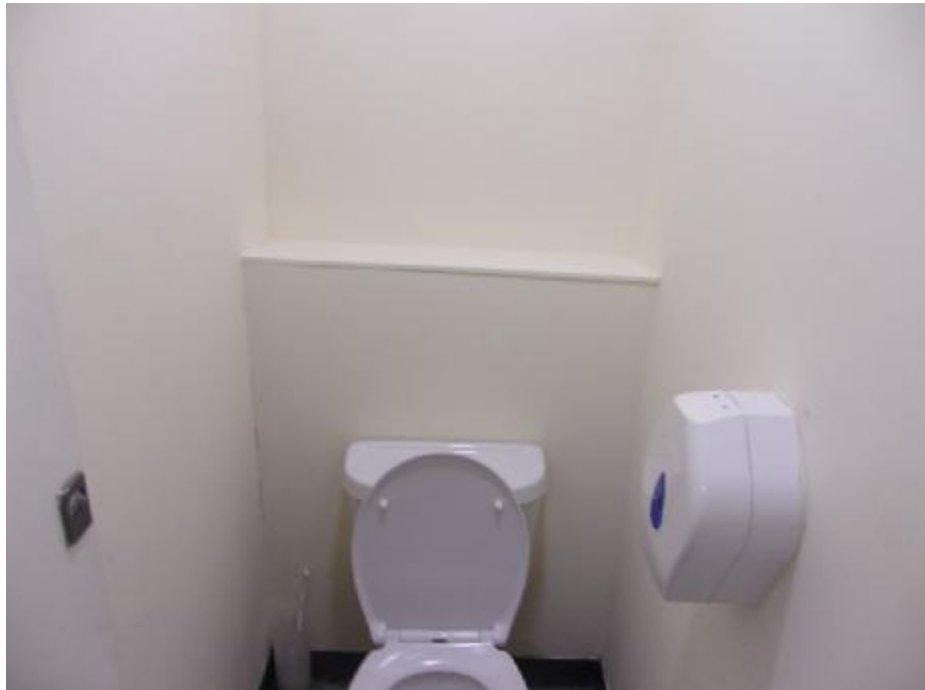
Material Comments: No access to timber boxing at rear of toilets due to damage limitations.

Action: Proceed With Caution

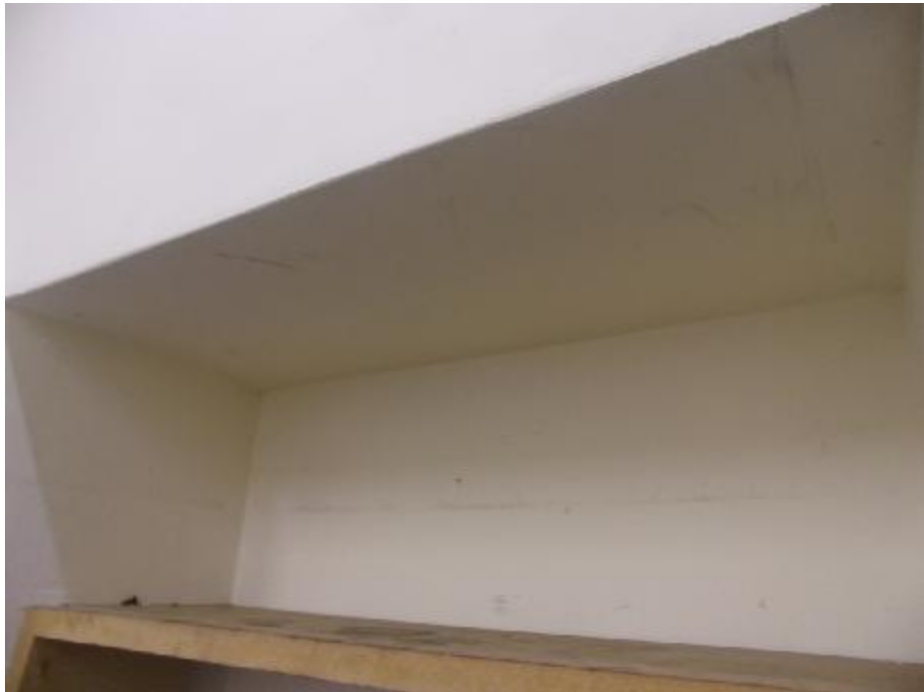
Material Comments: Plasterboard panels above book shelves and doors.

Action: No Action Required

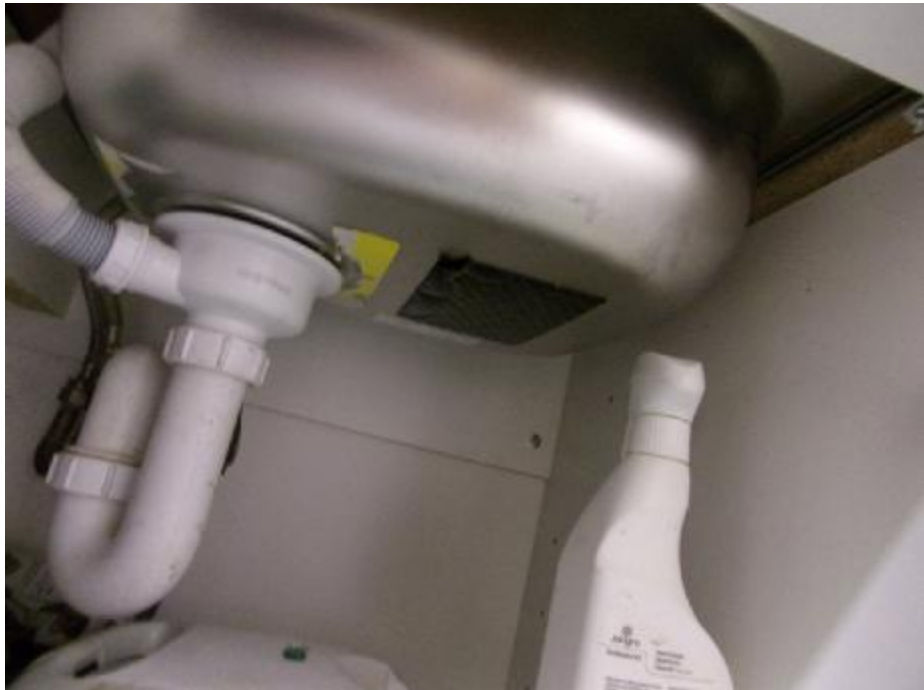
Sink pad to underside of sink unit.

No Action Required

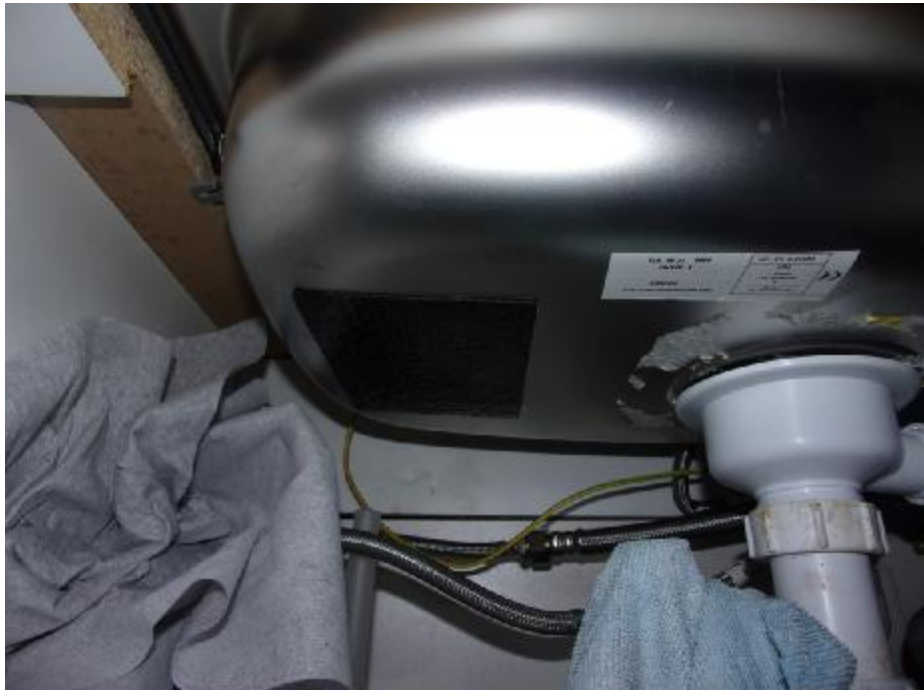
Material Comments: Sink pad to underside of sink unit.

Action: No Action Required

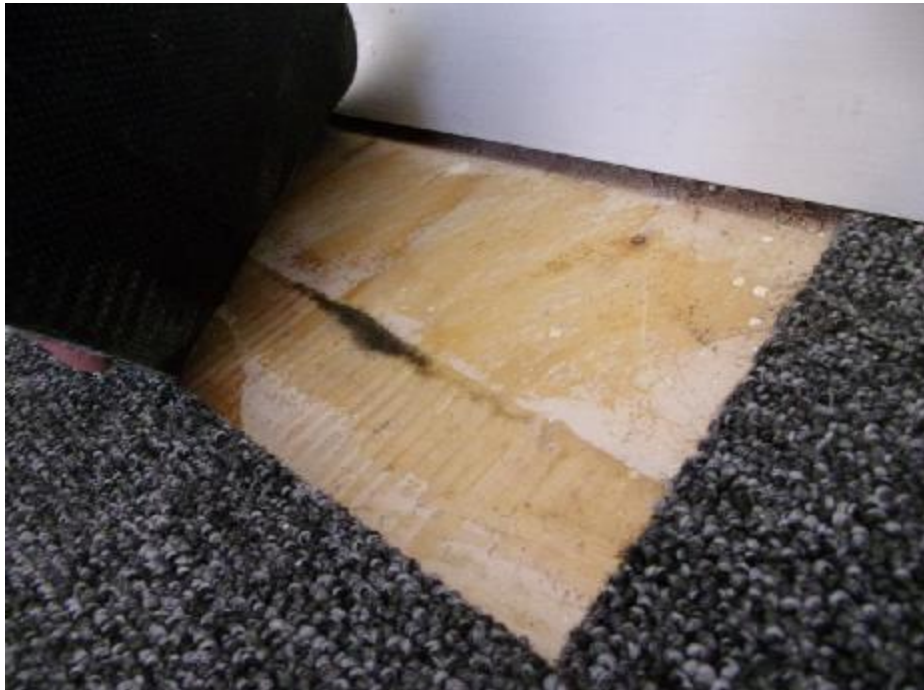
Flooring accessed throughout first floor. No ACM's present where inspected.

No Action Required

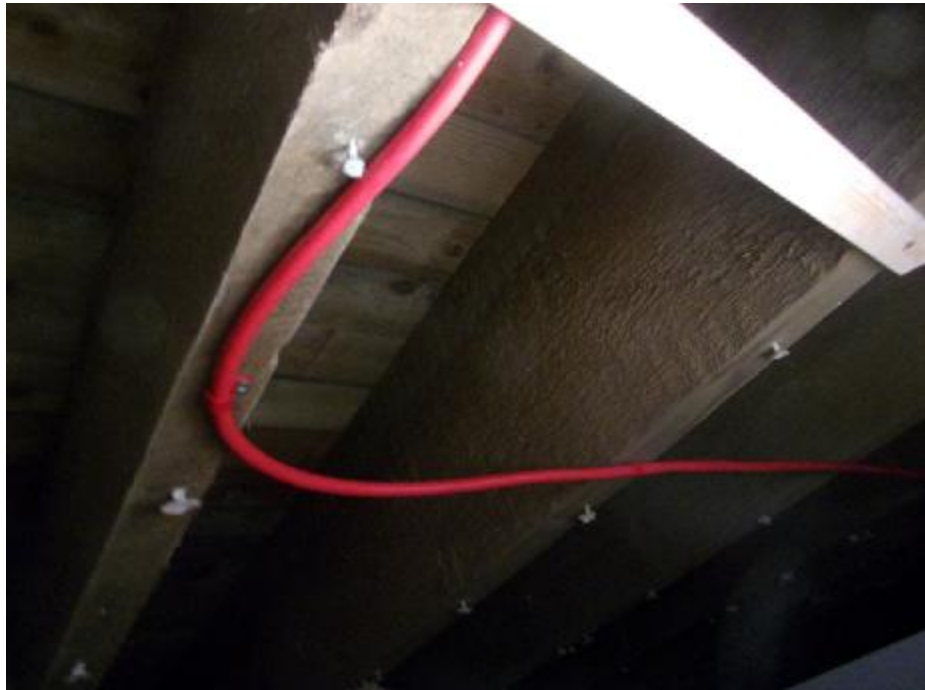
Material Comments: Residue around nail heads from old ceiling removal, above suspended ceiling.

Action: No Action Required

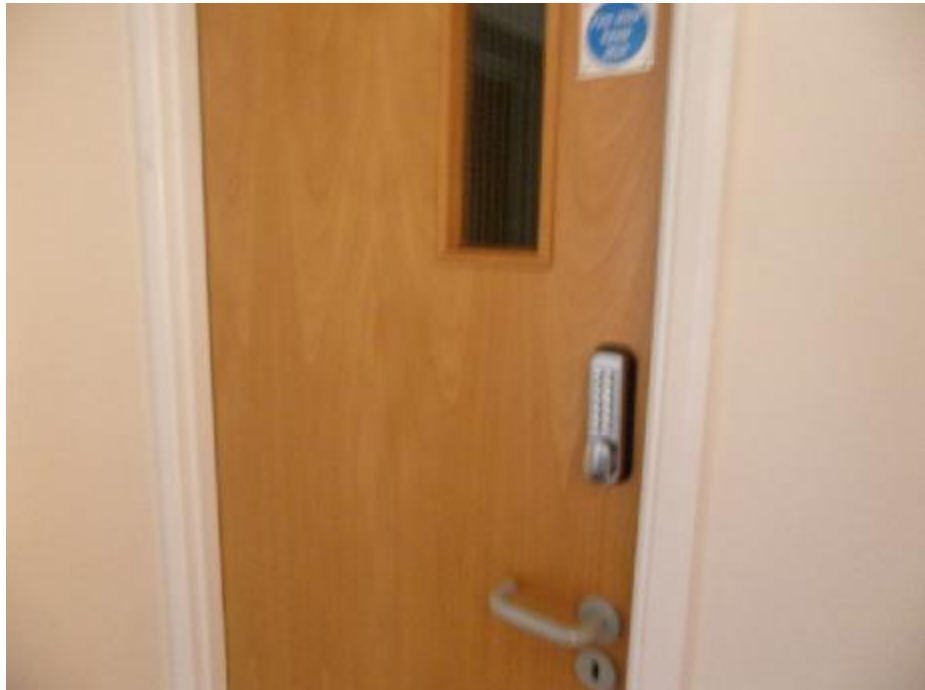
Material Comments: Area not accessed at time of survey as locked and no key provided. Assumed similar in construction type to adjoining rooms.

Action: Proceed With Caution

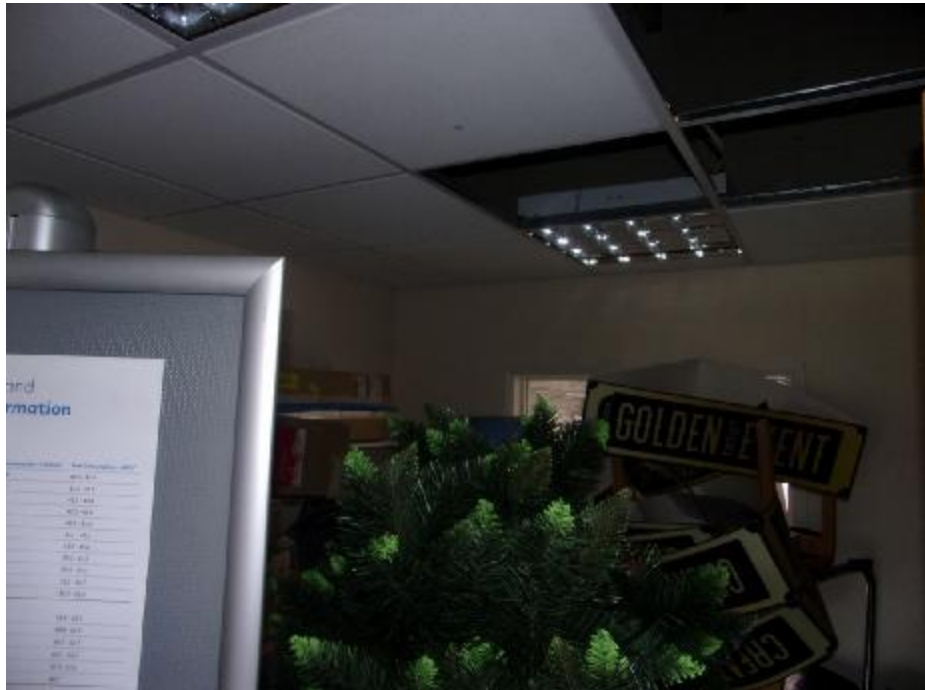
Material Comments: Limited access due to store items. No ACM's present where inspected.

Action: Proceed With Caution

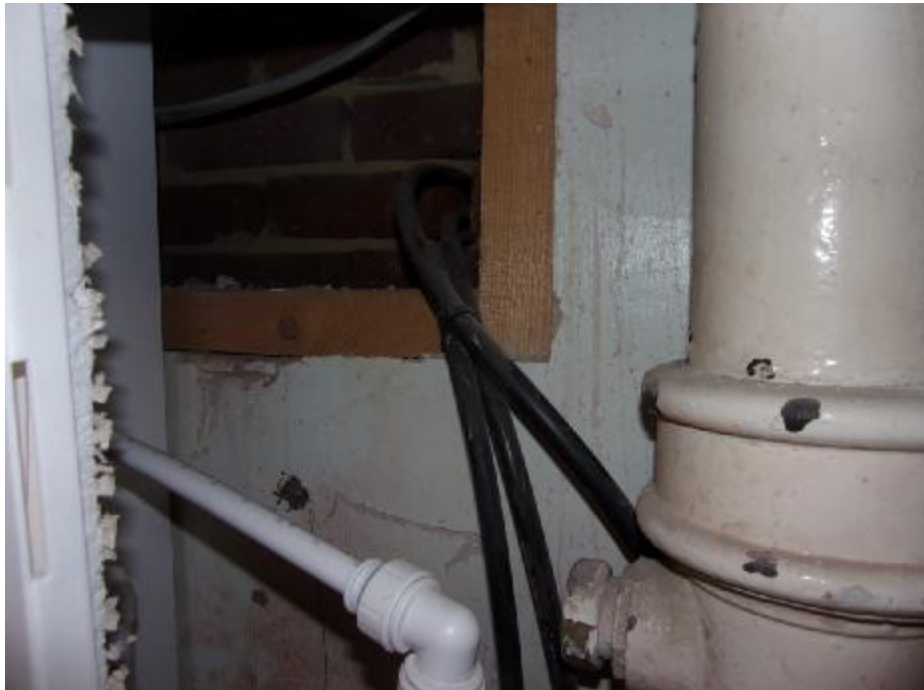
Material Comments: Riser panel accessed. No ACM's present where accessible.

Action: No Action Required

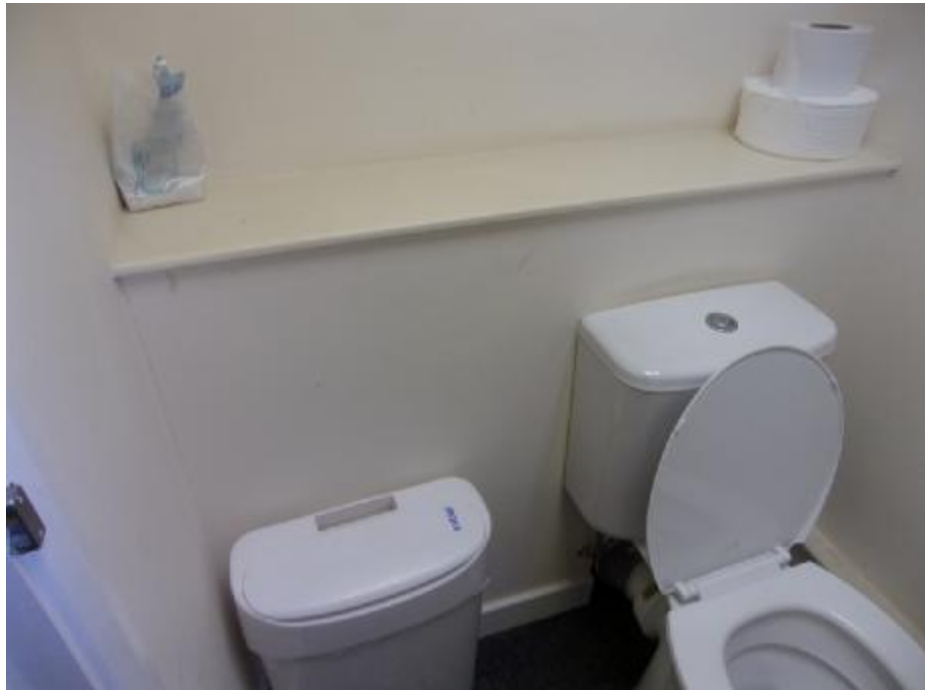
Material Comments: No access to timber boxing at rear of toilets throughout first floor area.

Action: Proceed With Caution

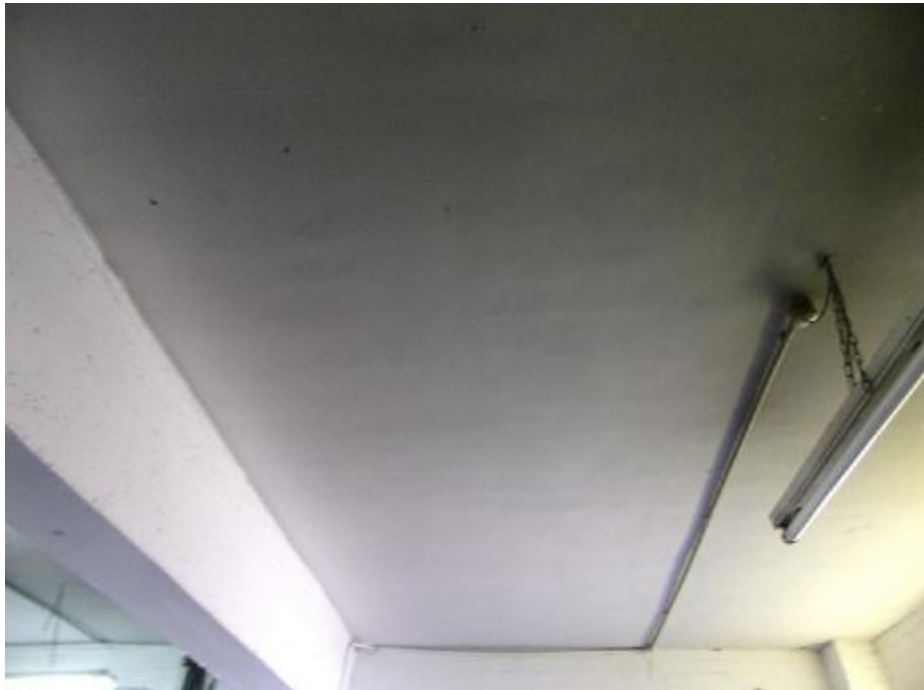
Cladding to ceiling of tyre store.

No Action Required

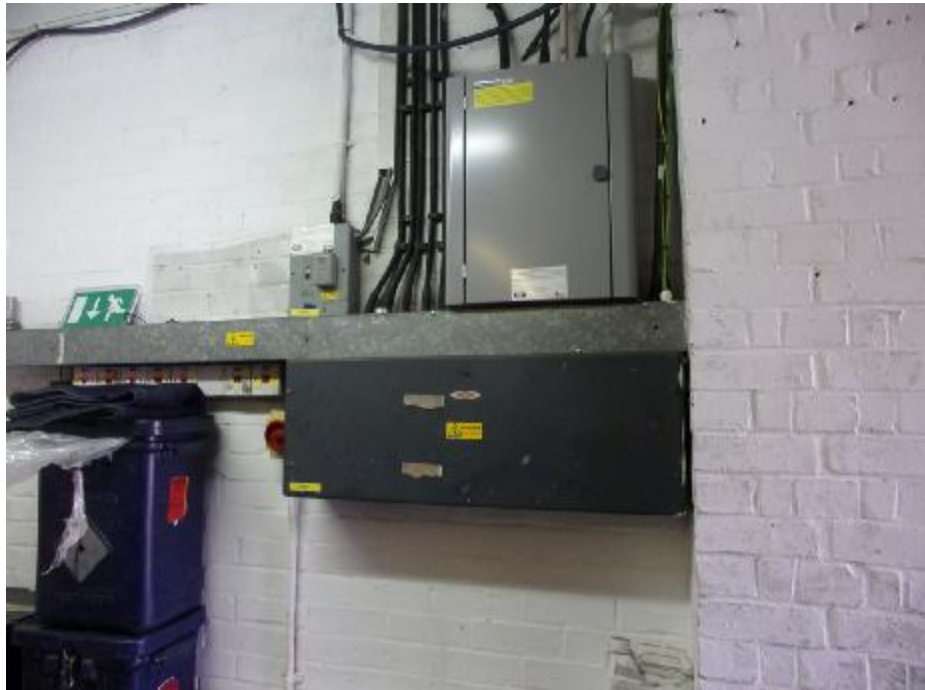
Material Risk Score:	4
Material Risk Band:	Very Low Risk
Priority Risk Score:	3

Material Comments: No access gained within electrical fuses due to live status. Presumed asbestos containing flash guards/rope lining within.

Action: Annually Re-Inspect

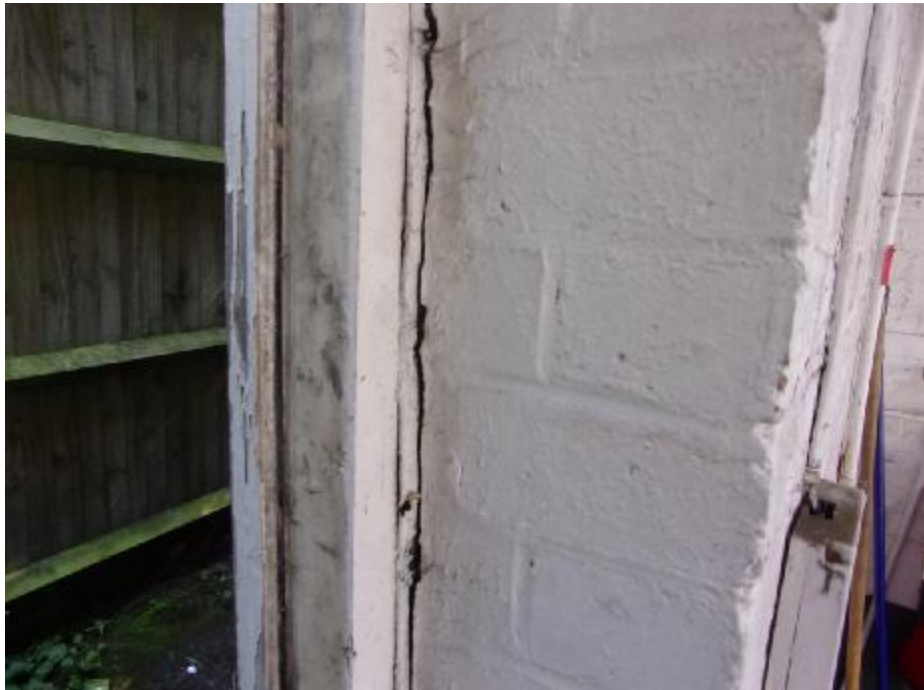
Bitumen packing to door.

No Action Required

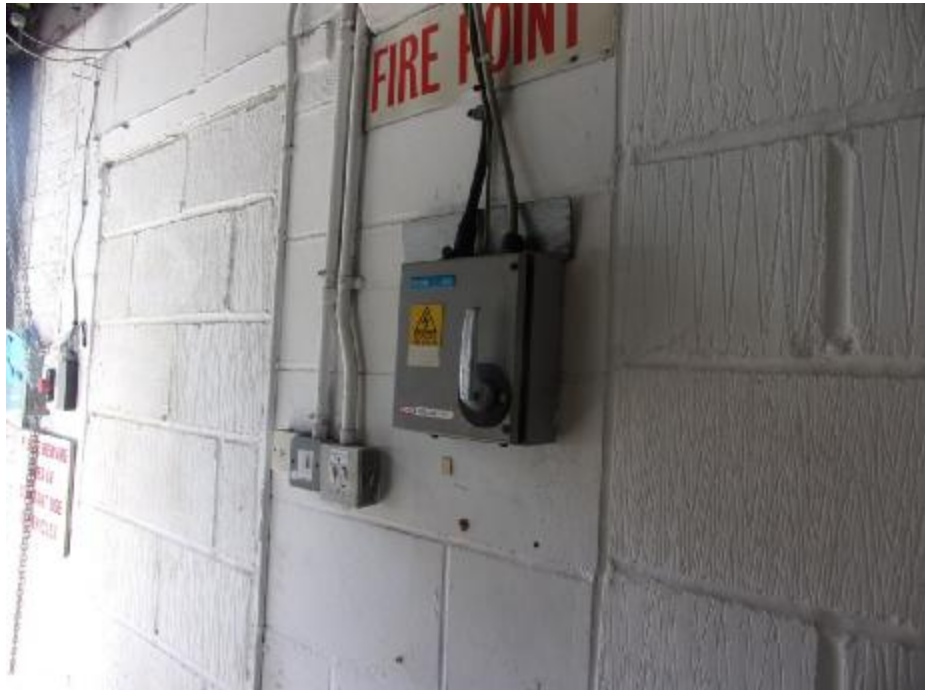
Material Comments: No access gained within electrical fuses due to live status. Presumed asbestos containing flash guards/rope lining within.

Action: Annually Re-Inspect

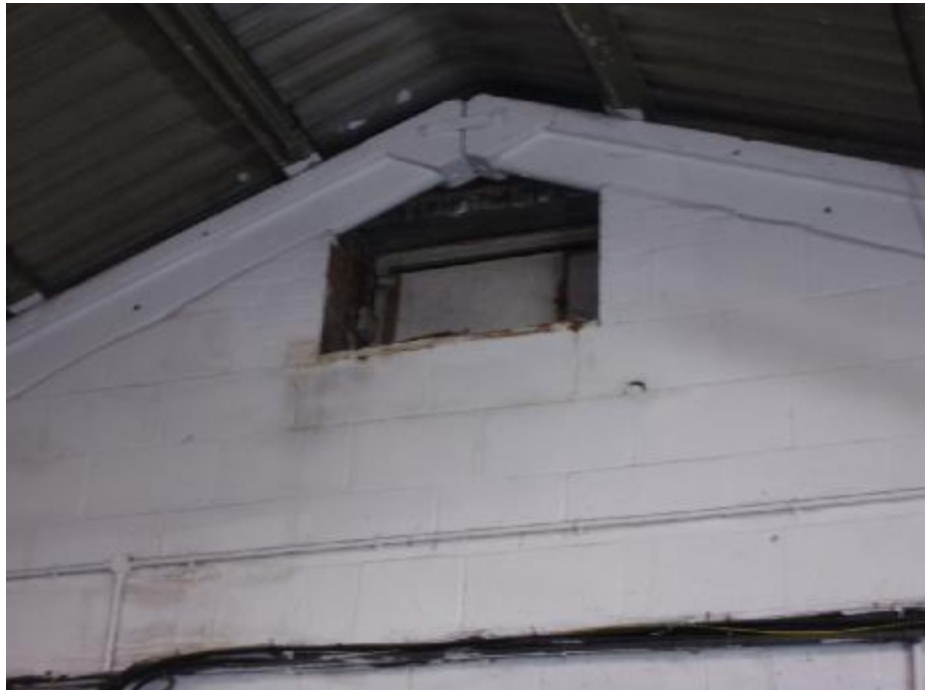
Material Comments: No access to high level hatch due to height restrictions. Should any maintenance/remedial works be planned inspection recommended once access is available.

Action: Proceed With Caution

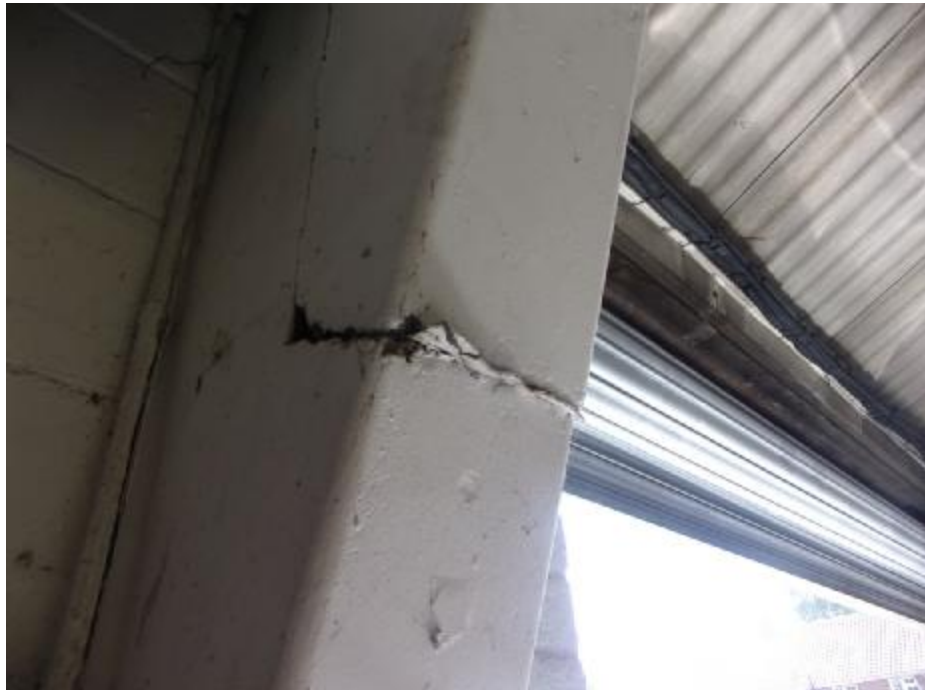
Material Comments: Bitumen packing to steels.

Action: No Action Required

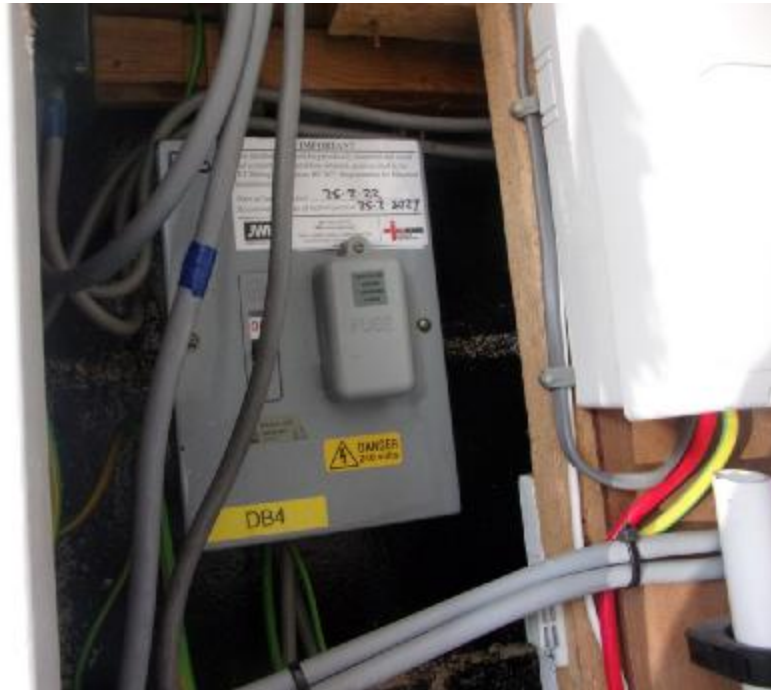
Material Comments: No access gained within electrical fuse by front wall due to live status. Presumed asbestos containing flash guards/rope lining within.

Action: Annually Re-Inspect

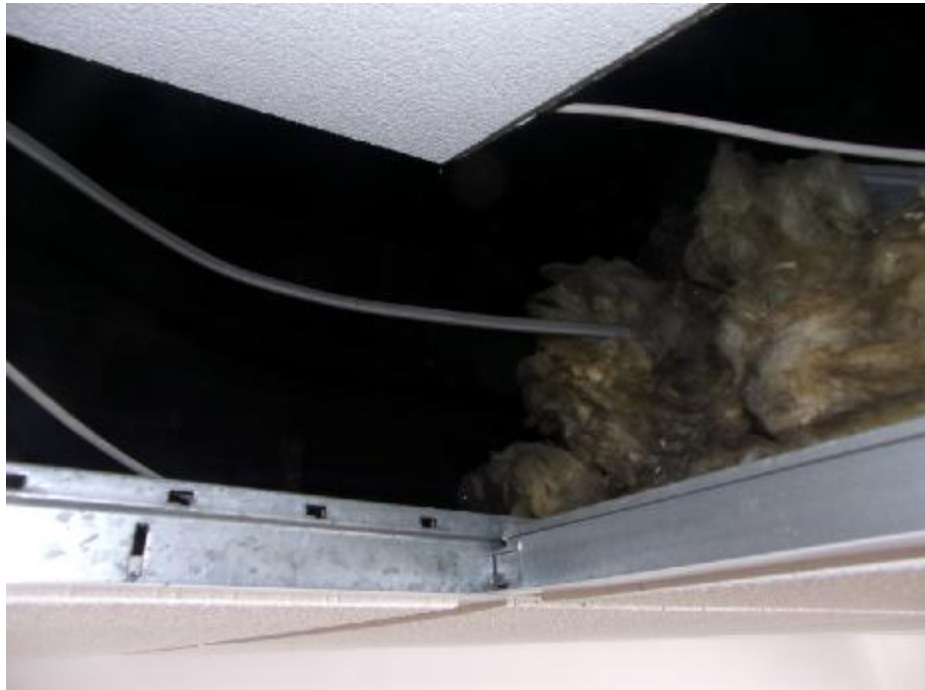
Material Comments: Limited access above suspended ceiling due to amount of MMMF insulation present. No ACM's present where inspected.

Action: Proceed With Caution

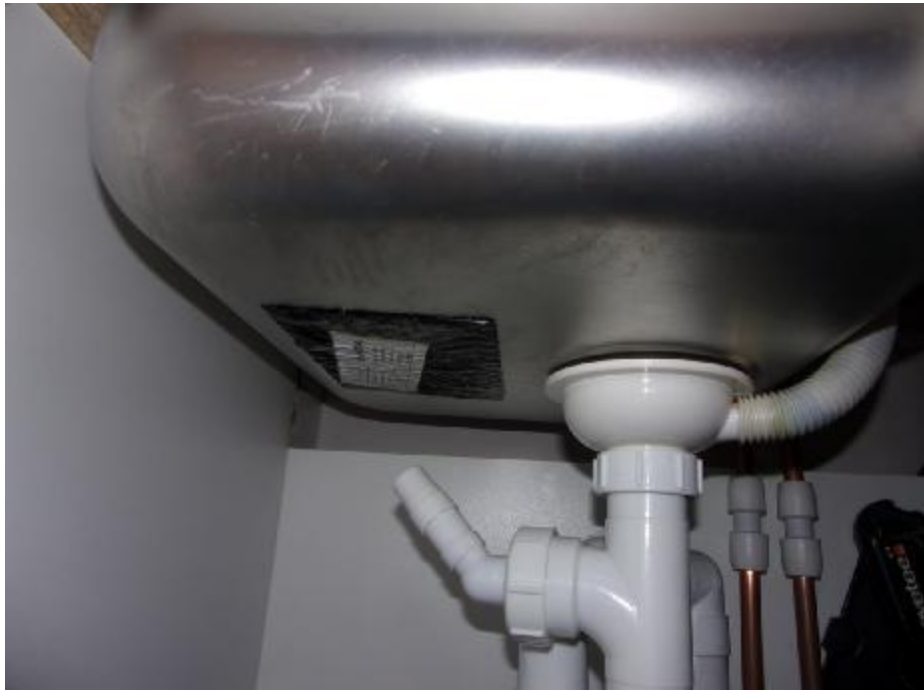
Material Comments: Sink pad to underside of sink unit.

Action: No Action Required

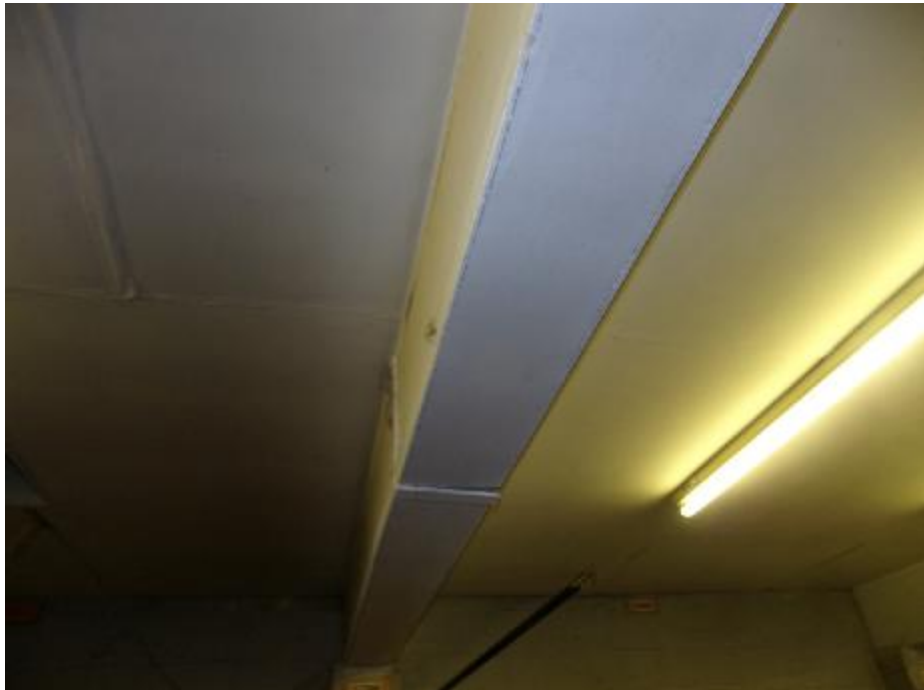
Insulation board cladding to beams including beading to beams also.

Annually Re-Inspect

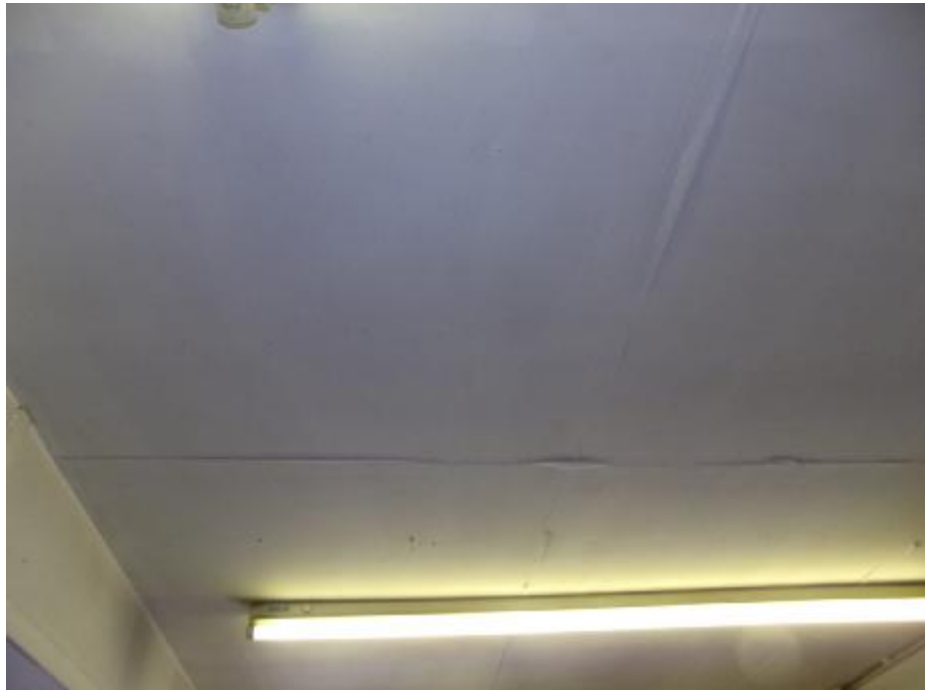
Material Comments: Non asbestos cladding to ceiling. No access was made above this due to damage limitations. Insulation board may be above due to its presence on the beams. Should any maintenance/remedial works be planned inspection recommended once access is available.

Action: Proceed With Caution

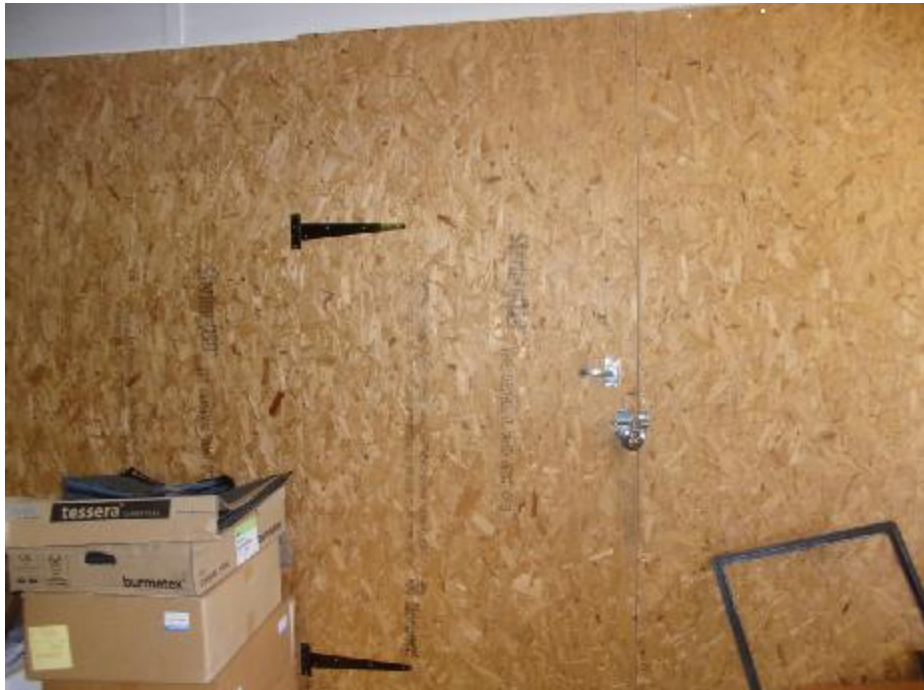
No access to store room due to being locked and no key provided at time of the survey. Presumed to have insulation board cladding to the beams also. Extent is unknown.

Action: Annually Re-Inspect

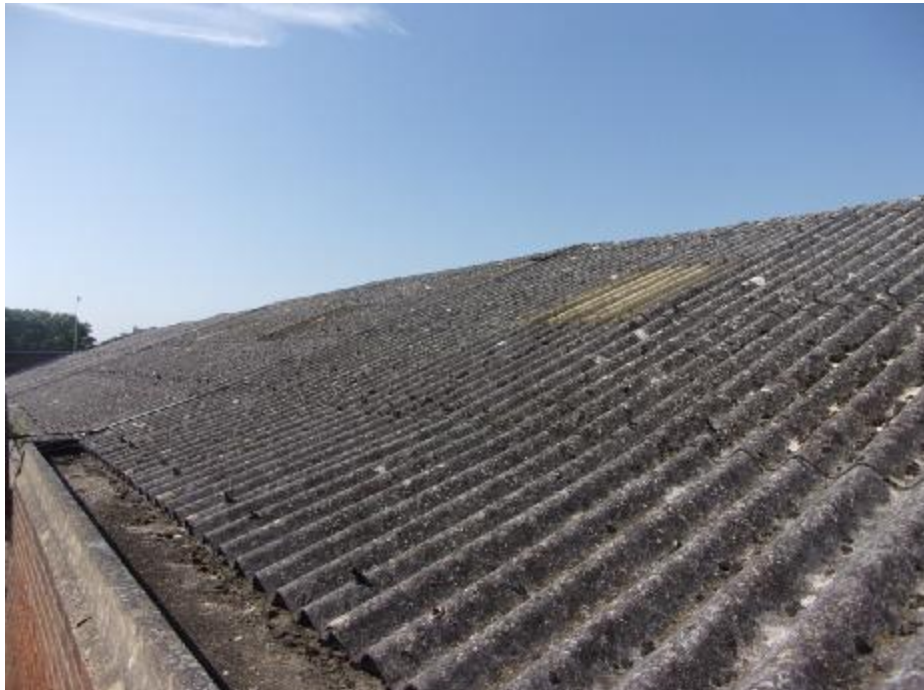
Cement roof sheets to mazda showroom.

Annually Re-Inspect
