Asbestos Management Survey for Hendy Group Limited

Hendy, 18-22 Lottbridge Drove
East Sussex
BN23 6NS

Project Number: AS10788

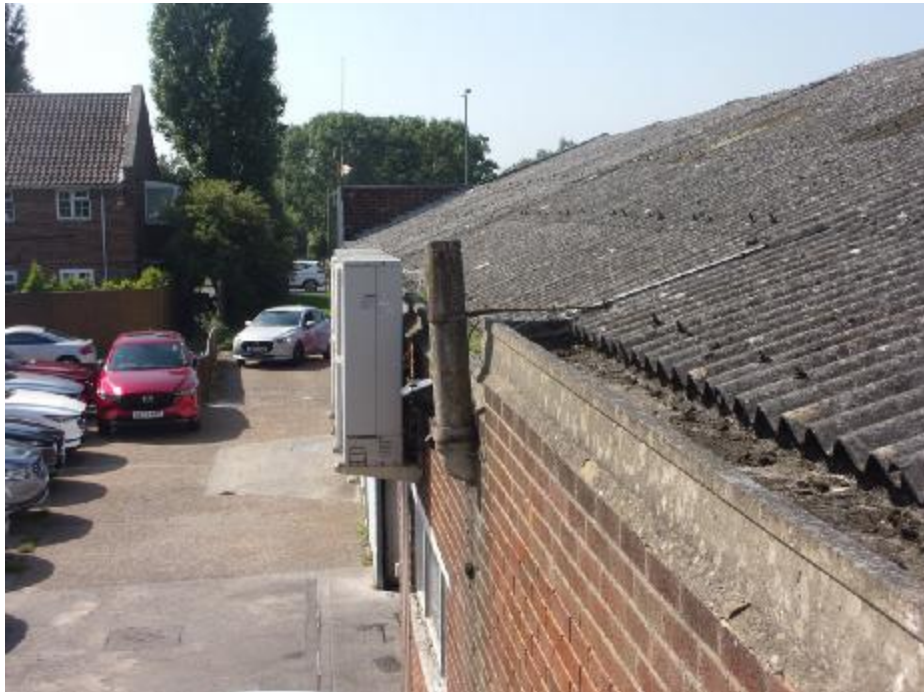
Cement flue pipe to Mazda showroom. Unable to sample due to access restrictions.

Annually Re-Inspect

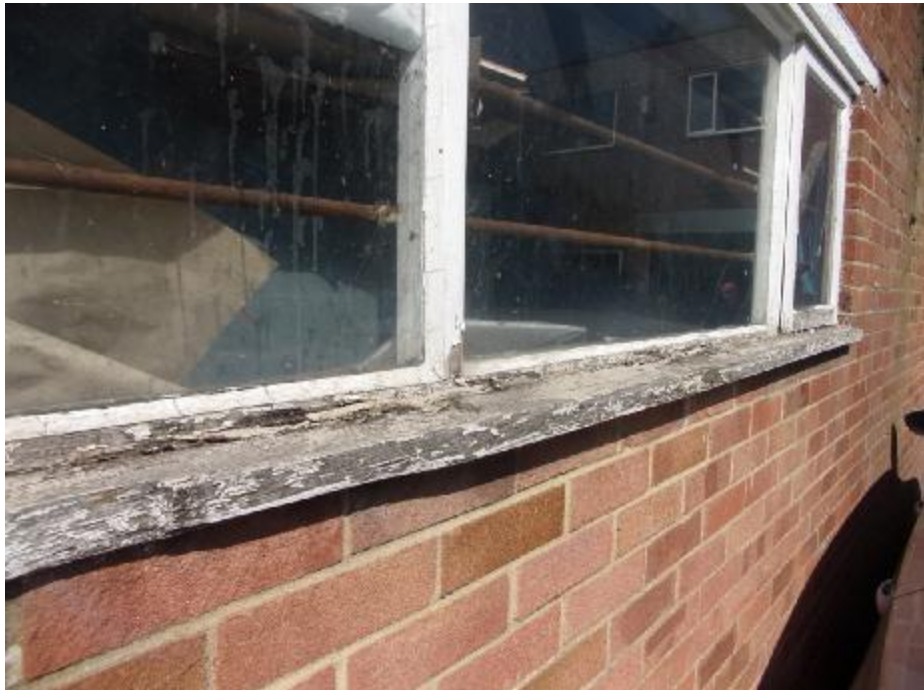
Mastic to windows at rear of Mazda showroom.

No Action Required

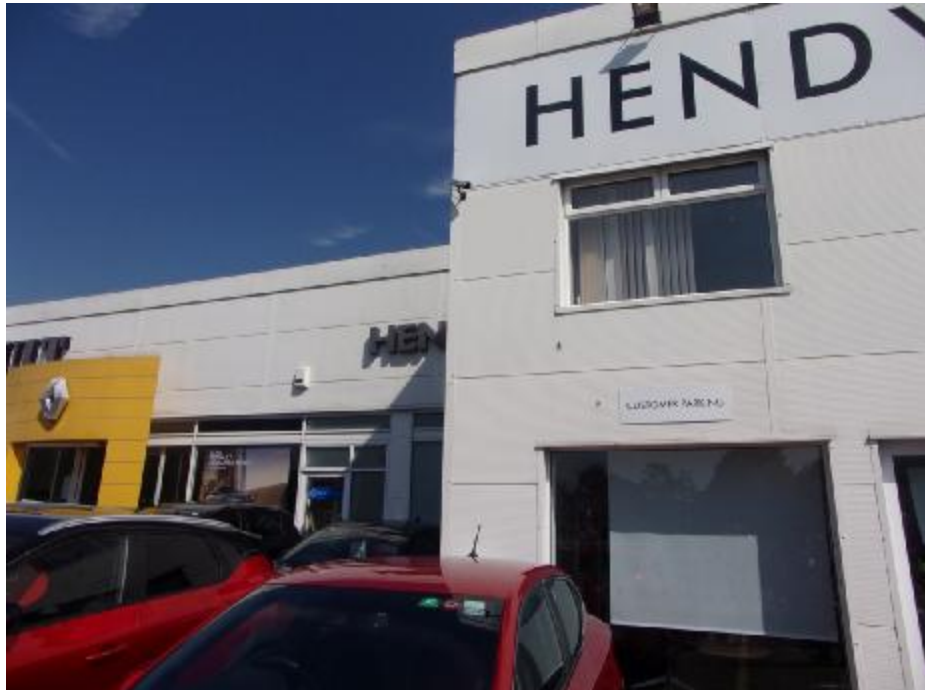
No access behind metal cladding due to damage limitations. Should any maintenance/remedial works be planned inspection recommended once access is available.

Action: No Action Required

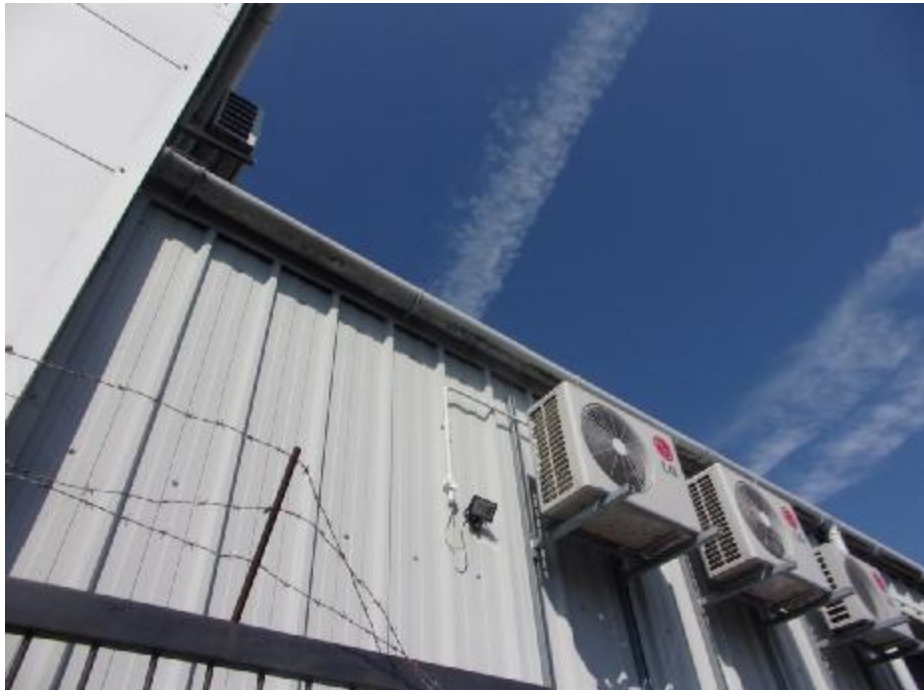
uPVC rainwater goods present throughout site.

No Action Required

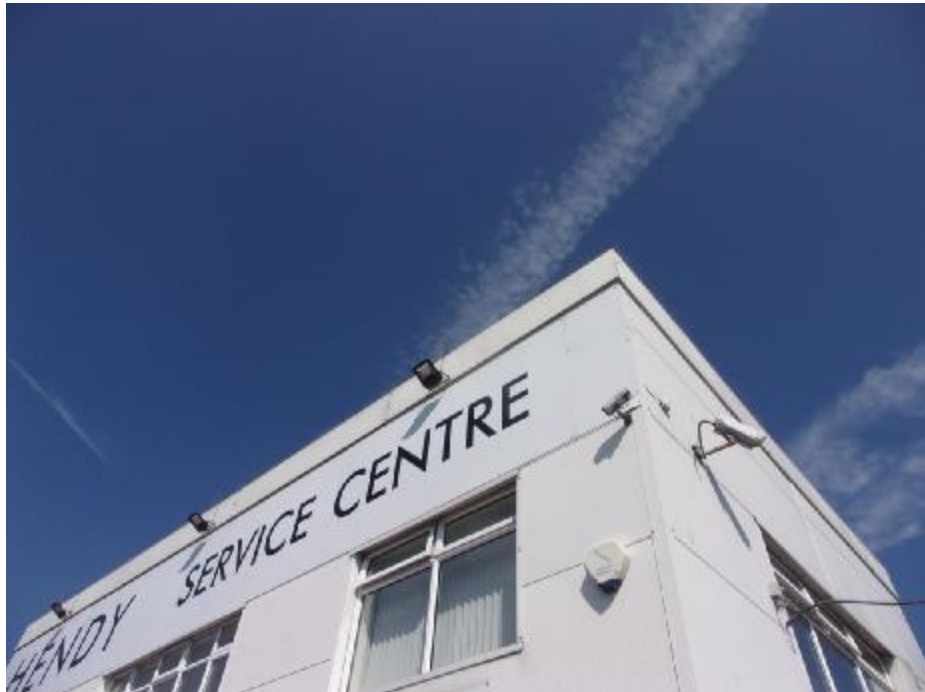
No access to high level roof due to access restrictions. Strongly presumed to be a galvanised metal roof based of evidence seen online and while on site.

Proceed With Caution
