STARK Re-inspection with Priority Assessments

SURVEY LOCATION: Jewson & Graham (Bexhill-on-Sea 471 & 365), Beeching Road, Bexhill-on-Sea, TN39 3LG

PROJECT NUMBER: M-162757

SURVEY DATE: 26 March 2025

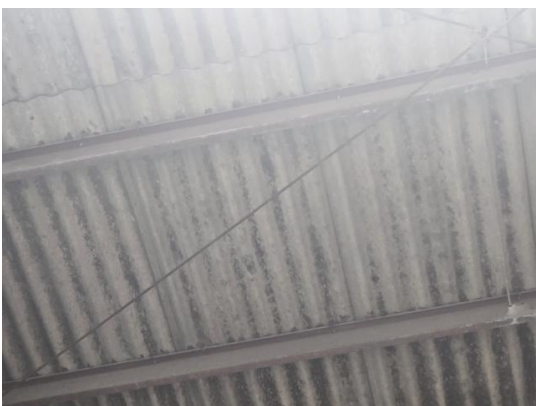
Building	Jewsons	Level	Ground Floor
Location	008 / Managers Office	Item	Corrugated roof sheets within ceiling void
Material	Cement	Extent	12m ²

Sample Reference	Sample XM-144793-X1	Asbestos Types(s)	Chrysotile
Accessibility	Usually inaccessible/Unlikely to be disturbed	Recommendation	Manage
Sample Notes	-

Product Type	Asbestos reinforced composites etc. (1)	Extent of Damage	Low damage (1)
Surface Treatment	Enclosed sprays & lagging, sealed AIB, textiles, gaskets & cement products (1)	Asbestos Type	Chrysotile (1)
Material Assessment Score	4 / Very Low

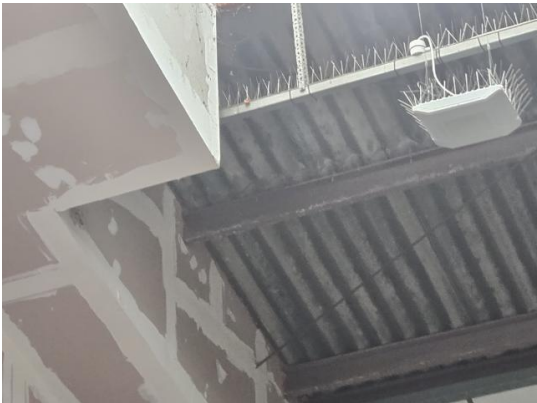
Building	Jewsons	Level	Ground Floor
Location	009 / Office	Item	Corrugated roof sheets within ceiling void
Material	Cement	Extent	90m ²

Sample Reference	Sample XM-144793-X1	Asbestos Types(s)	Chrysotile
Accessibility	Usually inaccessible/Unlikely to be disturbed	Recommendation	Manage
Sample Notes	-

Product Type	Asbestos reinforced composites etc. (1)	Extent of Damage	Low damage (1)
Surface Treatment	Enclosed sprays & lagging, sealed AIB, textiles, gaskets & cement products (1)	Asbestos Type	Chrysotile (1)
Material Assessment Score	4 / Very Low

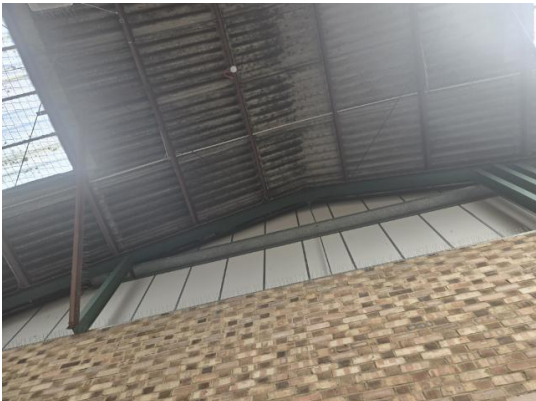
Building	Jewsons	Level	Ground Floor
Location	011 / Store	Item	Corrugated roof sheets within ceiling void
Material	Cement	Extent	15m ²

Sample Reference	Sample XM-144793-X1	Asbestos Types(s)	Chrysotile
Accessibility	Usually inaccessible/Unlikely to be disturbed	Recommendation	Manage
Sample Notes	-

Product Type	Asbestos reinforced composites etc. (1)	Extent of Damage	Low damage (1)
Surface Treatment	Enclosed sprays & lagging, sealed AIB, textiles, gaskets & cement products (1)	Asbestos Type	Chrysotile (1)
Material Assessment Score	4 / Very Low

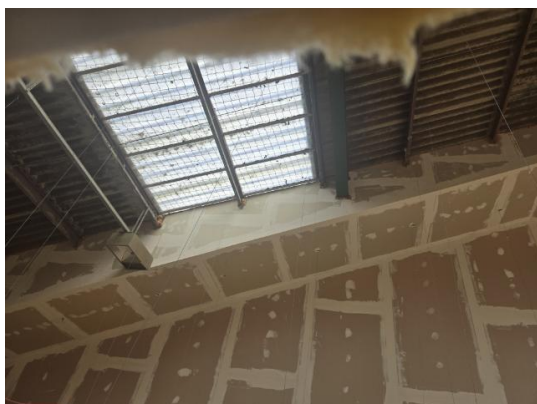
Building	Jewsons	Level	Ground Floor
Location	014 / Sales Area	Item	Corrugated roof sheets within ceiling void
Material	Cement	Extent	100m ²

Sample Reference	Sample XM-144793-X1	Asbestos Types(s)	Chrysotile
Accessibility	Usually inaccessible/Unlikely to be disturbed	Recommendation	Manage
Sample Notes	-

Product Type	Asbestos reinforced composites etc. (1)	Extent of Damage	Low damage (1)
Surface Treatment	Enclosed sprays & lagging, sealed AIB, textiles, gaskets & cement products (1)	Asbestos Type	Chrysotile (1)
Material Assessment Score	4 / Very Low

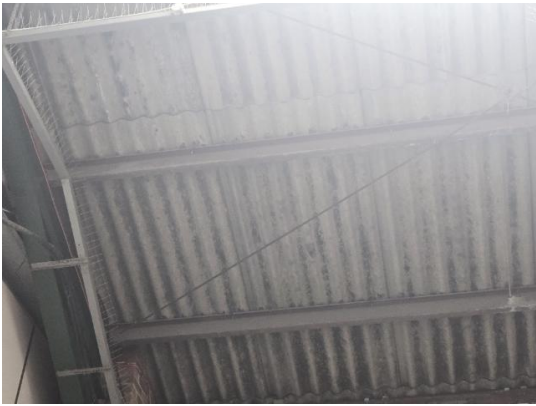
Building	Jewsons	Level	Ground Floor
Location	015 / Warehouse	Item	Corrugated roof sheets
Material	Cement	Extent	100m ²

Sample Reference	Sample XM-144793-X1	Asbestos Types(s)	Chrysotile
Accessibility	Usually inaccessible/Unlikely to be disturbed	Recommendation	Manage
Sample Notes	-

Product Type	Asbestos reinforced composites etc. (1)	Extent of Damage	Low damage (1)
Surface Treatment	Enclosed sprays & lagging, sealed AIB, textiles, gaskets & cement products (1)	Asbestos Type	Chrysotile (1)
Material Assessment Score	4 / Very Low

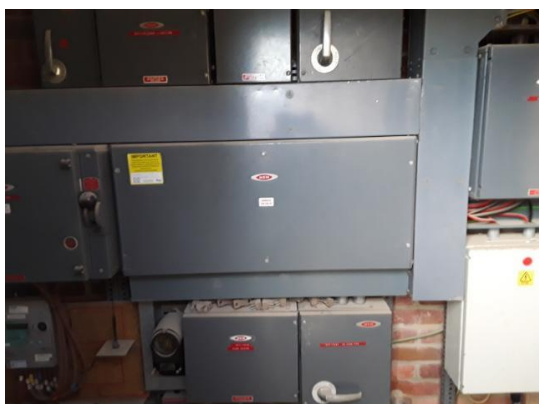
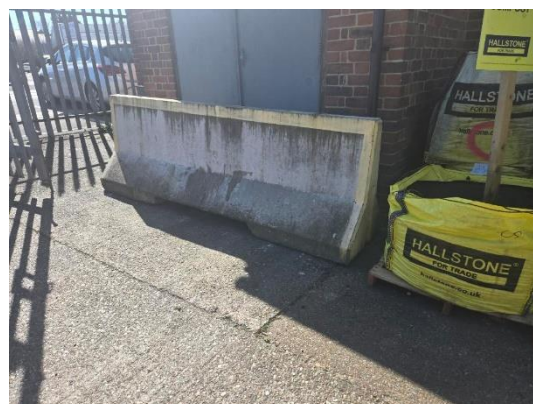
Building	Jewsons	Level	Ground Floor
Location	017 / External Store	Item	Within electrics
Material	Woven product	Extent	10no

Sample Reference	Presumed	Asbestos Types(s)	Chrysotile
Accessibility	Usually inaccessible/Unlikely to be disturbed	Recommendation	Further Inspection Required
Sample Notes	note: live so not inspected. 2025 area blocked off couldn't get inside.

Product Type	Asbestos insulating board, millboards, gaskets & ropes etc. (2)	Extent of Damage	Low damage (1)
Surface Treatment	Enclosed sprays & lagging, sealed AIB, textiles, gaskets & cement products (1)	Asbestos Type	Chrysotile (1)
Material Assessment Score	5 / Low

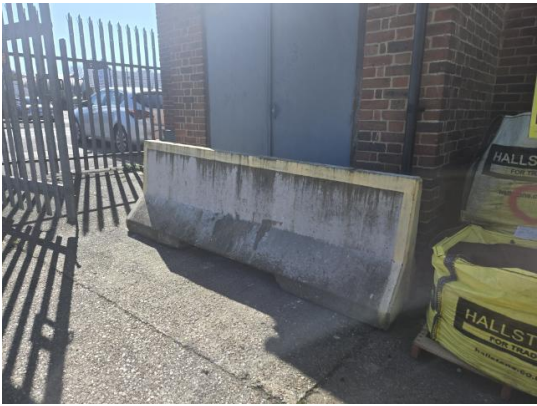
Building	Jewsons	Level	Ground Floor
Location	017 / External Store	Item	Ceiling panels
Material	Asbestos Insulating Board	Extent	4m ²

Sample Reference	Previously Sampled M-68015-04	Asbestos Types(s)	Amosite, Chrysotile
Accessibility	Usually inaccessible/Unlikely to be disturbed	Recommendation	Manage
Sample Notes	2025 area blocked off couldn't get inside

Product Type	Asbestos insulating board, millboards, gaskets & ropes etc. (2)	Extent of Damage	Good (0)
Surface Treatment	Enclosed sprays & lagging, sealed AIB, textiles, gaskets & cement products (1)	Asbestos Type	Amosite, Chrysotile (2)
Material Assessment Score	5 / Low

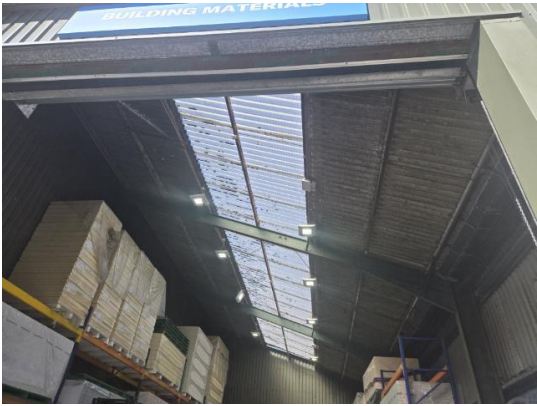
Building	Jewsons	Level	Ground Floor
Location	018 / Plaster Shed	Item	Corrugated roof sheets
Material	Cement	Extent	60m ²

Sample Reference	Sample XM-144793-X2	Asbestos Types(s)	Chrysotile
Accessibility	Usually inaccessible/Unlikely to be disturbed	Recommendation	Manage
Sample Notes	-

Product Type	Asbestos reinforced composites etc. (1)	Extent of Damage	Low damage (1)
Surface Treatment	Enclosed sprays & lagging, sealed AIB, textiles, gaskets & cement products (1)	Asbestos Type	Chrysotile (1)
Material Assessment Score	4 / Very Low

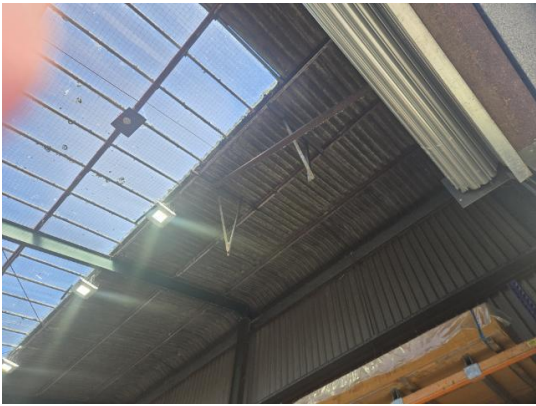
Building	Jewsons	Level	Ground Floor
Location	019 / Timber Shed	Item	Corrugated roof sheets
Material	Cement	Extent	60m ²

Sample Reference	Sample XM-144793-X2	Asbestos Types(s)	Chrysotile
Accessibility	Usually inaccessible/Unlikely to be disturbed	Recommendation	Manage
Sample Notes	-

Product Type	Asbestos reinforced composites etc. (1)	Extent of Damage	Low damage (1)
Surface Treatment	Enclosed sprays & lagging, sealed AIB, textiles, gaskets & cement products (1)	Asbestos Type	Chrysotile (1)
Material Assessment Score	4 / Very Low

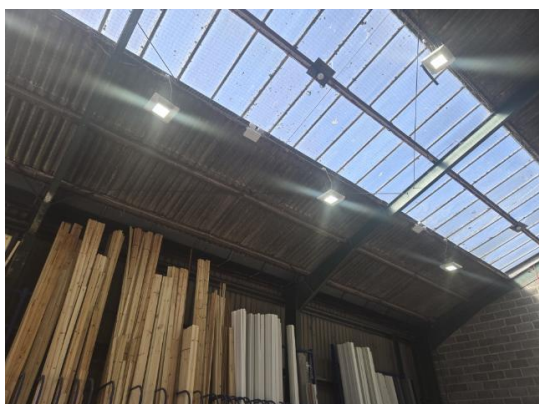
Building	Jewsons	Level	Ground Floor
Location	020 / Timber Mill	Item	Corrugated roof sheets
Material	Cement	Extent	100m ²

Sample Reference	Sample XM-144793-X2	Asbestos Types(s)	Chrysotile
Accessibility	Usually inaccessible/Unlikely to be disturbed	Recommendation	Manage
Sample Notes	-

Product Type	Asbestos reinforced composites etc. (1)	Extent of Damage	Low damage (1)
Surface Treatment	Enclosed sprays & lagging, sealed AIB, textiles, gaskets & cement products (1)	Asbestos Type	Chrysotile (1)
Material Assessment Score	4 / Very Low

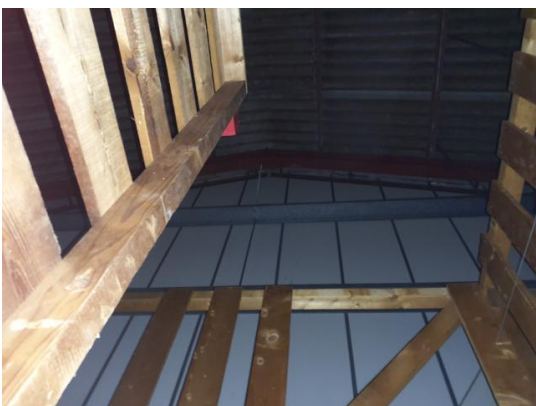
Building	Jewsons	Level	1st Floor
Location	013 / Loft	Item	Corrugated roof sheets within ceiling void
Material	Cement	Extent	25m ²

Sample Reference	Sample XM-144793-X1	Asbestos Types(s)	Chrysotile
Accessibility	Usually inaccessible/Unlikely to be disturbed	Recommendation	Manage
Sample Notes	-

Product Type	Asbestos reinforced composites etc. (1)	Extent of Damage	Low damage (1)
Surface Treatment	Enclosed sprays & lagging, sealed AIB, textiles, gaskets & cement products (1)	Asbestos Type	Chrysotile (1)
Material Assessment Score	4 / Very Low

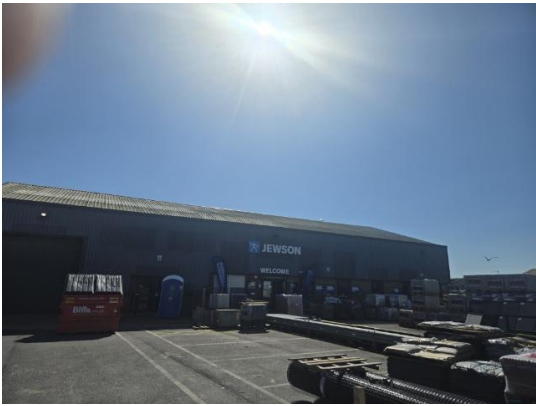
Building	Jewsons	Level	External
Location	016 / Externals of Building 1	Item	Corrugated roof sheets
Material	Cement	Extent	500m ²

Sample Reference	Previously Sampled M-144793-01	Asbestos Types(s)	Chrysotile
Accessibility	Usually inaccessible/Unlikely to be disturbed	Recommendation	Manage
Sample Notes	-

Product Type	Asbestos reinforced composites etc. (1)	Extent of Damage	Low damage (1)
Surface Treatment	Enclosed sprays & lagging, sealed AIB, textiles, gaskets & cement products (1)	Asbestos Type	Chrysotile (1)
Material Assessment Score	4 / Very Low

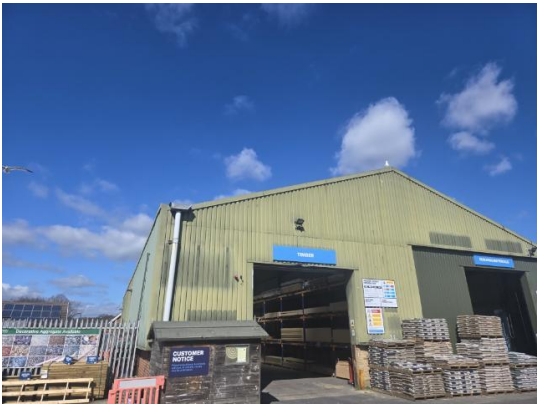
Building	Jewsons	Level	External
Location	021 / External building 2	Item	Corrugated roof sheets
Material	Cement	Extent	400m ²

Sample Reference	Previously Sampled M-144793-02	Asbestos Types(s)	Chrysotile
Accessibility	Usually inaccessible/Unlikely to be disturbed	Recommendation	Manage
Sample Notes	-

Product Type	Asbestos reinforced composites etc. (1)	Extent of Damage	Low damage (1)
Surface Treatment	Enclosed sprays & lagging, sealed AIB, textiles, gaskets & cement products (1)	Asbestos Type	Chrysotile (1)
Material Assessment Score	4 / Very Low
