# STARK Re-inspection with Priority Assessments

**SURVEY LOCATION:** Jewson (Northiam 3810), Whitbread Lane, Northiam,  
TN31 6QP  
**PROJECT NUMBER:** M-162769  
**CLIENT:** STARK Building Materials UK  
**UPRN:** 3810  
**SURVEY DATE:** 26 March 2025  
**REPORT DATE:** 16/05/2025

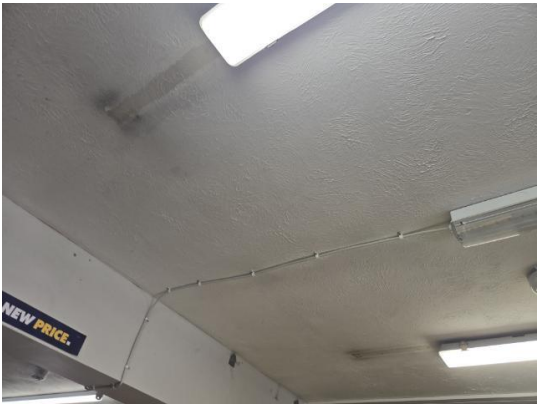
<b>Building</b>	Building 1	<b>Level</b>	Ground Floor
<b>Location</b>	001 / Shop Floor	<b>Item</b>	Ceiling
<b>Material</b>	Textured coating	<b>Extent</b>	60m <sup>2</sup>

<b>Sample Reference</b>	Previously Sampled M-68179-02	<b>Asbestos Types(s)</b>	Chrysotile
<b>Accessibility</b>	Occasional Disturbance	<b>Recommendation</b>	Manage
<b>Sample Notes</b>	-

<b>Product Type</b>	Asbestos reinforced composites etc. (1)	<b>Extent of Damage</b>	Good (0)
<b>Surface Treatment</b>	Composite materials, decorative finishes, vinyl products etc (0)	<b>Asbestos Type</b>	Chrysotile (1)
<b>Material Assessment Score</b>	2 / Very Low

<b>Normal Occupancy Activity</b>	Rare Disturbance - Store (0)	<b>Secondary Activity</b>	Rare Disturbance - Store (0)		
<b>Likelihood of Disturbance (Access)</b>	Occasional Disturbance (1)	<b>Likelihood of Disturbance (Extent)</b>	> 50m (3)	<b>Disturbance (Location)</b>	Rooms < 100M2 (2)
<b>Exposure Potential (Usage)</b>	Daily (3)	<b>Exposure Potential (Frequency of Use)</b>	Unlikely to be disturbed (0)	<b>Exposure Potential (No. of Persons)</b>	4 to 10 (2)
<b>Maintenance Activity (Frequency)</b>	3 - 6 Hours (2)	<b>Maintenance Activity (Type)</b>	Minor Disturbance (0)	<b>Total Risk Assessment Score</b>	7 / Very Low

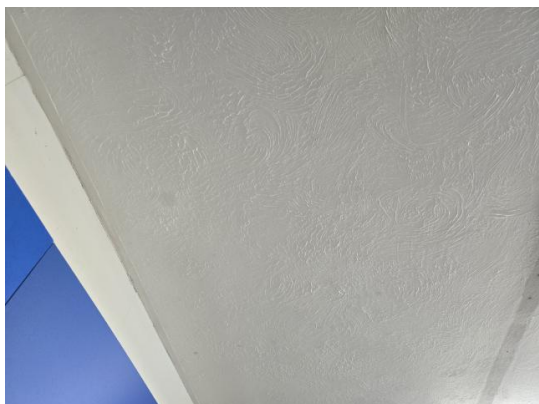
<b>Building</b>	Building 1	<b>Level</b>	Ground Floor
<b>Location</b>	002 / Counter	<b>Item</b>	Ceiling
<b>Material</b>	Textured coating	<b>Extent</b>	14m <sup>2</sup>

<b>Sample Reference</b>	Sample XM-68179-X2	<b>Asbestos Types(s)</b>	Chrysotile
<b>Accessibility</b>	Occasional Disturbance	<b>Recommendation</b>	Manage
<b>Sample Notes</b>	-

<b>Product Type</b>	Asbestos reinforced composites etc. (1)	<b>Extent of Damage</b>	Good (0)
<b>Surface Treatment</b>	Composite materials, decorative finishes, vinyl products etc (0)	<b>Asbestos Type</b>	Chrysotile (1)
<b>Material Assessment Score</b>	2 / Very Low

<b>Normal Occupancy Activity</b>	Rare Disturbance - Store (0)	<b>Secondary Activity</b>	Rare Disturbance - Store (0)		
<b>Likelihood of Disturbance (Access)</b>	Occasional Disturbance (1)	<b>Likelihood of Disturbance (Extent)</b>	10m - 50m (2)	<b>Disturbance (Location)</b>	Rooms < 100M2 (2)
<b>Exposure Potential (Usage)</b>	Daily (3)	<b>Exposure Potential (Frequency of Use)</b>	Unlikely to be disturbed (0)	<b>Exposure Potential (No. of Persons)</b>	1 to 3 (1)
<b>Maintenance Activity (Frequency)</b>	3 - 6 Hours (2)	<b>Maintenance Activity (Type)</b>	Minor Disturbance (0)	<b>Total Risk Assessment Score</b>	6 / Very Low

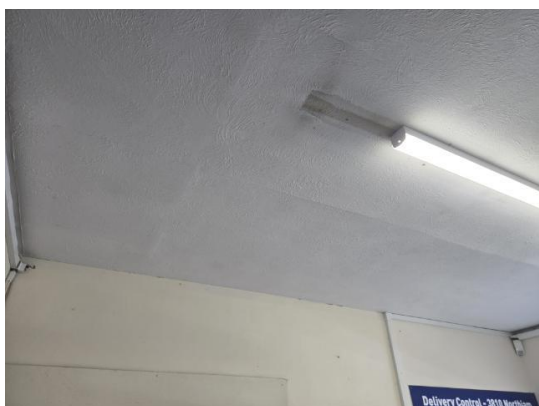
<b>Building</b>	Building 1	<b>Level</b>	Ground Floor
<b>Location</b>	003 / Sales Area	<b>Item</b>	Ceiling
<b>Material</b>	Textured coating	<b>Extent</b>	30m <sup>2</sup>

<b>Sample Reference</b>	Previously Sampled M-68179-03	<b>Asbestos Types(s)</b>	Chrysotile
<b>Accessibility</b>	Occasional Disturbance	<b>Recommendation</b>	Manage
<b>Sample Notes</b>	-

<b>Product Type</b>	Asbestos reinforced composites etc. (1)	<b>Extent of Damage</b>	Good (0)
<b>Surface Treatment</b>	Composite materials, decorative finishes, vinyl products etc (0)	<b>Asbestos Type</b>	Chrysotile (1)
<b>Material Assessment Score</b>	2 / Very Low

<b>Normal Occupancy Activity</b>	Rare Disturbance - Store (0)	<b>Secondary Activity</b>	Rare Disturbance - Store (0)		
<b>Likelihood of Disturbance (Access)</b>	Occasional Disturbance (1)	<b>Likelihood of Disturbance (Extent)</b>	10m - 50m (2)	<b>Disturbance (Location)</b>	Rooms < 100M2 (2)
<b>Exposure Potential (Usage)</b>	Daily (3)	<b>Exposure Potential (Frequency of Use)</b>	Unlikely to be disturbed (0)	<b>Exposure Potential (No. of Persons)</b>	1 to 3 (1)
<b>Maintenance Activity (Frequency)</b>	3 - 6 Hours (2)	<b>Maintenance Activity (Type)</b>	Minor Disturbance (0)	<b>Total Risk Assessment Score</b>	6 / Very Low

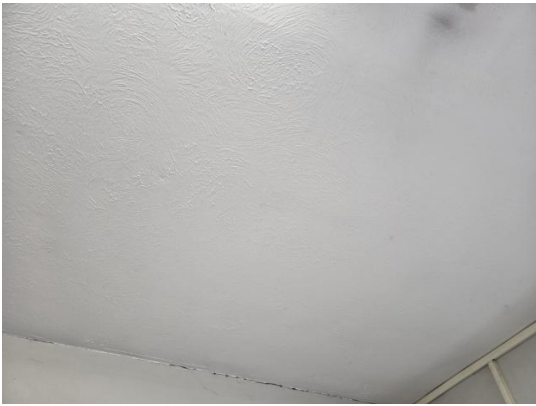
<b>Building</b>	Building 1	<b>Level</b>	Ground Floor
<b>Location</b>	004 / Manager's Office	<b>Item</b>	Ceiling
<b>Material</b>	Textured coating	<b>Extent</b>	14m <sup>2</sup>

<b>Sample Reference</b>	Sample XM-68179-X3	<b>Asbestos Types(s)</b>	Chrysotile
<b>Accessibility</b>	Occasional Disturbance	<b>Recommendation</b>	Manage
<b>Sample Notes</b>	-

<b>Product Type</b>	Asbestos reinforced composites etc. (1)	<b>Extent of Damage</b>	Good (0)
<b>Surface Treatment</b>	Composite materials, decorative finishes, vinyl products etc (0)	<b>Asbestos Type</b>	Chrysotile (1)
<b>Material Assessment Score</b>	2 / Very Low

<b>Normal Occupancy Activity</b>	Rare Disturbance - Store (0)	<b>Secondary Activity</b>	Rare Disturbance - Store (0)		
<b>Likelihood of Disturbance (Access)</b>	Occasional Disturbance (1)	<b>Likelihood of Disturbance (Extent)</b>	10m - 50m (2)	<b>Disturbance (Location)</b>	Rooms < 100M2 (2)
<b>Exposure Potential (Usage)</b>	Daily (3)	<b>Exposure Potential (Frequency of Use)</b>	Unlikely to be disturbed (0)	<b>Exposure Potential (No. of Persons)</b>	1 to 3 (1)
<b>Maintenance Activity (Frequency)</b>	3 - 6 Hours (2)	<b>Maintenance Activity (Type)</b>	Minor Disturbance (0)	<b>Total Risk Assessment Score</b>	6 / Very Low

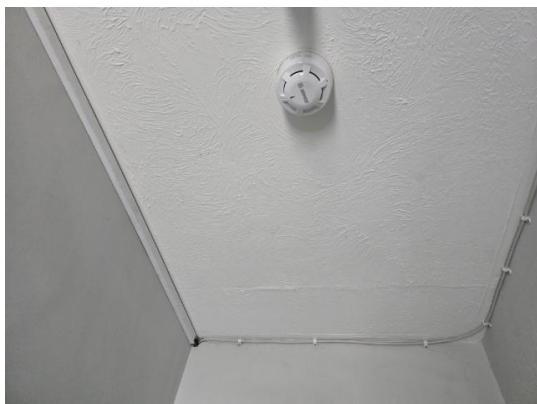
<b>Building</b>	Building 1	<b>Level</b>	Ground Floor
<b>Location</b>	005 / Corridor	<b>Item</b>	Ceiling
<b>Material</b>	Textured coating	<b>Extent</b>	3m <sup>2</sup>

<b>Sample Reference</b>	Sample XM-68179-X3	<b>Asbestos Types(s)</b>	Chrysotile
<b>Accessibility</b>	Occasional Disturbance	<b>Recommendation</b>	Manage
<b>Sample Notes</b>	-

<b>Product Type</b>	Asbestos reinforced composites etc. (1)	<b>Extent of Damage</b>	Good (0)
<b>Surface Treatment</b>	Composite materials, decorative finishes, vinyl products etc (0)	<b>Asbestos Type</b>	Chrysotile (1)
<b>Material Assessment Score</b>	2 / Very Low

<b>Normal Occupancy Activity</b>	Rare Disturbance - Store (0)	<b>Secondary Activity</b>	Rare Disturbance - Store (0)		
<b>Likelihood of Disturbance (Access)</b>	Occasional Disturbance (1)	<b>Likelihood of Disturbance (Extent)</b>	< 10m (1)	<b>Disturbance (Location)</b>	Rooms < 100M2 (2)
<b>Exposure Potential (Usage)</b>	Daily (3)	<b>Exposure Potential (Frequency of Use)</b>	Unlikely to be disturbed (0)	<b>Exposure Potential (No. of Persons)</b>	1 to 3 (1)
<b>Maintenance Activity (Frequency)</b>	< 1 Hour (0)	<b>Maintenance Activity (Type)</b>	Minor Disturbance (0)	<b>Total Risk Assessment Score</b>	6 / Very Low

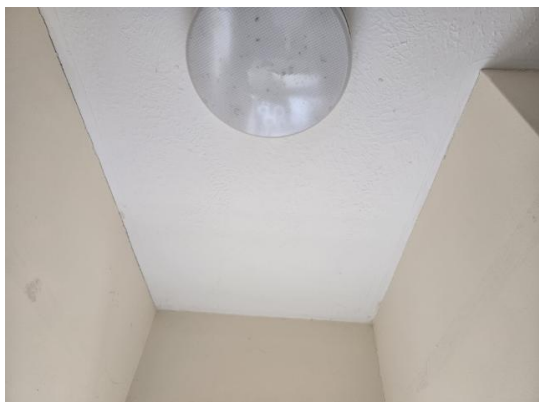
<b>Building</b>	Building 1	<b>Level</b>	Ground Floor
<b>Location</b>	006 / Ladies Toilets	<b>Item</b>	Ceiling
<b>Material</b>	Textured coating	<b>Extent</b>	3m <sup>2</sup>

<b>Sample Reference</b>	Sample XM-68179-X3	<b>Asbestos Types(s)</b>	Chrysotile
<b>Accessibility</b>	Occasional Disturbance	<b>Recommendation</b>	Manage
<b>Sample Notes</b>	-

<b>Product Type</b>	Asbestos reinforced composites etc. (1)	<b>Extent of Damage</b>	Good (0)
<b>Surface Treatment</b>	Composite materials, decorative finishes, vinyl products etc (0)	<b>Asbestos Type</b>	Chrysotile (1)
<b>Material Assessment Score</b>	2 / Very Low

<b>Normal Occupancy Activity</b>	Rare Disturbance - Store (0)	<b>Secondary Activity</b>	Rare Disturbance - Store (0)		
<b>Likelihood of Disturbance (Access)</b>	Occasional Disturbance (1)	<b>Likelihood of Disturbance (Extent)</b>	< 10m (1)	<b>Disturbance (Location)</b>	Rooms < 100M2 (2)
<b>Exposure Potential (Usage)</b>	Daily (3)	<b>Exposure Potential (Frequency of Use)</b>	Unlikely to be disturbed (0)	<b>Exposure Potential (No. of Persons)</b>	1 to 3 (1)
<b>Maintenance Activity (Frequency)</b>	< 1 Hour (0)	<b>Maintenance Activity (Type)</b>	Minor Disturbance (0)	<b>Total Risk Assessment Score</b>	6 / Very Low

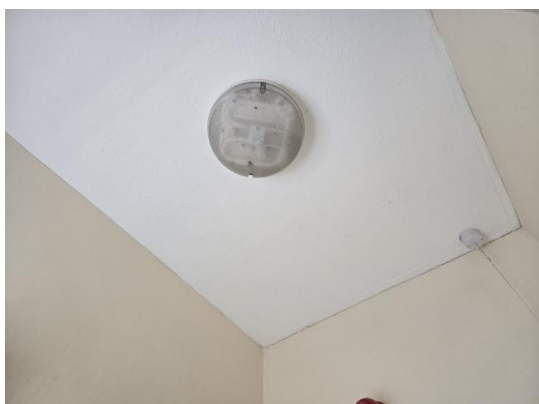
<b>Building</b>	Building 1	<b>Level</b>	Ground Floor
<b>Location</b>	007 / Gents Toilets	<b>Item</b>	Ceiling
<b>Material</b>	Textured coating	<b>Extent</b>	3m <sup>2</sup>

<b>Sample Reference</b>	Sample XM-68179-X3	<b>Asbestos Types(s)</b>	Chrysotile
<b>Accessibility</b>	Occasional Disturbance	<b>Recommendation</b>	Manage
<b>Sample Notes</b>	-

<b>Product Type</b>	Asbestos reinforced composites etc. (1)	<b>Extent of Damage</b>	Good (0)
<b>Surface Treatment</b>	Composite materials, decorative finishes, vinyl products etc (0)	<b>Asbestos Type</b>	Chrysotile (1)
<b>Material Assessment Score</b>	2 / Very Low

<b>Normal Occupancy Activity</b>	Rare Disturbance - Store (0)	<b>Secondary Activity</b>	Rare Disturbance - Store (0)		
<b>Likelihood of Disturbance (Access)</b>	Occasional Disturbance (1)	<b>Likelihood of Disturbance (Extent)</b>	< 10m (1)	<b>Disturbance (Location)</b>	Rooms < 100M2 (2)
<b>Exposure Potential (Usage)</b>	Daily (3)	<b>Exposure Potential (Frequency of Use)</b>	Unlikely to be disturbed (0)	<b>Exposure Potential (No. of Persons)</b>	1 to 3 (1)
<b>Maintenance Activity (Frequency)</b>	< 1 Hour (0)	<b>Maintenance Activity (Type)</b>	Minor Disturbance (0)	<b>Total Risk Assessment Score</b>	6 / Very Low

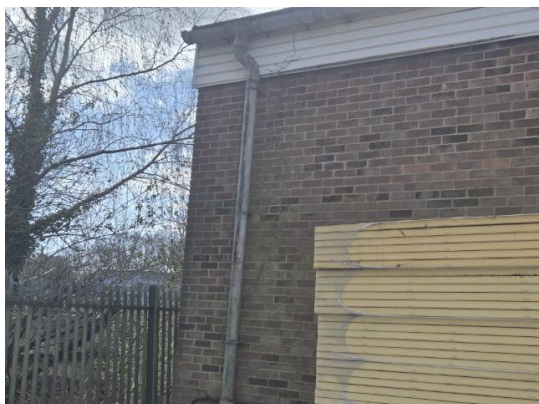
<b>Building</b>	Building 1	<b>Level</b>	External
<b>Location</b>	011 / Building 1 External	<b>Item</b>	Downpipe
<b>Material</b>	Cement	<b>Extent</b>	5lin m

<b>Sample Reference</b>	Previously Sampled M-68179-08	<b>Asbestos Types(s)</b>	Chrysotile
<b>Accessibility</b>	Occasional Disturbance	<b>Recommendation</b>	Manage
<b>Sample Notes</b>	-

<b>Product Type</b>	Asbestos reinforced composites etc. (1)	<b>Extent of Damage</b>	Low damage (1)
<b>Surface Treatment</b>	Enclosed sprays & lagging, sealed AIB, textiles, gaskets & cement products (1)	<b>Asbestos Type</b>	Chrysotile (1)
<b>Material Assessment Score</b>	4 / Very Low

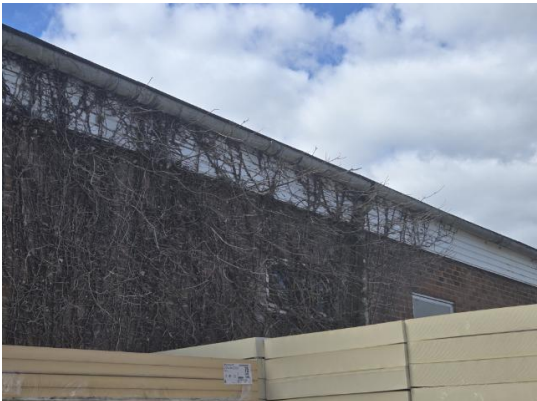
<b>Building</b>	Building 1	<b>Level</b>	External
<b>Location</b>	011 / Building 1 External	<b>Item</b>	Gutter
<b>Material</b>	Cement	<b>Extent</b>	22lin m

Building 1 011 External Building 1 External	Previously Sampled M-68179-09  Cement to Gutter	22lin m	Asbestos reinforced composites etc. <b>(1)</b>	Low damage <b>(1)</b>	Enclosed sprays & lagging, sealed AIB, textiles, gaskets & cement products <b>(1)</b>	Chrysotile <b>(1)</b>	4	3	7	Manage

<b>Sample Reference</b>	Previously Sampled M-68179-09	<b>Asbestos Types(s)</b>	Chrysotile
<b>Accessibility</b>	Usually inaccessible/Unlikely to be disturbed	<b>Recommendation</b>	Manage
<b>Sample Notes</b>	-

<b>Product Type</b>	Asbestos reinforced composites etc. (1)	<b>Extent of Damage</b>	Low damage (1)
<b>Surface Treatment</b>	Enclosed sprays & lagging, sealed AIB, textiles, gaskets & cement products (1)	<b>Asbestos Type</b>	Chrysotile (1)
<b>Material Assessment Score</b>	4 / Very Low
