Refurbishment Survey

Site: Meads End, Dukes Drive, Eastbourne, BN20 6XL
UPRN: N/A
Client: Bede's School Trust (Prep School)
Report No: J025905
Survey Date: 11th September 2023 to 12th September 2023
Report Date: 15th September 2023
Surveyors: Wayne Clarke
Report Produced By: Report Reviewed By:

Type of Survey: Refurbishment

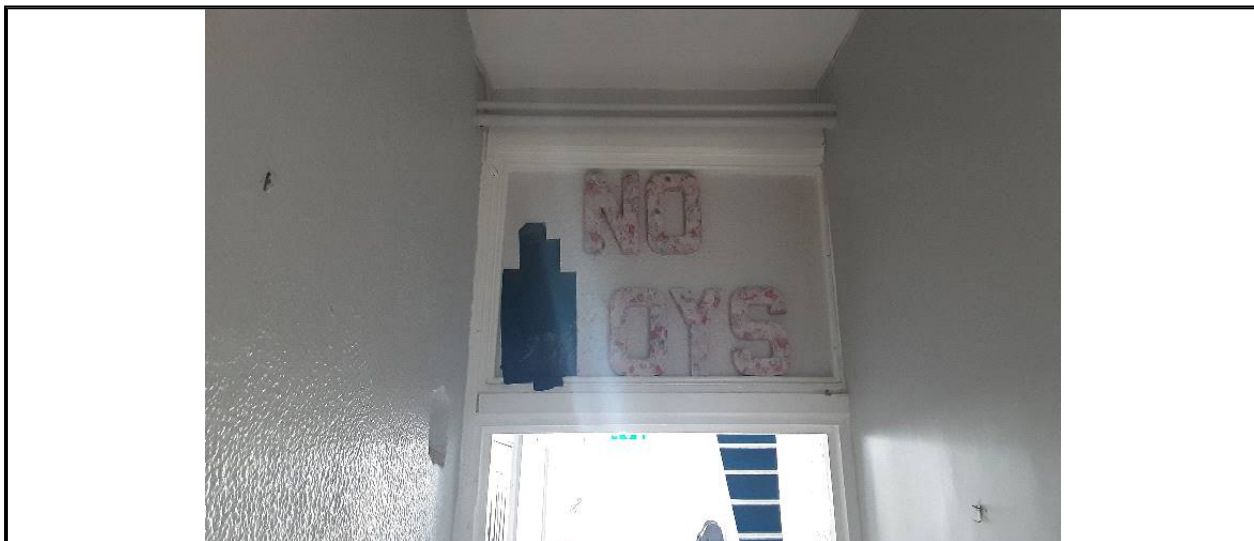
Picture 21
DA006701	Meads End, Dukes Drive	Ground Floor	Insulating Board	Lobby, Header	1m ²	Nailed	Timber	Amosite	
Recommendations					Assessment Scores			Risk Code	
					Material	Priority	Total		
Remove, repair or encapsulate by a licenced asbestos contractor under controlled conditions. Work on this material requires a license & is notifiable to the appropriate enforcing authority. Disposal of asbestos waste by a licensed contractor only. All work must conform to the 'Control of Asbestos Regulations 2012'.					5	6	11	C	
Reinspection Due		12 months	Actions Taken	N/A	Time Scale			Action Completed Sign & Date

Sample No:	DA006701
Item No:	21
Survey Date:	11/09/23 TO 12/09/23
Building:	Meads End, Dukes Drive
Floor:	Ground Floor
Room No:	Lobby
Position:	Header - Insulating Board
Extent:	1m ²
Substrate:	Nailed, Timber
Material:	(2) Asbestos Insulating Board
Accessibility:	(1) Occasionally likely to be disturbed
Asbestos Type:	Amosite
Risk Category:	C
Recommended Action:	Remove, repair or encapsulate by a licenced asbestos contractor under controlled conditions. Work on this material requires a license & is notifiable to the appropriate enforcing authority. Disposal of asbestos waste by a licensed contractor only. All work must conform to the 'Control of Asbestos Regulations 2012'.

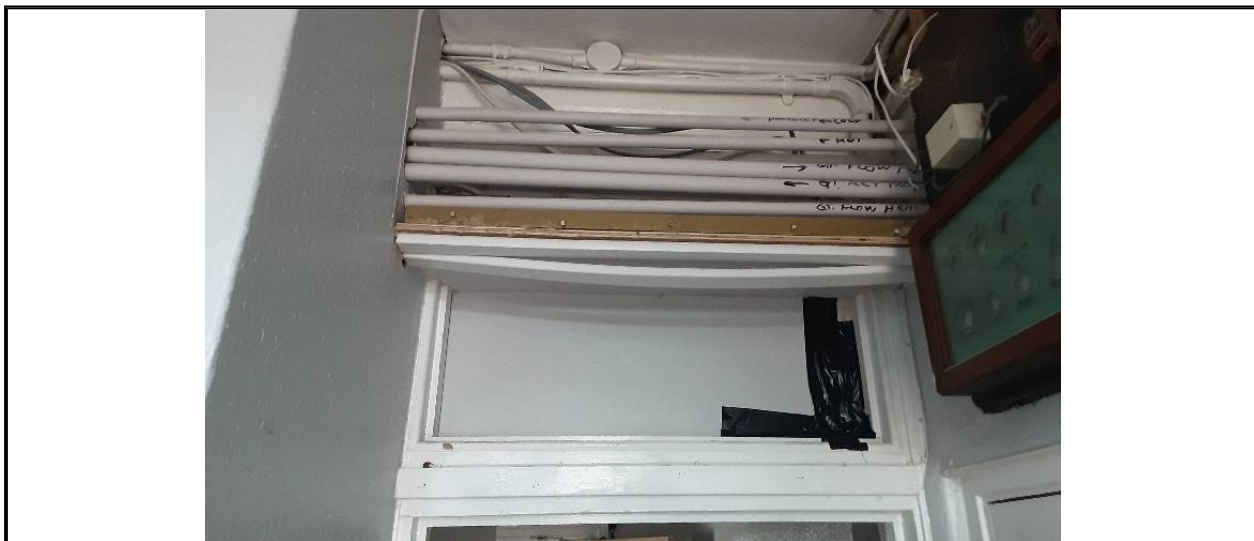
Picture 24
As DA006701	Meads End, Dukes Drive	Ground Floor	Insulating Board	Rear Stairwell and Lobby, Header	See associ	Nailed	Timber	Amosite	
Recommendations					Assessment Scores			Risk Code	
					Material	Priority	Total		
Remove, repair or encapsulate by a licenced asbestos contractor under controlled conditions. Work on this material requires a license & is notifiable to the appropriate enforcing authority. Disposal of asbestos waste by a licensed contractor only. All work must conform to the 'Control of Asbestos Regulations 2012'.					5	6	11	C	
Reinspection Due		12 months	Actions Taken	N/A	Time Scale			Action Completed Sign & Date

Sample No:	As DA006701
Item No:	24
Survey Date:	11/09/23 TO 12/09/23
Building:	Meads End, Dukes Drive
Floor:	Ground Floor
Room No:	Rear Stairwell and Lobby
Position:	Header - Insulating Board
Extent:	See associ
Substrate:	Nailed, Timber
Material:	(2) Asbestos Insulating Board
Accessibility:	(1) Occasionally likely to be disturbed
Asbestos Type:	Amosite
Risk Category:	C
Recommended Action:	Remove, repair or encapsulate by a licenced asbestos contractor under controlled conditions. Work on this material requires a license & is notifiable to the appropriate enforcing authority. Disposal of asbestos waste by a licensed contractor only. All work must conform to the 'Control of Asbestos Regulations 2012'.

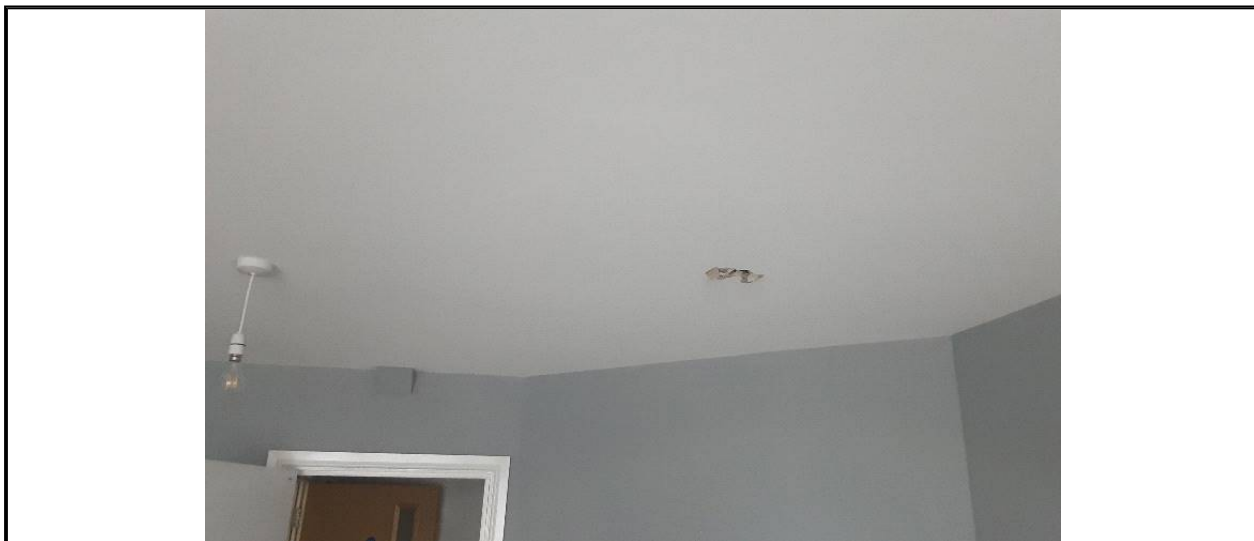
Picture 83
As DA006703	Meads End, Dukes Drive	Ground Floor	Thermal Insulation	Room 2, Hardest Pipework	Unknown	Bonded	Metal	Chrysotile + Amosite	
Recommendations					Assessment Scores			Risk Code	
					Material	Priority	Total		
Remove, repair or encapsulate by a licenced asbestos contractor under controlled conditions. Work on this material requires a license & is notifiable to the appropriate enforcing authority. Disposal of asbestos waste by a licensed contractor only. All work must conform to the 'Control of Asbestos Regulations 2012'.					7	6	13	B	
Reinspection Due		12 months	Actions Taken	N/A	Time Scale			Action Completed Sign & Date

Sample No:	As DA006703
Item No:	83
Survey Date:	11/09/23 TO 12/09/23
Building:	Meads End, Dukes Drive
Floor:	Ground Floor
Room No:	Room 2
Position:	Hardest Pipework - Thermal Insulation
Extent:	Unknown
Substrate:	Bonded, Metal
Material:	(3) Asbestos Insulation/Coating
Accessibility:	(0) Usually inaccessible or unlikely to be disturbed
Asbestos Type:	Chrysotile + Amosite
Risk Category:	B
Recommended Action:	Remove, repair or encapsulate by a licenced asbestos contractor under controlled conditions. Work on this material requires a license & is notifiable to the appropriate enforcing authority. Disposal of asbestos waste by a licensed contractor only. All work must conform to the 'Control of Asbestos Regulations 2012'.

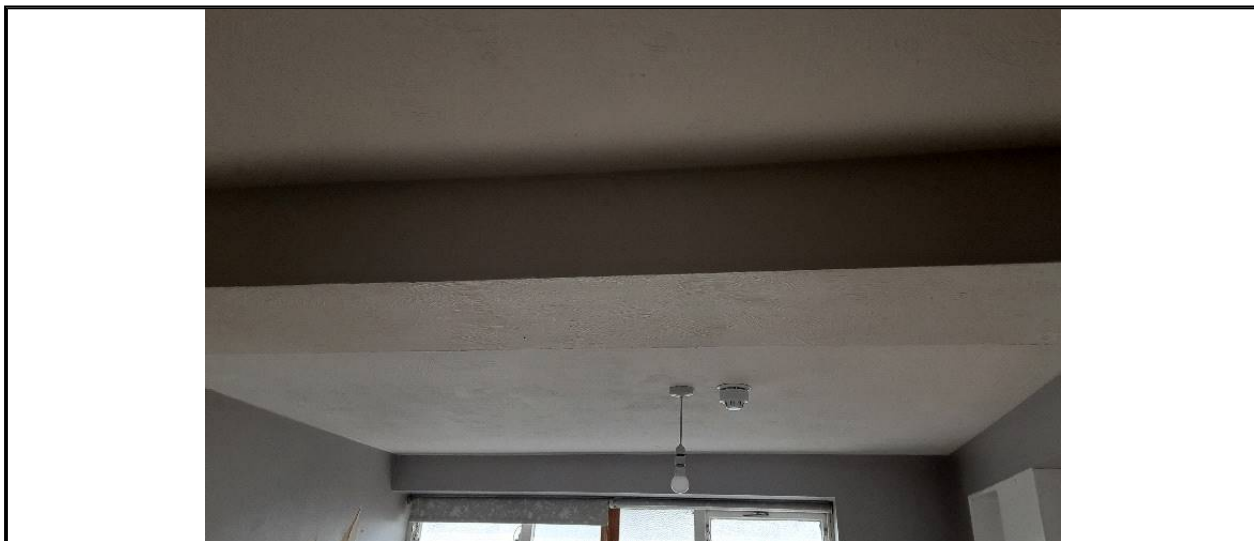
Picture 34
DA006702	Meads End, Dukes Drive	Ground Floor	Cement	Room 4, Ceiling	12m ²	Nailed	Timber	Chrysotile	
Recommendations					Assessment Scores			Risk Code	
					Material	Priority	Total		
Low risk ACM (bound in matrix) remove, repair or encapsulate under controlled conditions. Work on this material does not require a license. Work on this material may be notifiable to the appropriate enforcing authority. Disposal of asbestos waste by a licensed contractor only. All work must conform to the 'Control of Asbestos Regulations 2012'.					3	5	8	D	
Reinspection Due		12 months	Actions Taken	N/A	Time Scale			Action Completed Sign & Date

Sample No:	DA006702
Item No:	34
Survey Date:	11/09/23 TO 12/09/23
Building:	Meads End, Dukes Drive
Floor:	Ground Floor
Room No:	Room 4
Position:	Ceiling - Cement
Extent:	12m ²
Substrate:	Nailed, Timber
Material:	(1) Asbestos Cement
Accessibility:	(0) Usually inaccessible or unlikely to be disturbed
Asbestos Type:	Chrysotile
Risk Category:	D
Recommended Action:	Low risk ACM (bound in matrix) remove, repair or encapsulate under controlled conditions. Work on this material does not require a license. Work on this material may be notifiable to the appropriate enforcing authority. Disposal of asbestos waste by a licensed contractor only. All work must conform to the 'Control of Asbestos Regulations 2012'.

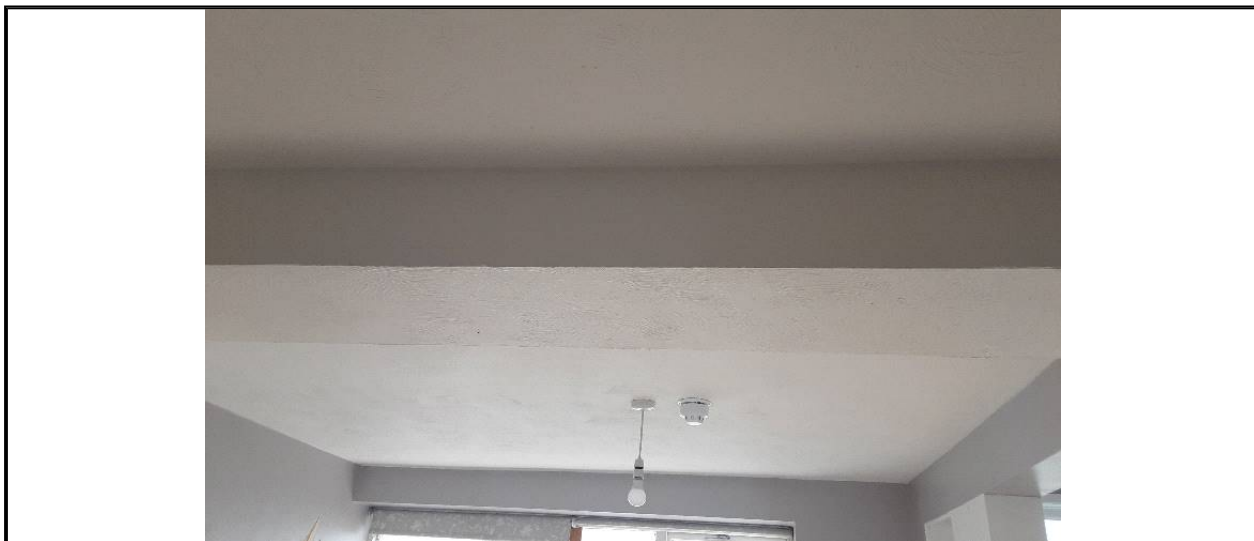
Picture 35
DA006703	Meads End, Dukes Drive	Ground Floor	Thermal Insulation	Room 4, Hardest Pipework	Unknown	Bonded	Metal	Chrysotile + Amosite	
Recommendations					Assessment Scores			Risk Code	
					Material	Priority	Total		
Remove, repair or encapsulate by a licenced asbestos contractor under controlled conditions. Work on this material requires a license & is notifiable to the appropriate enforcing authority. Disposal of asbestos waste by a licensed contractor only. All work must conform to the 'Control of Asbestos Regulations 2012'.					10	5	15	A	
Reinspection Due		12 months	Actions Taken	N/A	Time Scale			Action Completed Sign & Date

Sample No:	DA006703
Item No:	35
Survey Date:	11/09/23 TO 12/09/23
Building:	Meads End, Dukes Drive
Floor:	Ground Floor
Room No:	Room 4
Position:	Hardest Pipework - Thermal Insulation
Extent:	Unknown
Substrate:	Bonded, Metal
Material:	(3) Asbestos Insulation/Coating
Accessibility:	(0) Usually inaccessible or unlikely to be disturbed
Asbestos Type:	Chrysotile + Amosite
Risk Category:	A
Recommended Action:	Remove, repair or encapsulate by a licenced asbestos contractor under controlled conditions. Work on this material requires a license & is notifiable to the appropriate enforcing authority. Disposal of asbestos waste by a licensed contractor only. All work must conform to the 'Control of Asbestos Regulations 2012'.

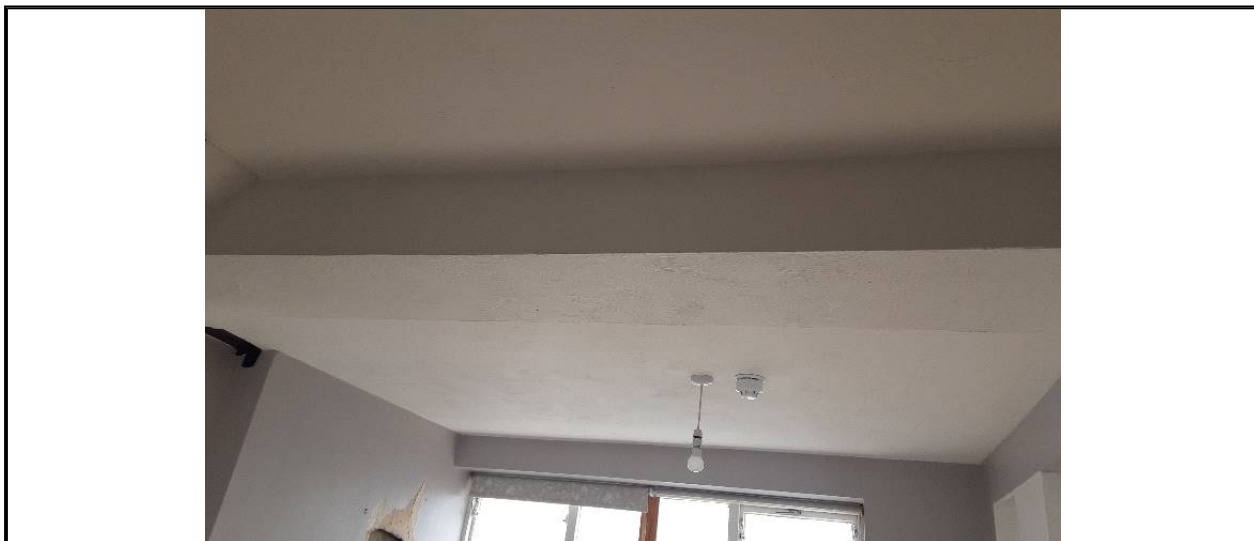
Picture 36
DA006704	Meads End, Dukes Drive	Ground Floor	Textured Coating/Decorative Finish	Room 4, Ceiling	12m ²	Bonded	Plasterboard	Chrysotile	
Recommendations					Assessment Scores			Risk Code	
					Material	Priority	Total		
Low risk ACM (bound in matrix) remove, repair or encapsulate under controlled conditions. Work on this material does not require a license. Work on this material may be notifiable to the appropriate enforcing authority. Disposal of asbestos waste by a licensed contractor only. All work must conform to the 'Control of Asbestos Regulations 2012'.					3	7	10	D	
Reinspection Due		12 months	Actions Taken	N/A	Time Scale			Action Completed Sign & Date

Sample No:	DA006704
Item No:	36
Survey Date:	11/09/23 TO 12/09/23
Building:	Meads End, Dukes Drive
Floor:	Ground Floor
Room No:	Room 4
Position:	Ceiling - Textured Coating/Decorative Finish
Extent:	12m ²
Substrate:	Bonded, Plasterboard
Material:	(1) Textured Coating
Accessibility:	(1) Occasionally likely to be disturbed
Asbestos Type:	Chrysotile
Risk Category:	D
Recommended Action:	Low risk ACM (bound in matrix) remove, repair or encapsulate under controlled conditions. Work on this material does not require a license. Work on this material may be notifiable to the appropriate enforcing authority. Disposal of asbestos waste by a licensed contractor only. All work must conform to the 'Control of Asbestos Regulations 2012'.

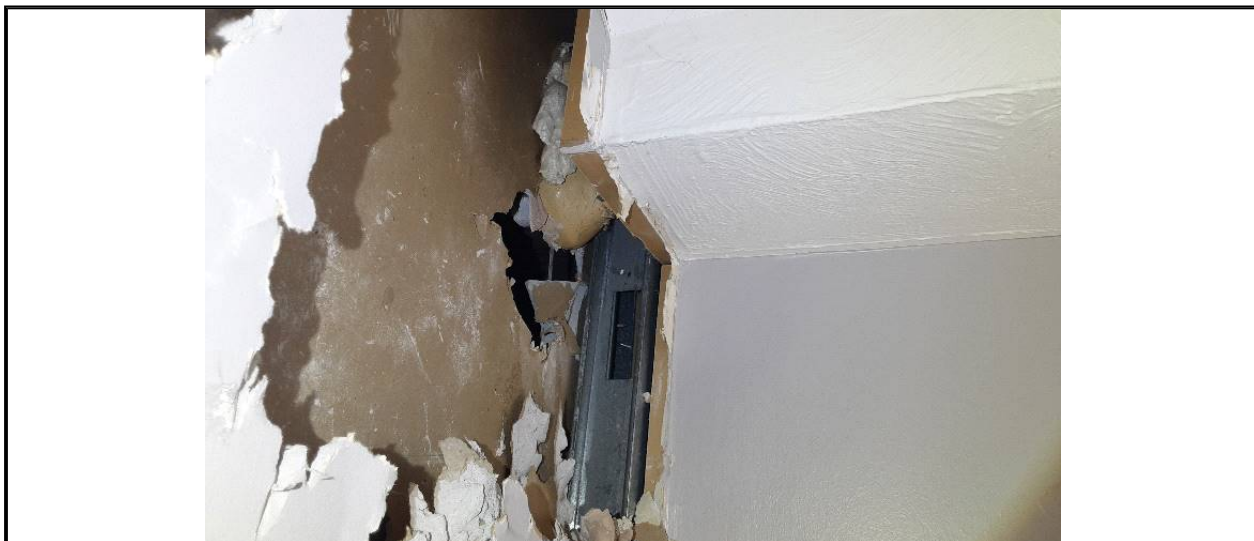
Picture 37
As DA006703	Meads End, Dukes Drive	Ground Floor	Thermal Insulation	Room 4, Hardest Pipework	<1lm	Bonded	Metal	Chrysotile + Amosite	
Recommendations					Assessment Scores			Risk Code	
					Material	Priority	Total		
Remove, repair or encapsulate by a licenced asbestos contractor under controlled conditions. Work on this material requires a license & is notifiable to the appropriate enforcing authority. Disposal of asbestos waste by a licensed contractor only. All work must conform to the 'Control of Asbestos Regulations 2012'.					10	6	16	A	
Reinspection Due		12 months	Actions Taken	N/A	Time Scale			Action Completed Sign & Date

Sample No:	As DA006703
Item No:	37
Survey Date:	11/09/23 TO 12/09/23
Building:	Meads End, Dukes Drive
Floor:	Ground Floor
Room No:	Room 4
Position:	Hardest Pipework - Thermal Insulation
Extent:	<1lm
Substrate:	Bonded, Metal
Material:	(3) Asbestos Insulation/Coating
Accessibility:	(0) Usually inaccessible or unlikely to be disturbed
Asbestos Type:	Chrysotile + Amosite
Risk Category:	A
Recommended Action:	Remove, repair or encapsulate by a licenced asbestos contractor under controlled conditions. Work on this material requires a license & is notifiable to the appropriate enforcing authority. Disposal of asbestos waste by a licensed contractor only. All work must conform to the 'Control of Asbestos Regulations 2012'.

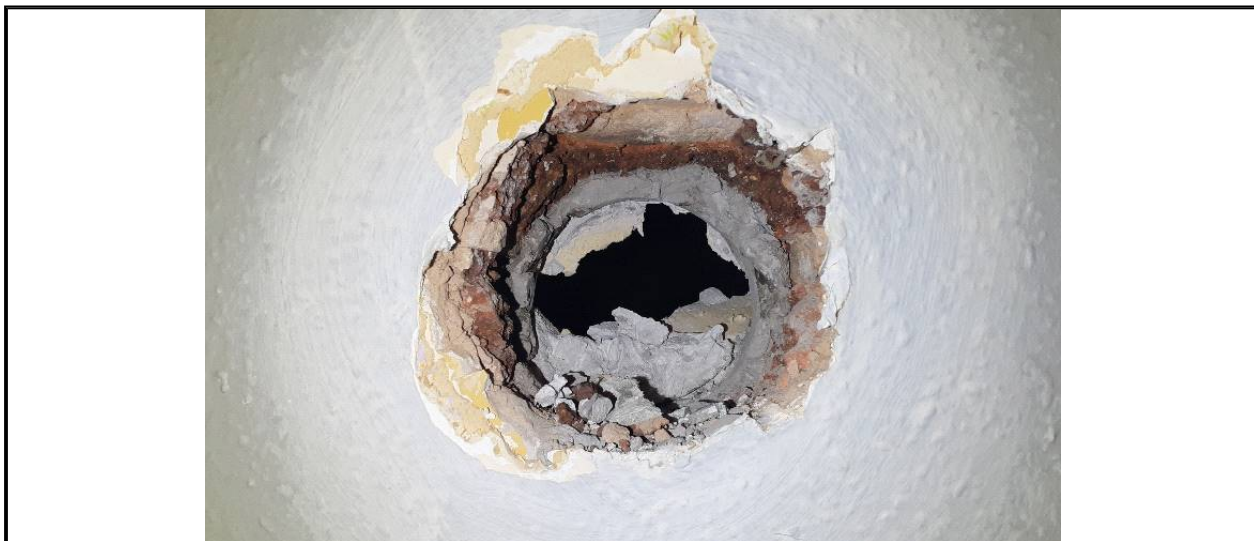
Picture 38
DA006705	Meads End, Dukes Drive	Ground Floor	Cement	Under Stairs Toilet, Debris Within Penetration	<1m	Debris	Brick	Chrysotile + Crocidolite	
Recommendations					Assessment Scores			Risk Code	
					Material	Priority	Total		
Low risk ACM (bound in matrix) remove, repair or encapsulate under controlled conditions. Work on this material does not require a license. Work on this material may be notifiable to the appropriate enforcing authority. Disposal of asbestos waste by a licensed contractor only. All work must conform to the 'Control of Asbestos Regulations 2012'.					7	5	12	B	
Reinspection Due		12 months	Actions Taken	N/A	Time Scale			Action Completed Sign & Date

Sample No:	DA006705
Item No:	38
Survey Date:	11/09/23 TO 12/09/23
Building:	Meads End, Dukes Drive
Floor:	Ground Floor
Room No:	Under Stairs Toilet
Position:	Debris Within Penetration - Cement
Extent:	<1lm
Substrate:	Debris, Brick
Material:	(1) Asbestos Cement
Accessibility:	(1) Occasionally likely to be disturbed
Asbestos Type:	Chrysotile + Crocidolite
Risk Category:	B
Recommended Action:	Low risk ACM (bound in matrix) remove, repair or encapsulate under controlled conditions. Work on this material does not require a license. Work on this material may be notifiable to the appropriate enforcing authority. Disposal of asbestos waste by a licensed contractor only. All work must conform to the 'Control of Asbestos Regulations 2012'.

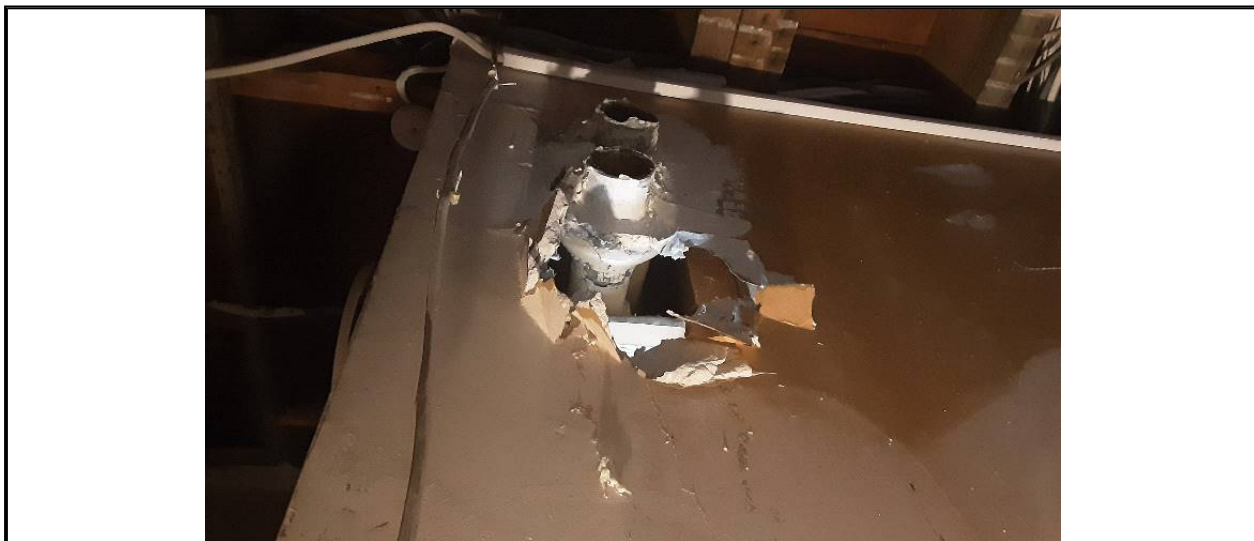
<p>Picture 61</p>
As DA006703	Meads End, Dukes Drive	Ground Floor	Thermal Insulation	Plantroom, Hardest Pipework	<1lm	Bonded	Metal	Chrysotile + Amosite	
Recommendations					Assessment Scores			Risk Code	
					Material	Priority	Total		
Remove, repair or encapsulate by a licenced asbestos contractor under controlled conditions. Work on this material requires a license & is notifiable to the appropriate enforcing authority. Disposal of asbestos waste by a licensed contractor only. All work must conform to the 'Control of Asbestos Regulations 2012'.					10	4	14	A	
Reinspection Due		12 months	Actions Taken	N/A	Time Scale			Action Completed Sign & Date

Sample No:	As DA006703
Item No:	61
Survey Date:	11/09/23 TO 12/09/23
Building:	Meads End, Dukes Drive
Floor:	Ground Floor
Room No:	Plantroom
Position:	Hardest Pipework - Thermal Insulation
Extent:	<1lm
Substrate:	Bonded, Metal
Material:	(3) Asbestos Insulation/Coating
Accessibility:	(0) Usually inaccessible or unlikely to be disturbed
Asbestos Type:	Chrysotile + Amosite
Risk Category:	A
Recommended Action:	Remove, repair or encapsulate by a licenced asbestos contractor under controlled conditions. Work on this material requires a license & is notifiable to the appropriate enforcing authority. Disposal of asbestos waste by a licensed contractor only. All work must conform to the 'Control of Asbestos Regulations 2012'.

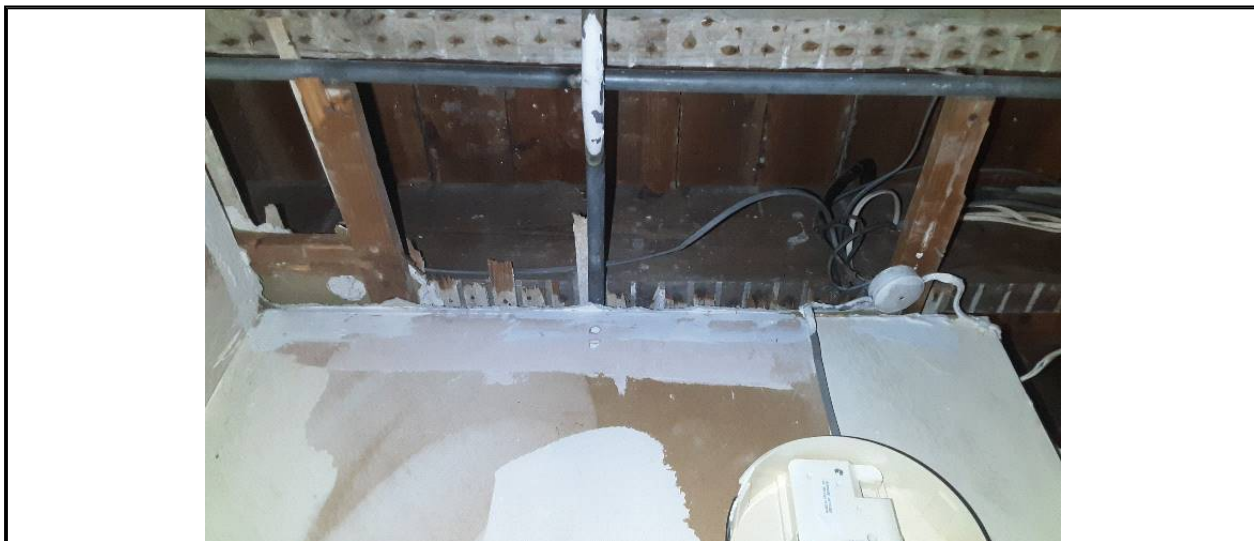
<p>Picture 62</p>
As DA006702	Meads End, Dukes Drive	Ground Floor	Cement	Plantroom, Ceiling	<1m ²	Nailed	Timber	Chrysotile	
Recommendations					Assessment Scores			Risk Code	
					Material	Priority	Total		
Low risk ACM (bound in matrix) remove, repair or encapsulate under controlled conditions. Work on this material does not require a license. Work on this material may be notifiable to the appropriate enforcing authority. Disposal of asbestos waste by a licensed contractor only. All work must conform to the 'Control of Asbestos Regulations 2012'.					4	3	7	D	
Reinspection Due		12 months	Actions Taken	N/A	Time Scale			Action Completed Sign & Date

Sample No:	As DA006702
Item No:	62
Survey Date:	11/09/23 TO 12/09/23
Building:	Meads End, Dukes Drive
Floor:	Ground Floor
Room No:	Plantroom
Position:	Ceiling - Cement
Extent:	<1m ²
Substrate:	Nailed, Timber
Material:	(1) Asbestos Cement
Accessibility:	(1) Occasionally likely to be disturbed
Asbestos Type:	Chrysotile
Risk Category:	D
Recommended Action:	Low risk ACM (bound in matrix) remove, repair or encapsulate under controlled conditions. Work on this material does not require a license. Work on this material may be notifiable to the appropriate enforcing authority. Disposal of asbestos waste by a licensed contractor only. All work must conform to the 'Control of Asbestos Regulations 2012'.

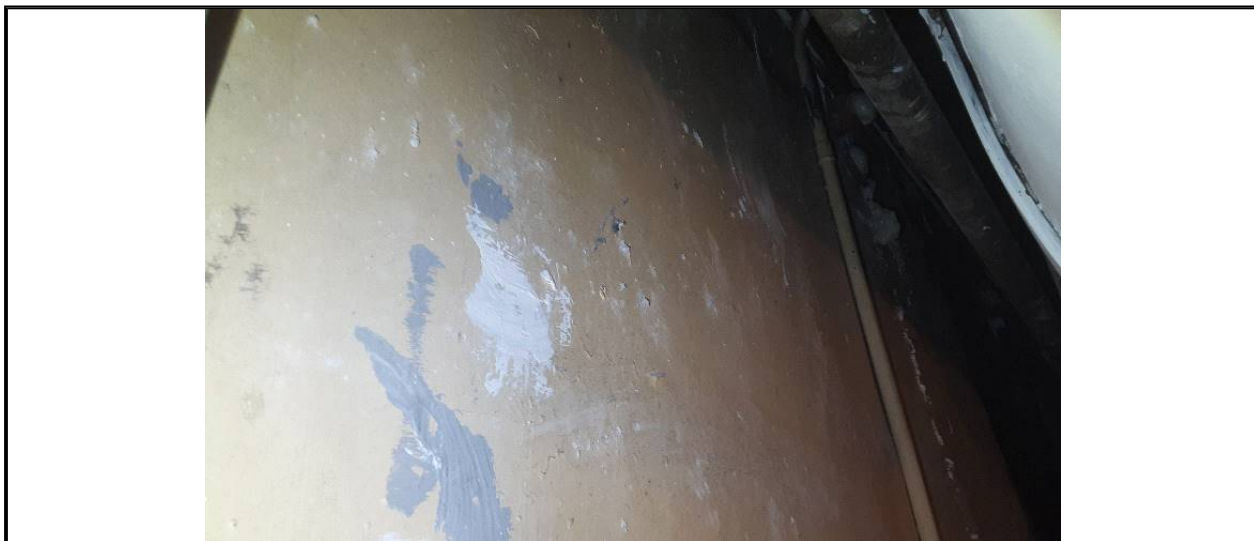
<p>Picture 63</p>
DA006707	Meads End, Dukes Drive	Ground Floor	Thermal Insulation	Plantroom, Hardest Residue To Walls.	Throughout	Bonded	Metal	Amo + Chrys + Croc	
Recommendations					Assessment Scores			Risk Code	
					Material	Priority	Total		
Remove, repair or encapsulate by a licenced asbestos contractor under controlled conditions. Work on this material requires a license & is notifiable to the appropriate enforcing authority. Disposal of asbestos waste by a licensed contractor only. All work must conform to the 'Control of Asbestos Regulations 2012'.					11	6	17	A	
Reinspection Due		12 months	Actions Taken	N/A	Time Scale			Action Completed Sign & Date

Sample No:	DA006707
Item No:	63
Survey Date:	11/09/23 TO 12/09/23
Building:	Meads End, Dukes Drive
Floor:	Ground Floor
Room No:	Plantroom
Position:	Hardest Residue To Walls. - Thermal Insulation
Extent:	Throughout
Substrate:	Bonded, Metal
Material:	(3) Asbestos Insulation/Coating
Accessibility:	(2) Easily disturbed
Asbestos Type:	Amo + Chrys + Croc
Risk Category:	A
Recommended Action:	Remove, repair or encapsulate by a licenced asbestos contractor under controlled conditions. Work on this material requires a license & is notifiable to the appropriate enforcing authority. Disposal of asbestos waste by a licensed contractor only. All work must conform to the 'Control of Asbestos Regulations 2012'.

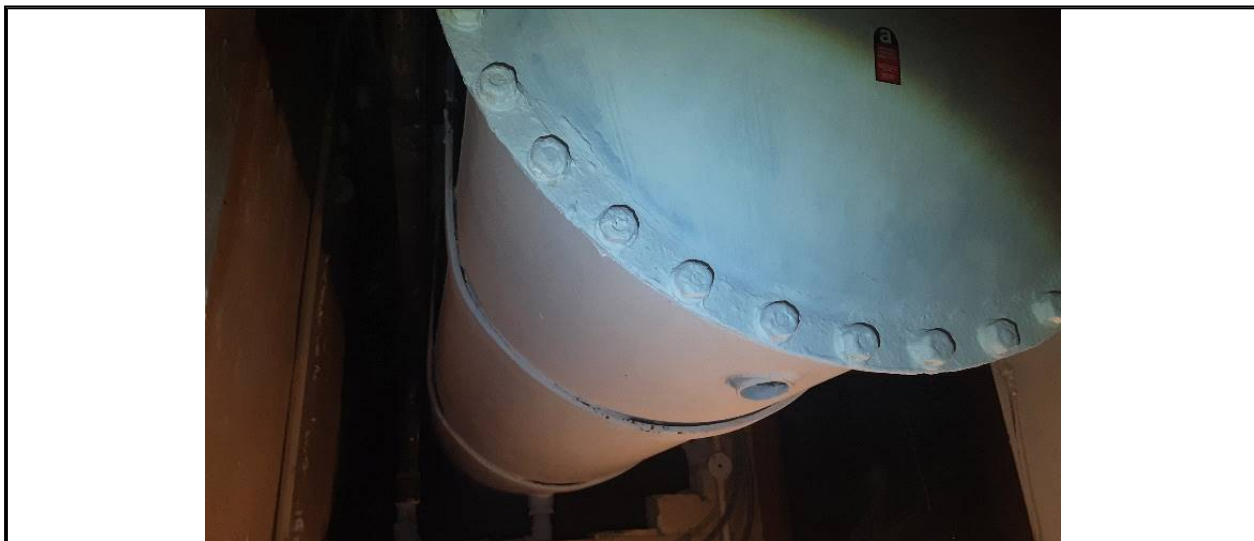
Picture 64
DA006708	Meads End, Dukes Drive	Ground Floor	Thermal Insulation	Plantroom, Insulation Residue To Calorifier and Hangers	4m ²	Bonded	Metal	Amo + Chrys + Croc	
Recommendations					Assessment Scores			Risk Code	
					Material	Priority	Total		
Remove, repair or encapsulate by a licenced asbestos contractor under controlled conditions. Work on this material requires a license & is notifiable to the appropriate enforcing authority. Disposal of asbestos waste by a licensed contractor only. All work must conform to the 'Control of Asbestos Regulations 2012'.					9	5	14	B	
Reinspection Due		12 months	Actions Taken	N/A	Time Scale			Action Completed Sign & Date

Sample No:	DA006708
Item No:	64
Survey Date:	11/09/23 TO 12/09/23
Building:	Meads End, Dukes Drive
Floor:	Ground Floor
Room No:	Plantroom
Position:	Insulation Residue To Calorifier and Hangers - Thermal Insulation
Extent:	4m ²
Substrate:	Bonded, Metal
Material:	(3) Asbestos Insulation/Coating
Accessibility:	(2) Easily disturbed
Asbestos Type:	Amo + Chrys + Croc
Risk Category:	B
Recommended Action:	Remove, repair or encapsulate by a licenced asbestos contractor under controlled conditions. Work on this material requires a license & is notifiable to the appropriate enforcing authority. Disposal of asbestos waste by a licensed contractor only. All work must conform to the 'Control of Asbestos Regulations 2012'.

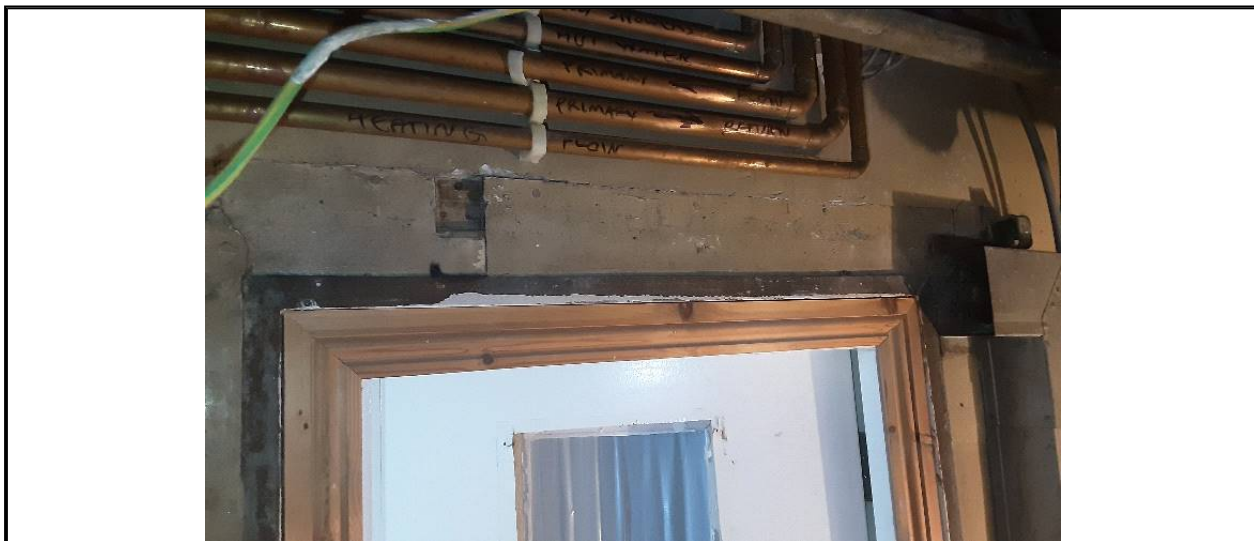
Picture 65
DA006709	Meads End, Dukes Drive	Ground Floor	Cement	Plantroom, Panel Above Door	1lm	Nailed	Timber	Chrysotile	
Recommendations					Assessment Scores			Risk Code	
					Material	Priority	Total		
Low risk ACM (bound in matrix) remove, repair or encapsulate under controlled conditions. Work on this material does not require a license. Work on this material may be notifiable to the appropriate enforcing authority. Disposal of asbestos waste by a licensed contractor only. All work must conform to the 'Control of Asbestos Regulations 2012'.					4	5	9	D	
Reinspection Due		12 months	Actions Taken	N/A	Time Scale			Action Completed Sign & Date

Sample No:	DA006709
Item No:	65
Survey Date:	11/09/23 TO 12/09/23
Building:	Meads End, Dukes Drive
Floor:	Ground Floor
Room No:	Plantroom
Position:	Panel Above Door - Cement
Extent:	1lm
Substrate:	Nailed, Timber
Material:	(1) Asbestos Cement
Accessibility:	(1) Occasionally likely to be disturbed
Asbestos Type:	Chrysotile
Risk Category:	D
Recommended Action:	Low risk ACM (bound in matrix) remove, repair or encapsulate under controlled conditions. Work on this material does not require a license. Work on this material may be notifiable to the appropriate enforcing authority. Disposal of asbestos waste by a licensed contractor only. All work must conform to the 'Control of Asbestos Regulations 2012'.

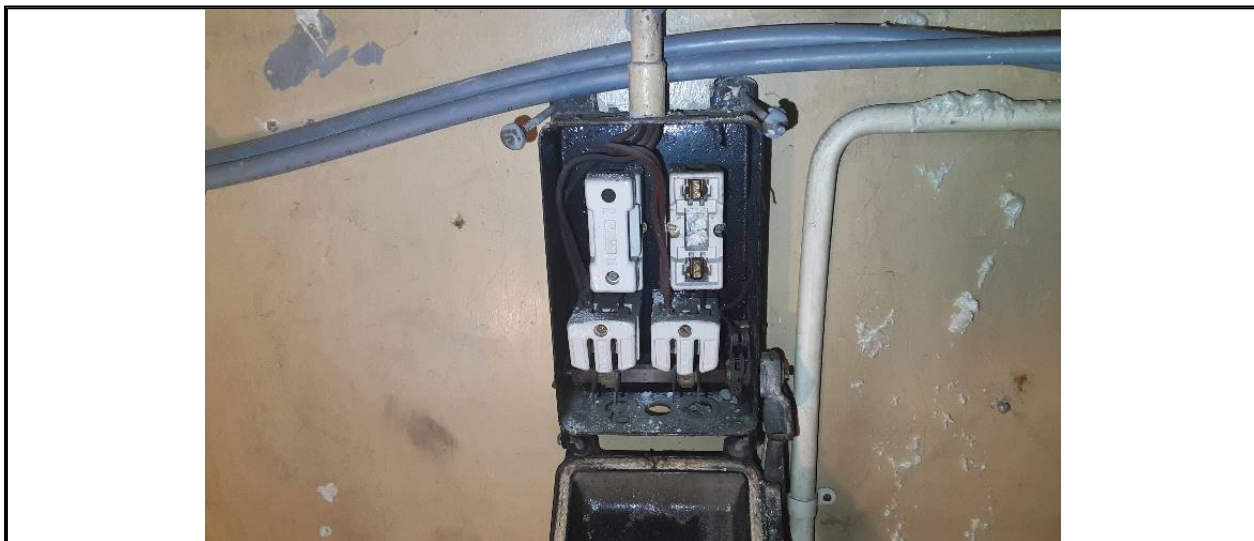
<p>Picture 66</p>
DA006710	Meads End, Dukes Drive	Ground Floor	Textiles	Plantroom, Flashguards	2no.	Bonded	Metal	Chrysotile	
Recommendations					Assessment Scores			Risk Code	
					Material	Priority	Total		
Low risk ACM (bound in matrix) remove, repair or encapsulate under controlled conditions. Work on this material does not require a license. Work on this material may be notifiable to the appropriate enforcing authority. Disposal of asbestos waste by a licensed contractor only. All work must conform to the 'Control of Asbestos Regulations 2012'.					5	3	8	C	
Reinspection Due		12 months	Actions Taken	N/A	Time Scale			Action Completed Sign & Date

Sample No:	DA006710
Item No:	66
Survey Date:	11/09/23 TO 12/09/23
Building:	Meads End, Dukes Drive
Floor:	Ground Floor
Room No:	Plantroom
Position:	Flashguards - Textiles
Extent:	2no.
Substrate:	Bonded, Metal
Material:	(2) Asbestos Textiles/Paper
Accessibility:	(0) Usually inaccessible or unlikely to be disturbed
Asbestos Type:	Chrysotile
Risk Category:	C
Recommended Action:	Low risk ACM (bound in matrix) remove, repair or encapsulate under controlled conditions. Work on this material does not require a license. Work on this material may be notifiable to the appropriate enforcing authority. Disposal of asbestos waste by a licensed contractor only. All work must conform to the 'Control of Asbestos Regulations 2012'.

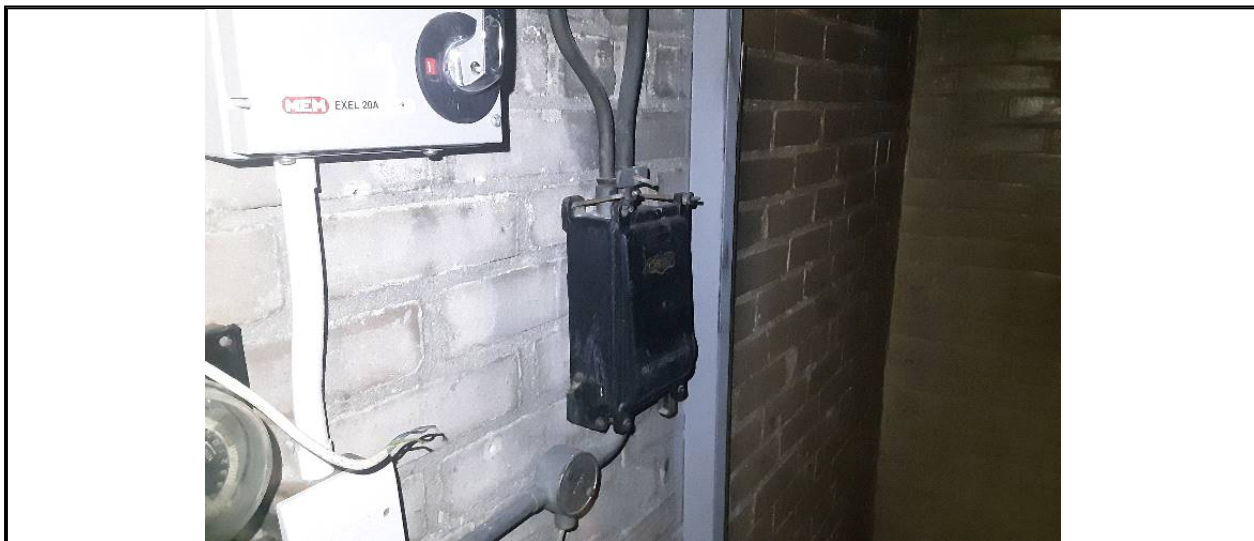
<p>Picture 67</p>
As DA006710	Meads End, Dukes Drive	Ground Floor	Textiles	Plantroom, Flashguards	2no.	Bonded	Metal	Chrysotile	
Recommendations					Assessment Scores			Risk Code	
					Material	Priority	Total		
Low risk ACM (bound in matrix) remove, repair or encapsulate under controlled conditions. Work on this material does not require a license. Work on this material may be notifiable to the appropriate enforcing authority. Disposal of asbestos waste by a licensed contractor only. All work must conform to the 'Control of Asbestos Regulations 2012'.					5	3	8	C	
Reinspection Due		12 months	Actions Taken	N/A	Time Scale			Action Completed Sign & Date

Sample No:	As DA006710
Item No:	67
Survey Date:	11/09/23 TO 12/09/23
Building:	Meads End, Dukes Drive
Floor:	Ground Floor
Room No:	Plantroom
Position:	Flashguards - Textiles
Extent:	2no.
Substrate:	Bonded, Metal
Material:	(2) Asbestos Textiles/Paper
Accessibility:	(0) Usually inaccessible or unlikely to be disturbed
Asbestos Type:	Chrysotile
Risk Category:	C
Recommended Action:	Low risk ACM (bound in matrix) remove, repair or encapsulate under controlled conditions. Work on this material does not require a license. Work on this material may be notifiable to the appropriate enforcing authority. Disposal of asbestos waste by a licensed contractor only. All work must conform to the 'Control of Asbestos Regulations 2012'.

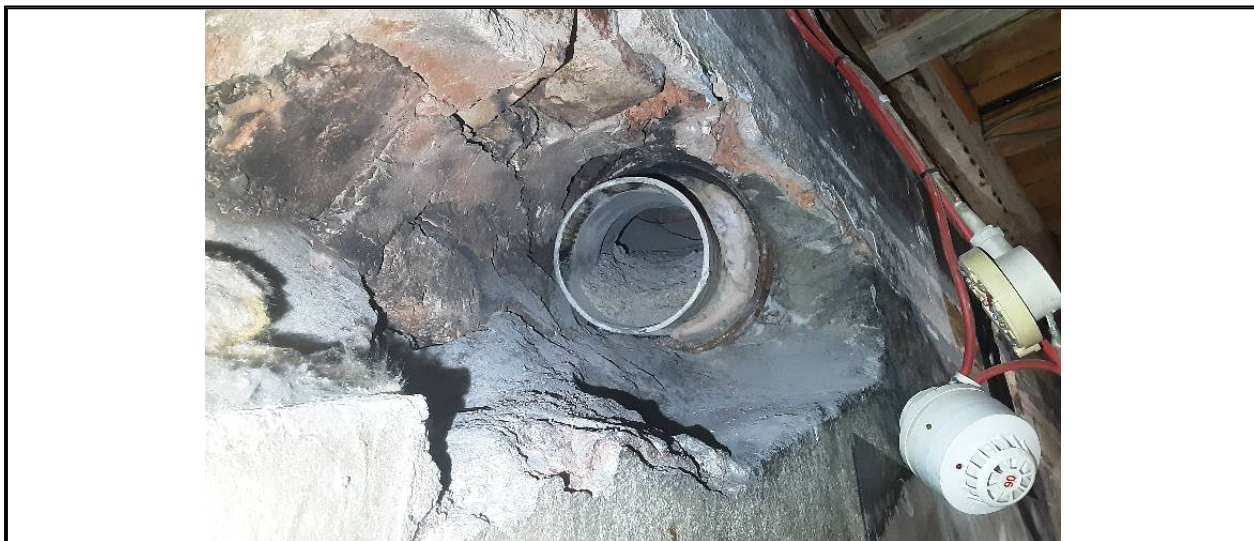
Picture 68
DA006711	Meads End, Dukes Drive	Ground Floor	Cement	Plantroom, Flue Pipe	1lm	Bonded	Brick	Chrysotile	
Recommendations					Assessment Scores			Risk Code	
					Material	Priority	Total		
Low risk ACM (bound in matrix) remove, repair or encapsulate under controlled conditions. Work on this material does not require a license. Work on this material may be notifiable to the appropriate enforcing authority. Disposal of asbestos waste by a licensed contractor only. All work must conform to the 'Control of Asbestos Regulations 2012'.					3	5	8	D	
Reinspection Due		12 months	Actions Taken	N/A	Time Scale			Action Completed Sign & Date

Sample No:	DA006711
Item No:	68
Survey Date:	11/09/23 TO 12/09/23
Building:	Meads End, Dukes Drive
Floor:	Ground Floor
Room No:	Plantroom
Position:	Flue Pipe - Cement
Extent:	1lm
Substrate:	Bonded, Brick
Material:	(1) Asbestos Cement
Accessibility:	(1) Occasionally likely to be disturbed
Asbestos Type:	Chrysotile
Risk Category:	D
Recommended Action:	Low risk ACM (bound in matrix) remove, repair or encapsulate under controlled conditions. Work on this material does not require a license. Work on this material may be notifiable to the appropriate enforcing authority. Disposal of asbestos waste by a licensed contractor only. All work must conform to the 'Control of Asbestos Regulations 2012'.

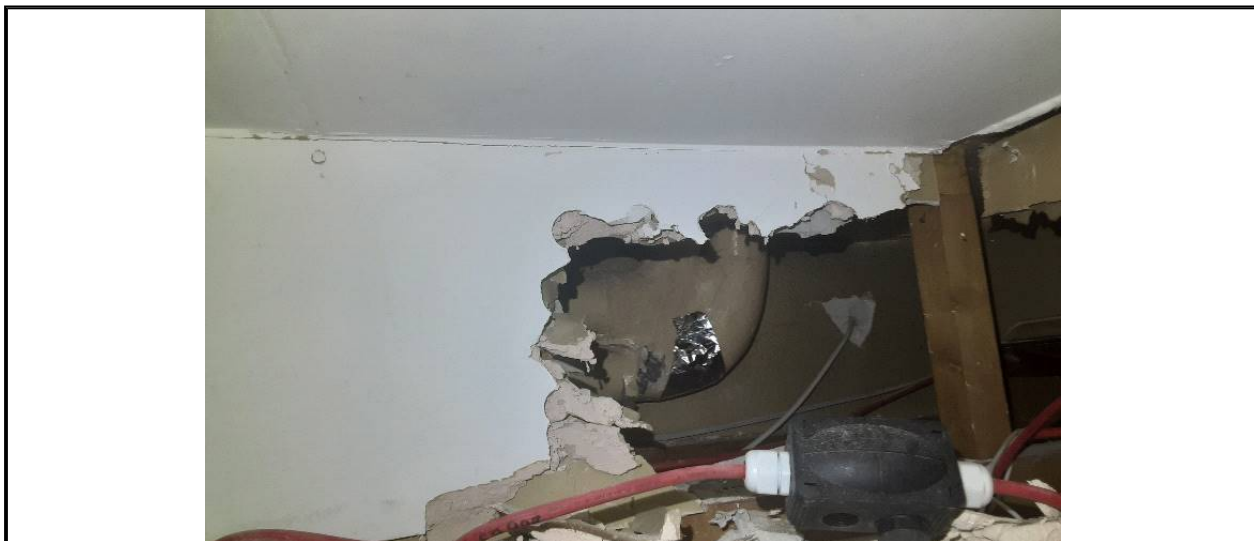
Picture 82
As DA006703	Meads End, Dukes Drive	Ground Floor	Thermal Insulation	Void Above Lobby, Hardest Pipework	Unknown	Bonded	Metal	Chrysotile + Amosite	
Recommendations					Assessment Scores			Risk Code	
					Material	Priority	Total		
Remove, repair or encapsulate by a licenced asbestos contractor under controlled conditions. Work on this material requires a license & is notifiable to the appropriate enforcing authority. Disposal of asbestos waste by a licensed contractor only. All work must conform to the 'Control of Asbestos Regulations 2012'.					7	5	12	B	
Reinspection Due		12 months	Actions Taken	N/A	Time Scale			Action Completed Sign & Date

Sample No:	As DA006703
Item No:	82
Survey Date:	11/09/23 TO 12/09/23
Building:	Meads End, Dukes Drive
Floor:	Ground Floor
Room No:	Void Above Lobby
Position:	Hardest Pipework - Thermal Insulation
Extent:	Unknown
Substrate:	Bonded, Metal
Material:	(3) Asbestos Insulation/Coating
Accessibility:	(0) Usually inaccessible or unlikely to be disturbed
Asbestos Type:	Chrysotile + Amosite
Risk Category:	B
Recommended Action:	Remove, repair or encapsulate by a licenced asbestos contractor under controlled conditions. Work on this material requires a license & is notifiable to the appropriate enforcing authority. Disposal of asbestos waste by a licensed contractor only. All work must conform to the 'Control of Asbestos Regulations 2012'.

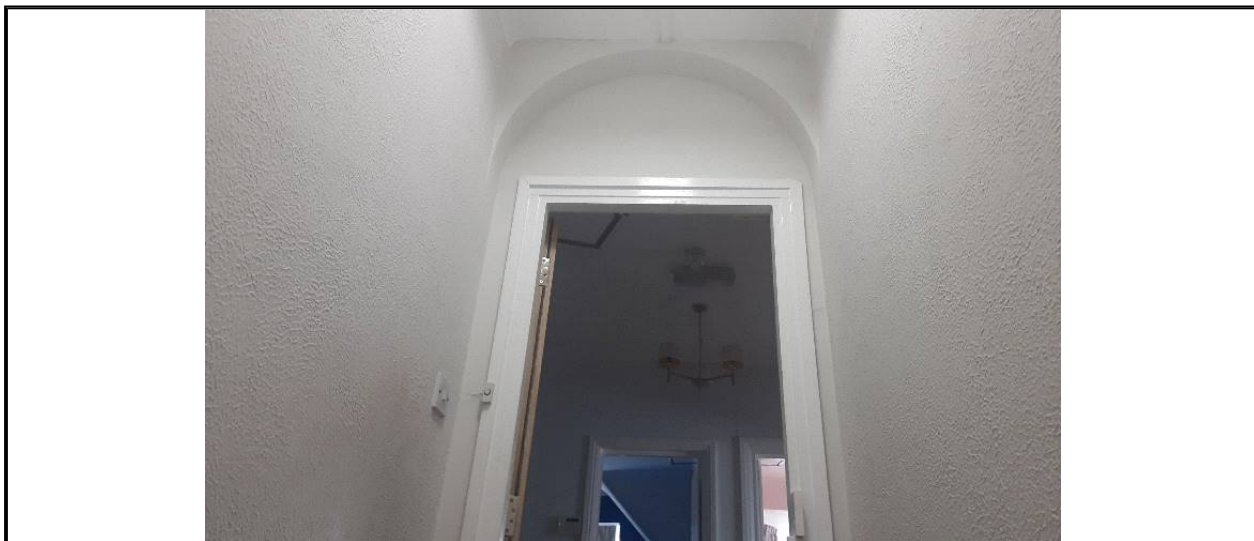
Picture 41
DA006706	Meads End, Dukes Drive	1st Floor	Insulating Board	Stairwell 1, Wall	2m²	Nailed	Timber	Amosite	
Recommendations					Assessment Scores			Risk Code	
					Material	Priority	Total		
Remove, repair or encapsulate by a licenced asbestos contractor under controlled conditions. Work on this material requires a license & is notifiable to the appropriate enforcing authority. Disposal of asbestos waste by a licensed contractor only. All work must conform to the 'Control of Asbestos Regulations 2012'.					5	6	11	C	
Reinspection Due		12 months	Actions Taken	N/A	Time Scale			Action Completed Sign & Date

Sample No:	DA006706
Item No:	41
Survey Date:	11/09/23 TO 12/09/23
Building:	Meads End, Dukes Drive
Floor:	1st Floor
Room No:	Stairwell 1
Position:	Wall - Insulating Board
Extent:	2m ²
Substrate:	Nailed, Timber
Material:	(2) Asbestos Insulating Board
Accessibility:	(2) Easily disturbed
Asbestos Type:	Amosite
Risk Category:	C
Recommended Action:	Remove, repair or encapsulate by a licenced asbestos contractor under controlled conditions. Work on this material requires a license & is notifiable to the appropriate enforcing authority. Disposal of asbestos waste by a licensed contractor only. All work must conform to the 'Control of Asbestos Regulations 2012'.

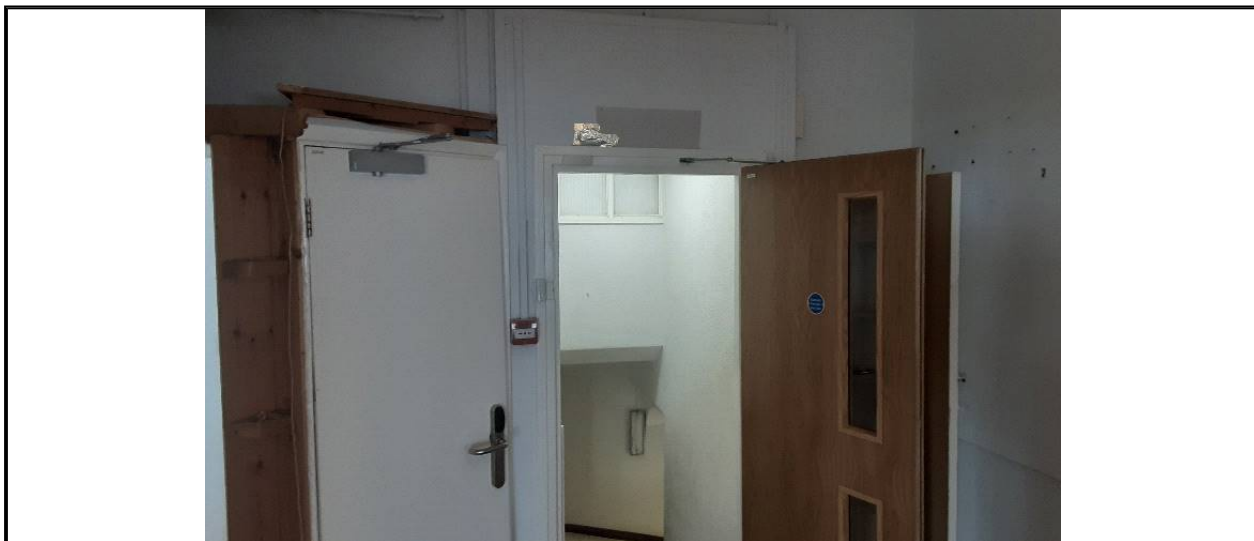
<p>Picture 44</p>
As DA006706	Meads End, Dukes Drive	1st Floor	Insulating Board	Hall, Wall	2m ²	Nailed	Timber	Amosite	
Recommendations					Assessment Scores			Risk Code	
					Material	Priority	Total		
Remove, repair or encapsulate by a licenced asbestos contractor under controlled conditions. Work on this material requires a license & is notifiable to the appropriate enforcing authority. Disposal of asbestos waste by a licensed contractor only. All work must conform to the 'Control of Asbestos Regulations 2012'.					5	6	11	C	
Reinspection Due		12 months	Actions Taken	N/A	Time Scale			Action Completed Sign & Date

Sample No:	As DA006706
Item No:	44
Survey Date:	11/09/23 TO 12/09/23
Building:	Meads End, Dukes Drive
Floor:	1st Floor
Room No:	Hall
Position:	Wall - Insulating Board
Extent:	2m ²
Substrate:	Nailed, Timber
Material:	(2) Asbestos Insulating Board
Accessibility:	(2) Easily disturbed
Asbestos Type:	Amosite
Risk Category:	C
Recommended Action:	Remove, repair or encapsulate by a licenced asbestos contractor under controlled conditions. Work on this material requires a license & is notifiable to the appropriate enforcing authority. Disposal of asbestos waste by a licensed contractor only. All work must conform to the 'Control of Asbestos Regulations 2012'.

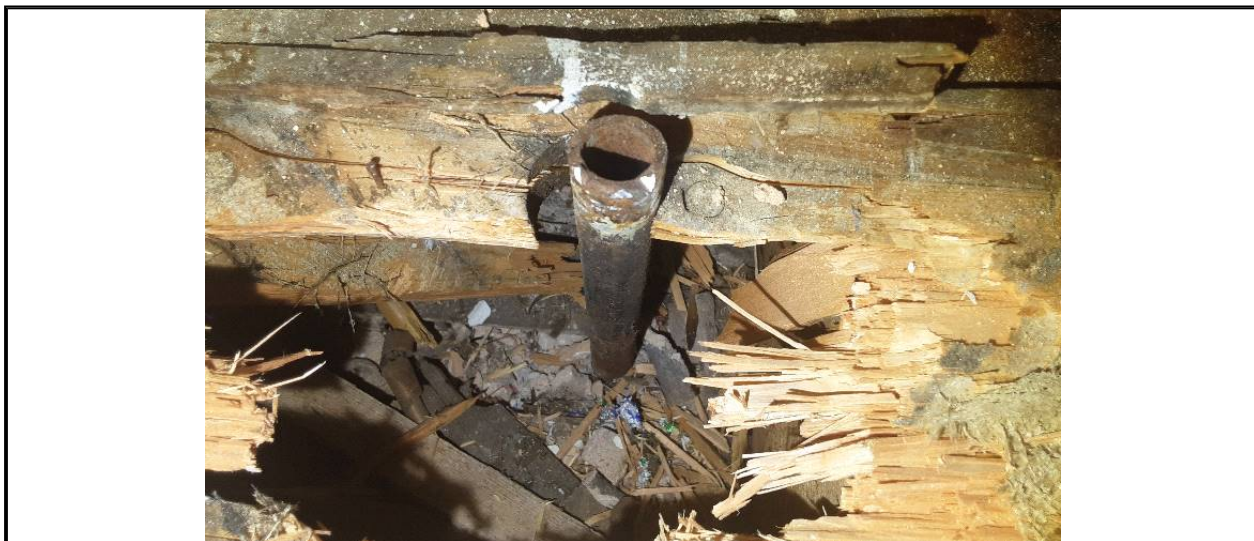
<p>Picture 51</p>
As DA006703	Meads End, Dukes Drive	1st Floor	Thermal Insulation	Medical Room, Hardset Below Floor.	<1lm	Bonded	Metal	Chrysotile + Amosite	
Recommendations					Assessment Scores			Risk Code	
					Material	Priority	Total		
Remove, repair or encapsulate by a licenced asbestos contractor under controlled conditions. Work on this material requires a license & is notifiable to the appropriate enforcing authority. Disposal of asbestos waste by a licensed contractor only. All work must conform to the 'Control of Asbestos Regulations 2012'.					10	3	13	A	
Reinspection Due		12 months	Actions Taken	N/A	Time Scale			Action Completed Sign & Date

Sample No:	As DA006703
Item No:	51
Survey Date:	11/09/23 TO 12/09/23
Building:	Meads End, Dukes Drive
Floor:	1st Floor
Room No:	Medical Room
Position:	Hardset Below Floor. - Thermal Insulation
Extent:	<1lm
Substrate:	Bonded, Metal
Material:	(3) Asbestos Insulation/Coating
Accessibility:	(0) Usually inaccessible or unlikely to be disturbed
Asbestos Type:	Chrysotile + Amosite
Risk Category:	A
Recommended Action:	Remove, repair or encapsulate by a licenced asbestos contractor under controlled conditions. Work on this material requires a license & is notifiable to the appropriate enforcing authority. Disposal of asbestos waste by a licensed contractor only. All work must conform to the 'Control of Asbestos Regulations 2012'.

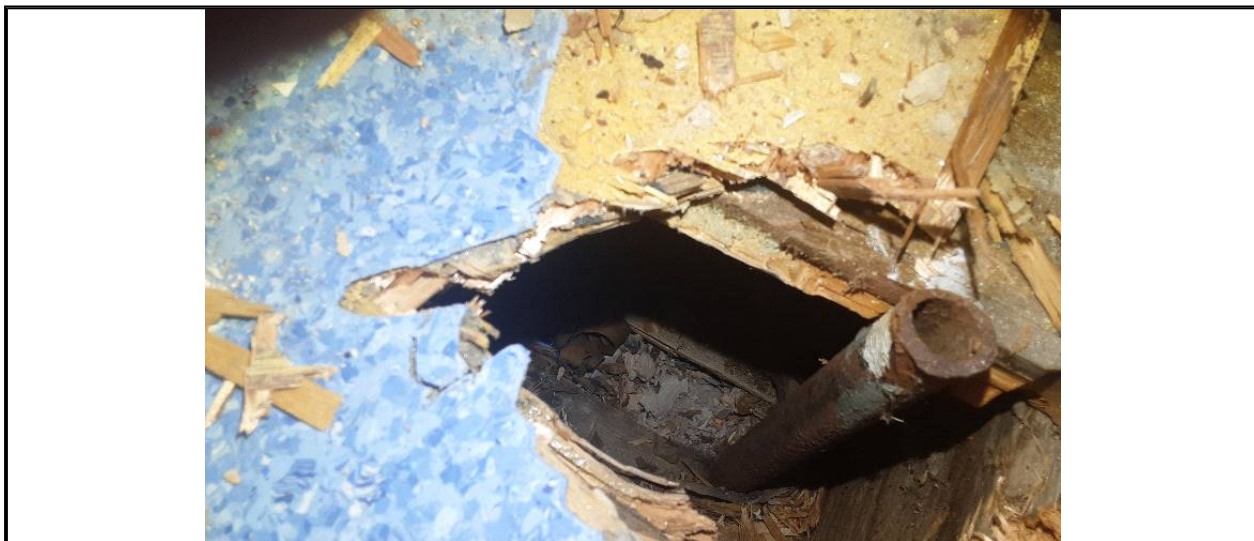
<p>Picture 52</p>
As DA006703	Meads End, Dukes Drive	1st Floor	Thermal Insulation	Medical Room, Hardest Pipework	<1lm	Bonded	Metal	Chrysotile + Amosite	
Recommendations					Assessment Scores			Risk Code	
					Material	Priority	Total		
Remove, repair or encapsulate by a licenced asbestos contractor under controlled conditions. Work on this material requires a license & is notifiable to the appropriate enforcing authority. Disposal of asbestos waste by a licensed contractor only. All work must conform to the 'Control of Asbestos Regulations 2012'.					10	3	13	A	
Reinspection Due		12 months	Actions Taken	N/A	Time Scale			Action Completed Sign & Date

Sample No:	As DA006703
Item No:	52
Survey Date:	11/09/23 TO 12/09/23
Building:	Meads End, Dukes Drive
Floor:	1st Floor
Room No:	Medical Room
Position:	Hardest Pipework - Thermal Insulation
Extent:	<1lm
Substrate:	Bonded, Metal
Material:	(3) Asbestos Insulation/Coating
Accessibility:	(0) Usually inaccessible or unlikely to be disturbed
Asbestos Type:	Chrysotile + Amosite
Risk Category:	A
Recommended Action:	Remove, repair or encapsulate by a licenced asbestos contractor under controlled conditions. Work on this material requires a license & is notifiable to the appropriate enforcing authority. Disposal of asbestos waste by a licensed contractor only. All work must conform to the 'Control of Asbestos Regulations 2012'.
