ARBORICULTURAL SURVEY

**Plot PX & NX 2 & 3
Sidney Little Road
St Leonards on Sea
TN38 9UB**

Document date: 19th November 2024

Document ref: PJC/6709/24-01 Rev -

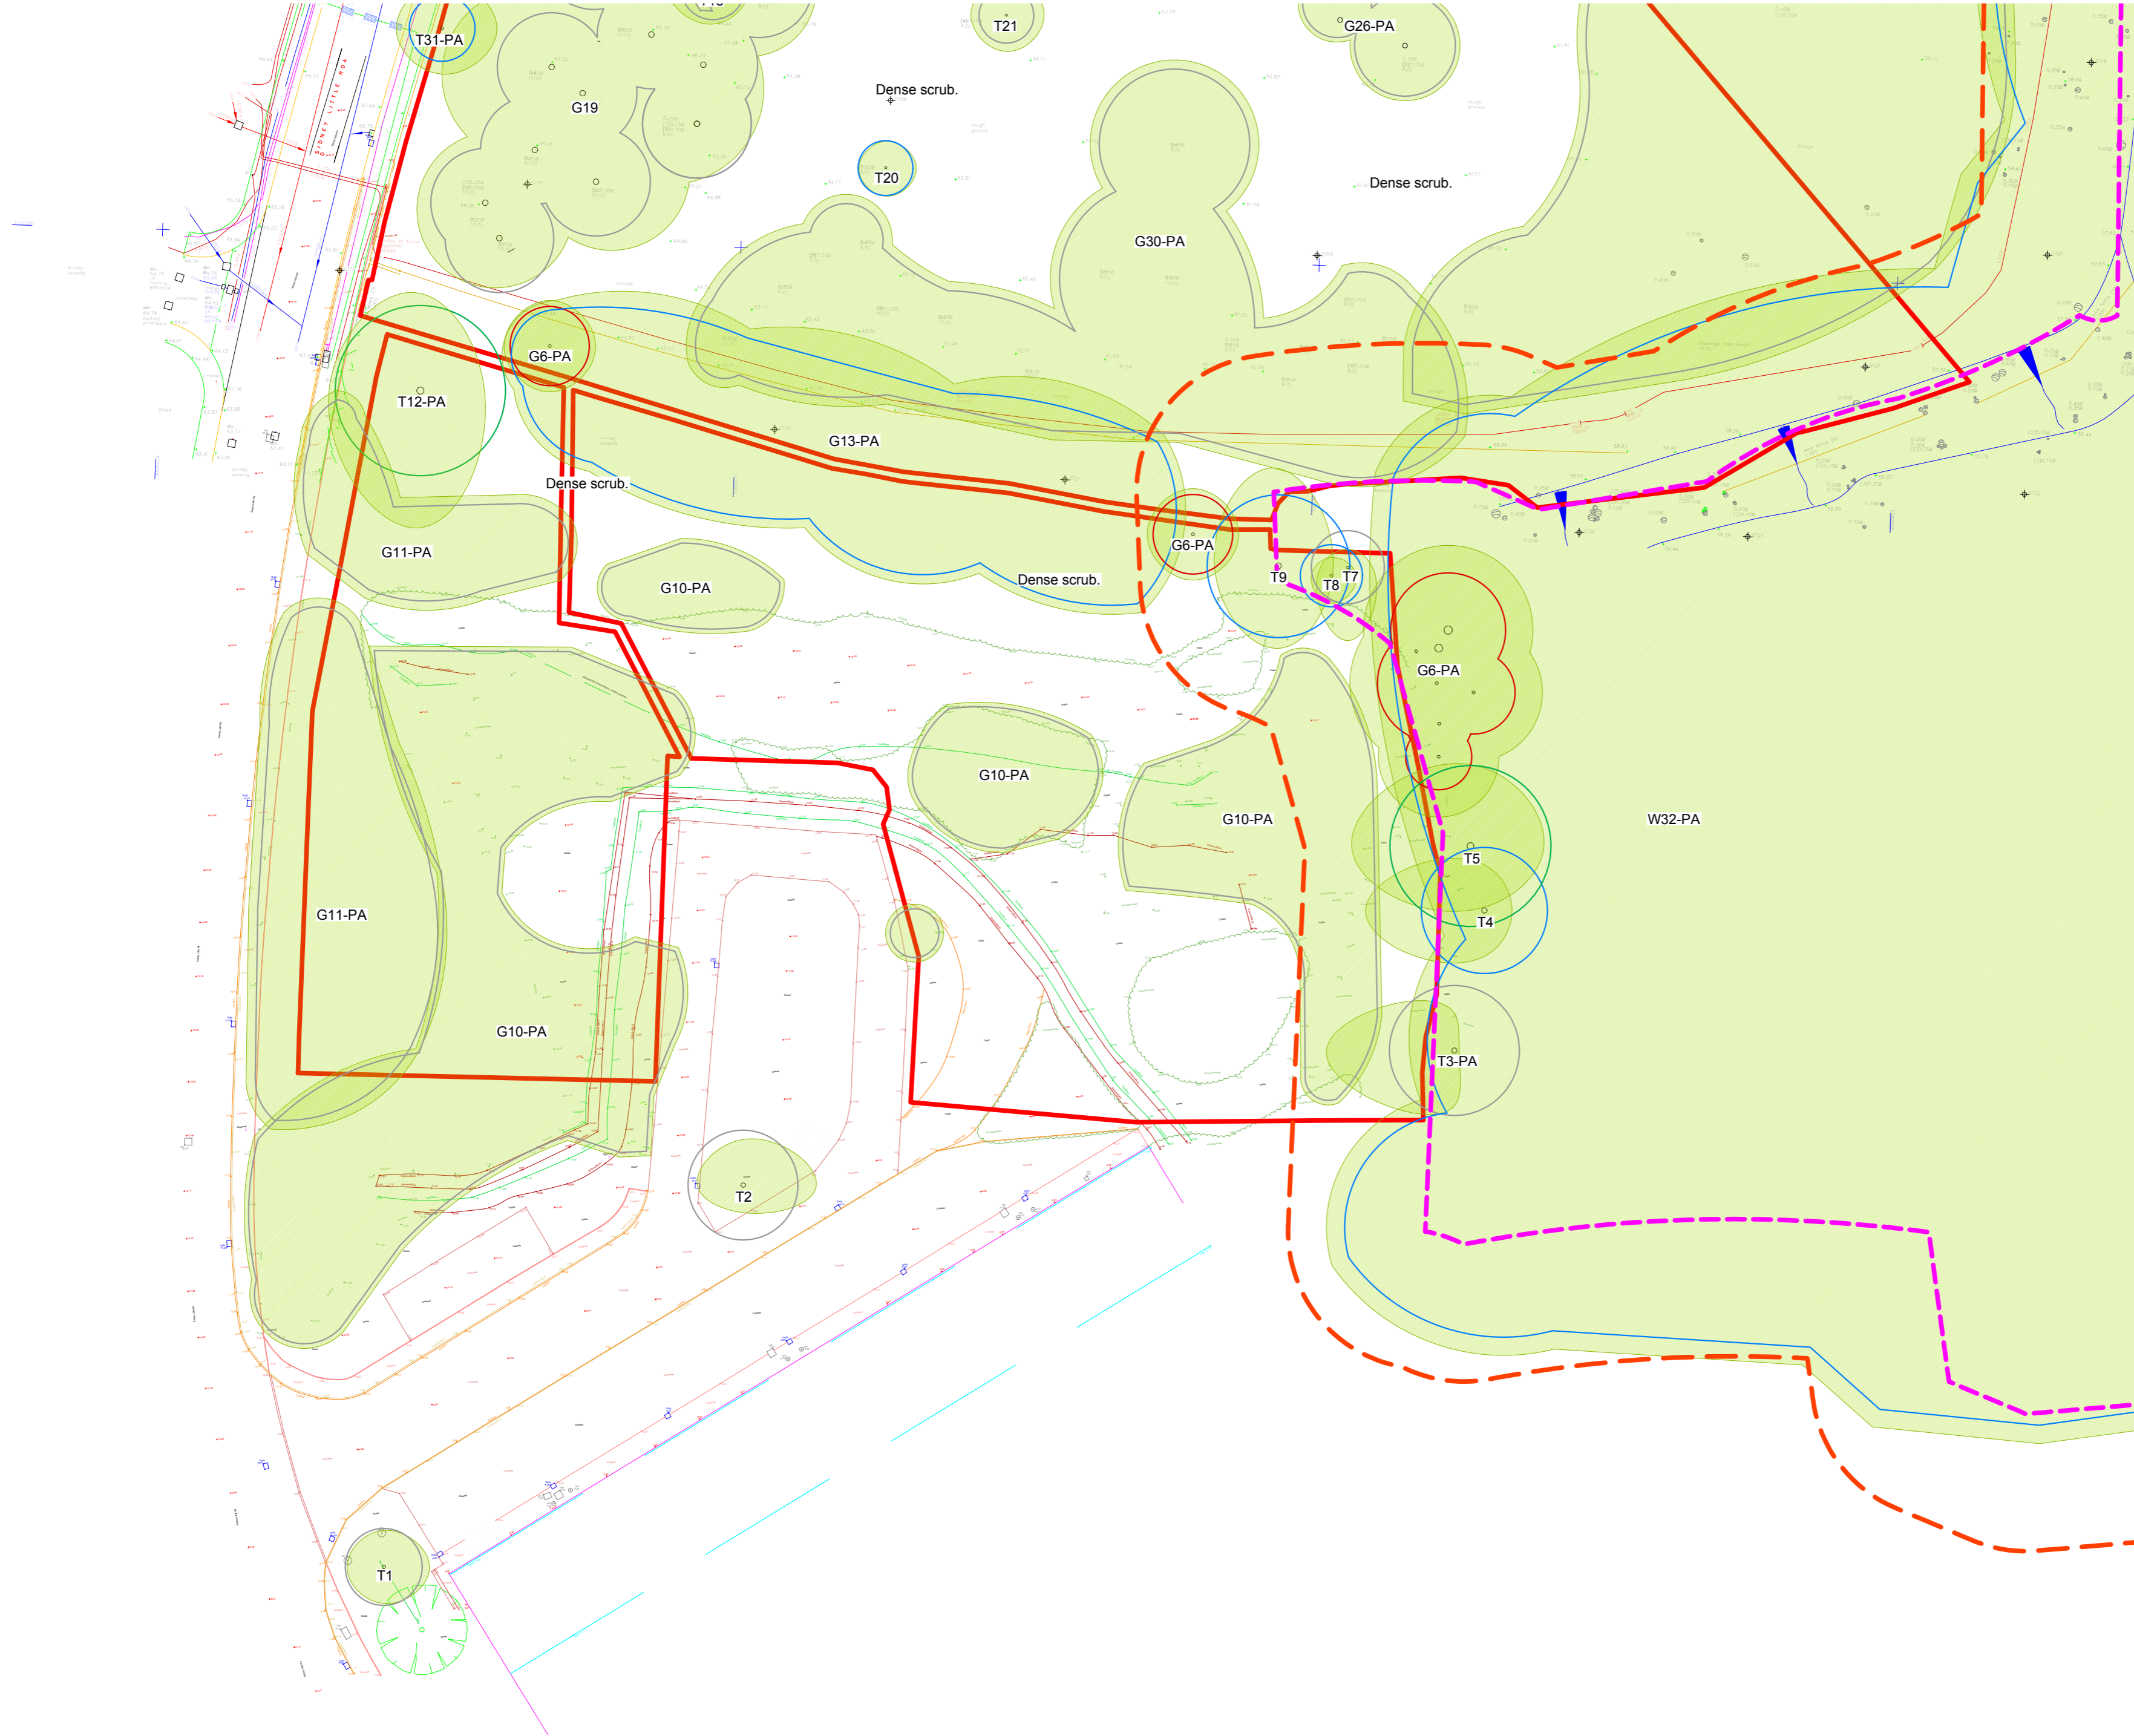
Drawing no: PJC/6709/24/A **Rev:** - **Sheet number:** 1 of 2

3.4.1 A total of 22 trees, nine tree groups and one woodland were surveyed. Their locations are shown on the tree constraints plan at Appendix 1 and details and measurements are shown in the tree survey schedule at Appendix 2.

Drawing title: Tree Constraints Plan

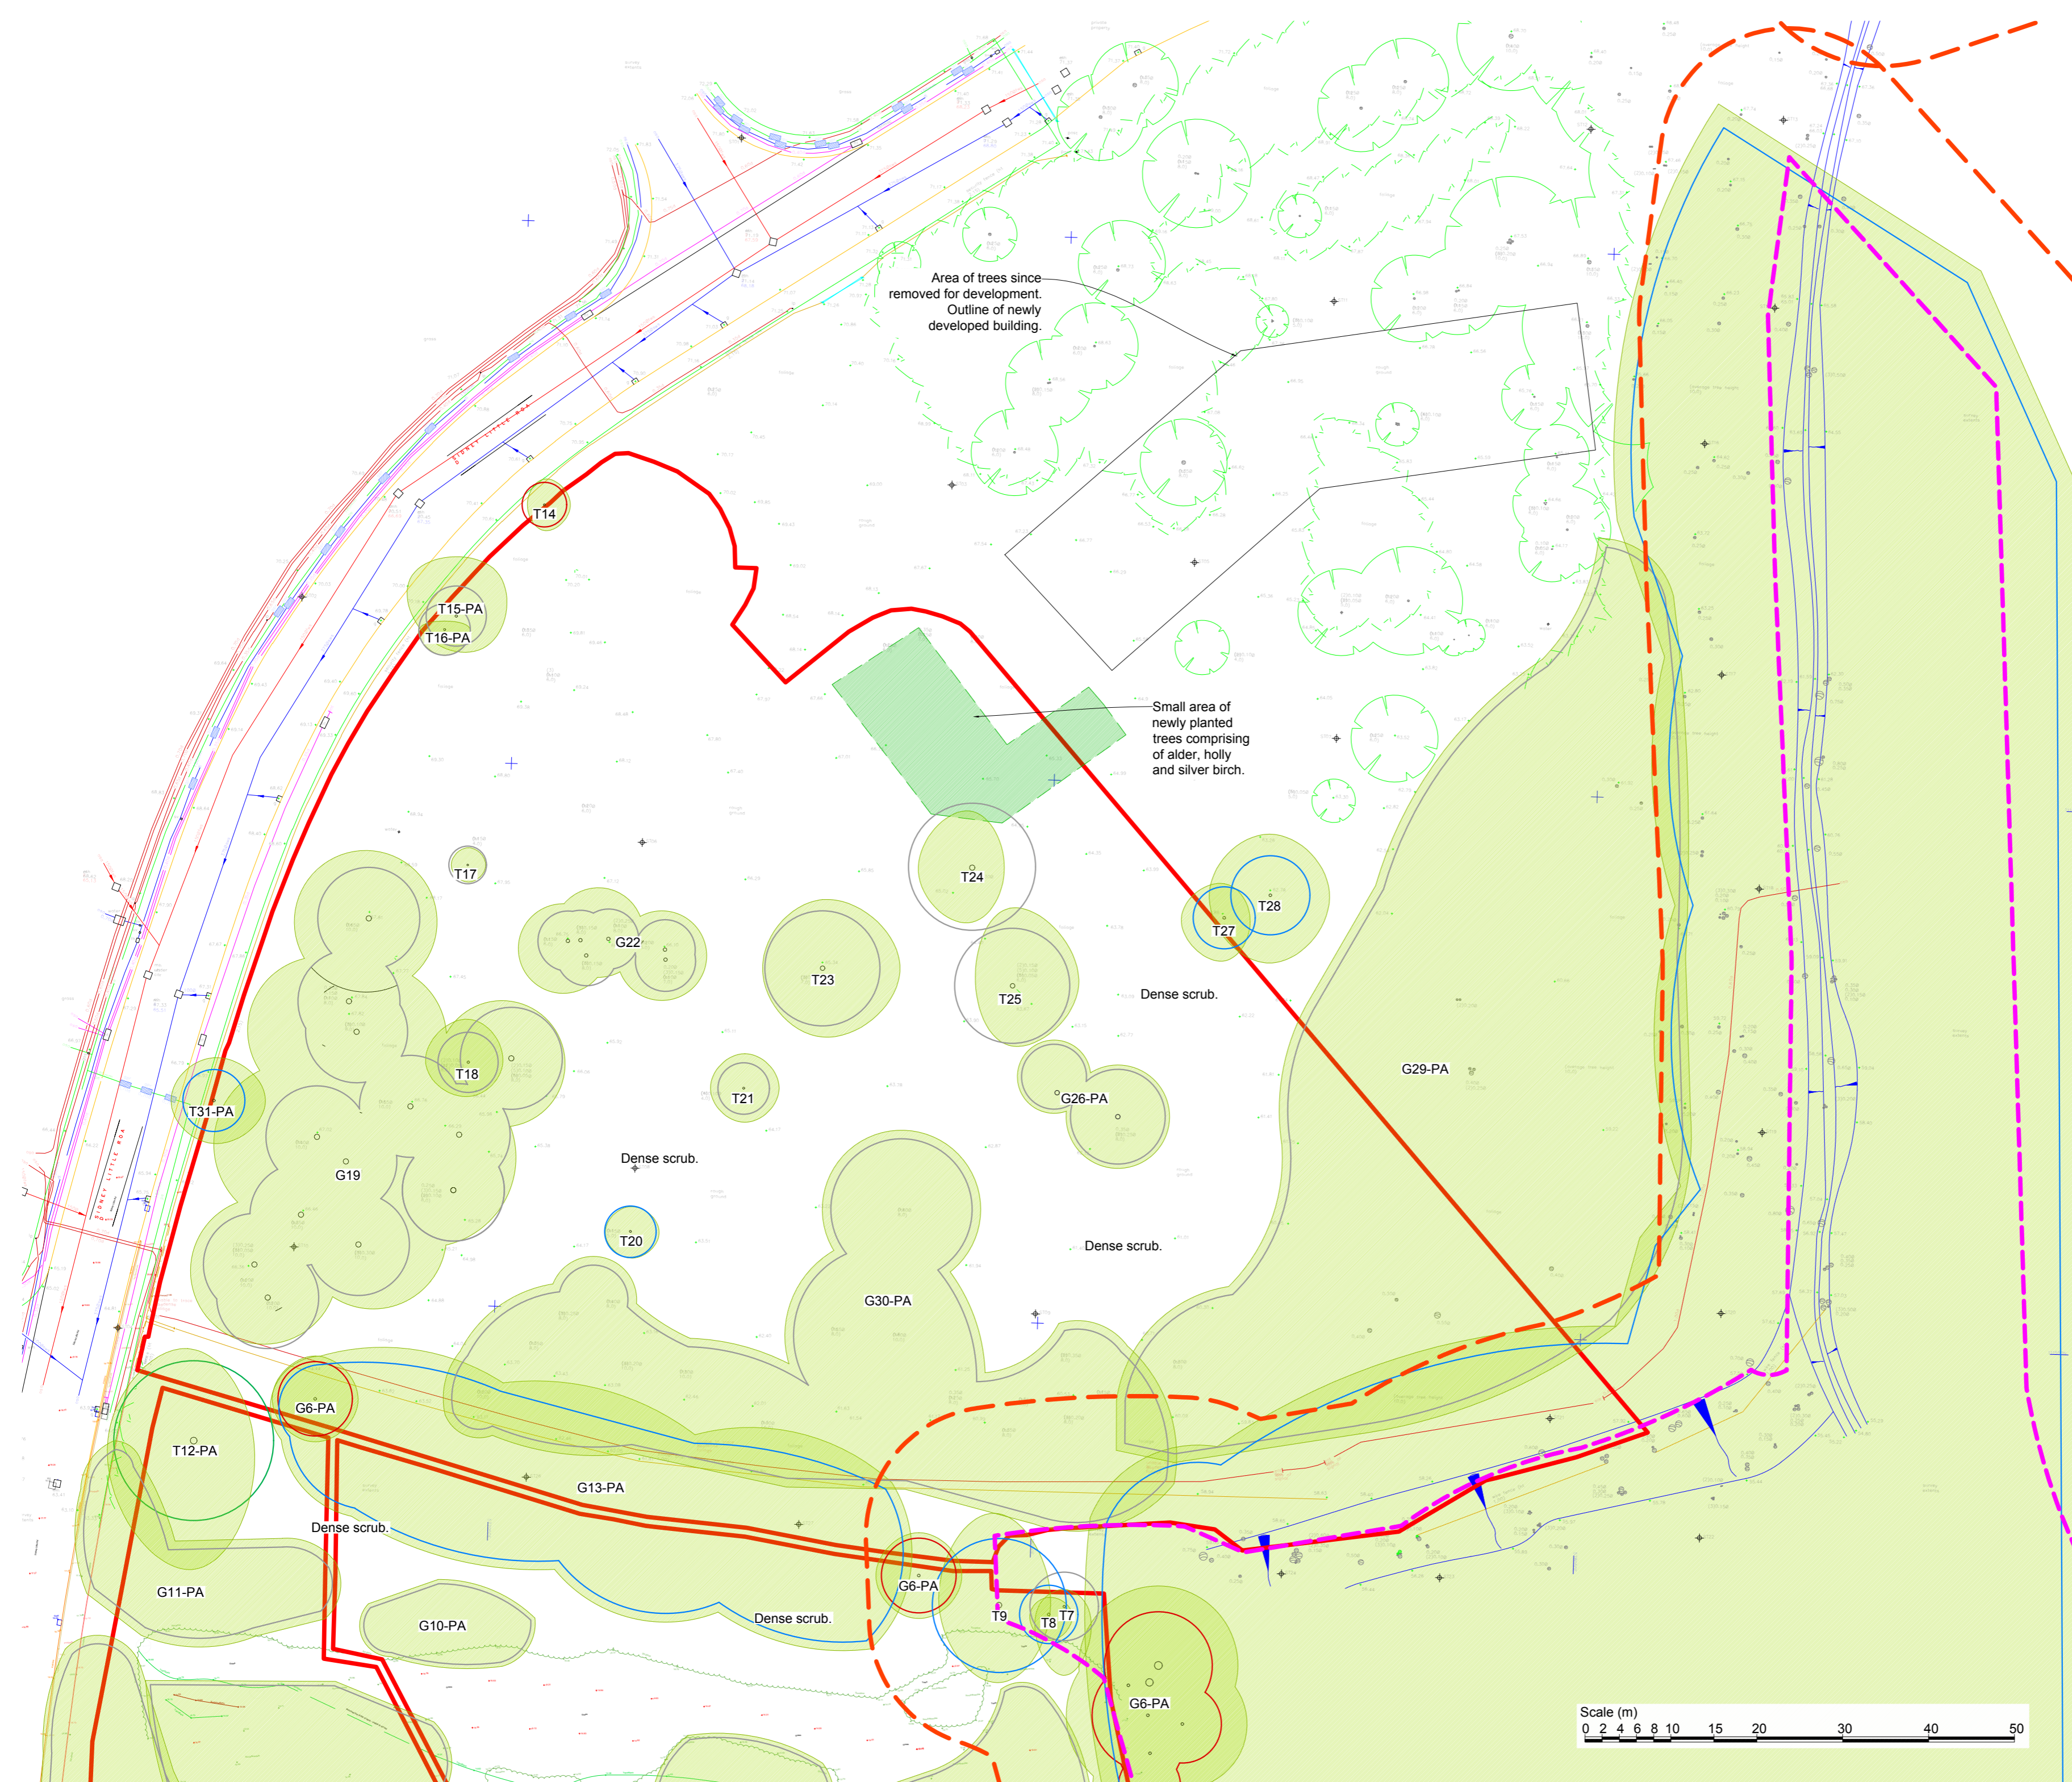
Drawing no: PJC/6709/24/A Rev: - Sheet number: 2 of 2

Drawing title: Tree Constraints Plan
