Asbestos Management Survey for Hendy Group Limited

Hendy, 18-22 Lottbridge Drove
East Sussex
BN23 6NS

Project Number: AS10788

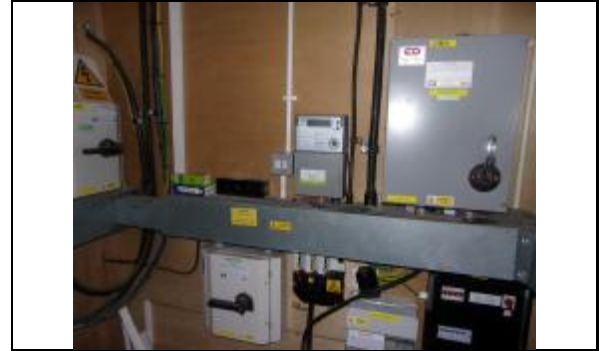
Location ID:	79343
Location Ref:	Visual ID
Product:	Fuse & Switchgear
Area:	08
Floor:	Ground floor
Room:	Lobby
Surveyor Name:	Jake Lyons
Drawing Ref:	08
Asbestos ?	Yes
Date:	07 September 2023

Priority Assessment Algorithm			
Assessment factor	Variable(s) selected	Score for each variable	Overall score
Normal Occupant Activity:			
Main type of activity in area:	Low disturbance	1	average
Secondary activities for area:	Low disturbance	1	1
Likelihood Of Disturbance:			
Location:	Rooms up to 100 m2	2	average 1
Accessibility:	Usually inaccessible or unlikely to be disturbed	0	
Extent/Amount:	<=10 m ² or <=10 m pipe run	1	
Human Exposure Potential:			
Number of occupants:	None	0	average 1
Frequency of use of area:	Daily	3	
Average time area is in use:	<1 hour	0	
Maintenance Activity:			
Type of maintenance activity:	Minor disturbance	0	average
Frequency of maintenance activity:	Unlikely to be disturbed	0	0

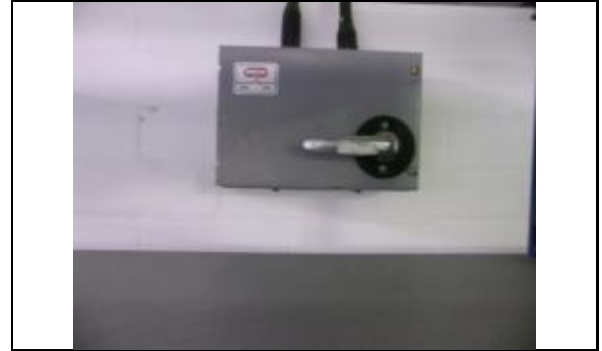
Location ID:	79355
Location Ref:	Visual ID
Product:	Fuse & Switchgear
Area:	14
Floor:	Ground floor
Room:	Parts Department
Surveyor Name:	Jake Lyons
Drawing Ref:	14
Asbestos ?	Yes
Date:	07 September 2023

Priority Assessment Algorithm			
Assessment factor	Variable(s) selected	Score for each variable	Overall score
Normal Occupant Activity:			
Main type of activity in area:	Low disturbance	1	average
Secondary activities for area:	Low disturbance	1	1
Likelihood Of Disturbance:			
Location:	Rooms up to 100 m2	2	average 1
Accessibility:	Usually inaccessible or unlikely to be disturbed	0	
Extent/Amount:	<=10 m ² or <=10 m pipe run	1	
Human Exposure Potential:			
Number of occupants:	None	0	average 1
Frequency of use of area:	Daily	3	
Average time area is in use:	<1 hour	0	
Maintenance Activity:			
Type of maintenance activity:	Minor disturbance	0	average
Frequency of maintenance activity:	Unlikely to be disturbed	0	0

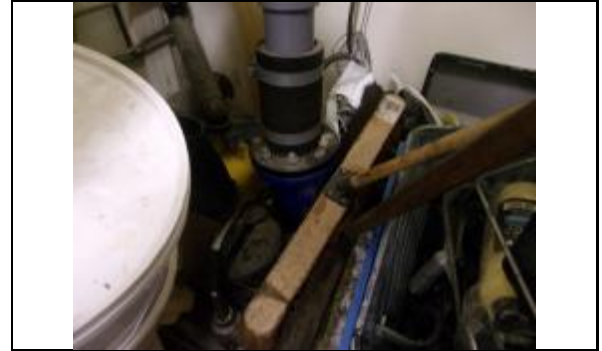
Location ID:	79358
Location Ref:	Visual ID
Product:	Gasket
Area:	16
Floor:	Ground floor
Room:	Store
Surveyor Name:	Jake Lyons
Drawing Ref:	16
Asbestos ?	Yes
Date:	07 September 2023

Priority Assessment Algorithm			
Assessment factor	Variable(s) selected	Score for each variable	Overall score
Normal Occupant Activity:			
Main type of activity in area:	Low disturbance	1	average
Secondary activities for area:	Low disturbance	1	1
Likelihood Of Disturbance:			
Location:	Rooms up to 100 m2	2	average 1
Accessibility:	Usually inaccessible or unlikely to be disturbed	0	
Extent/Amount:	Small items strings gaskets	0	
Human Exposure Potential:			
Number of occupants:	None	0	average 1
Frequency of use of area:	Weekly	2	
Average time area is in use:	<1 hour	0	
Maintenance Activity:			
Type of maintenance activity:	Low disturbance	1	average
Frequency of maintenance activity:	Unlikely to be disturbed	0	1

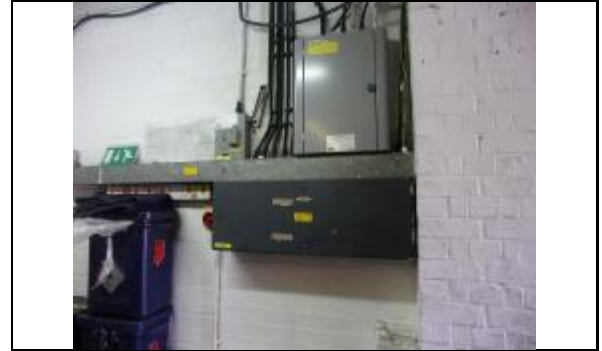
Location ID:	79386
Location Ref:	Visual ID
Product:	Fuse & Switchgear
Area:	30
Floor:	Ground floor
Room:	Tyre Store
Surveyor Name:	Jake Lyons
Drawing Ref:	30
Asbestos ?	Yes
Date:	07 September 2023

Priority Assessment Algorithm			
Assessment factor	Variable(s) selected	Score for each variable	Overall score
Normal Occupant Activity:			
Main type of activity in area:	Low disturbance	1	average
Secondary activities for area:	Low disturbance	1	1
Likelihood Of Disturbance:			
Location:	Rooms up to 100 m2	2	average 1
Accessibility:	Usually inaccessible or unlikely to be disturbed	0	
Extent/Amount:	<=10 m ² or <=10 m pipe run	1	
Human Exposure Potential:			
Number of occupants:	None	0	average 1
Frequency of use of area:	Daily	3	
Average time area is in use:	<1 hour	0	
Maintenance Activity:			
Type of maintenance activity:	Minor disturbance	0	average
Frequency of maintenance activity:	Unlikely to be disturbed	0	0

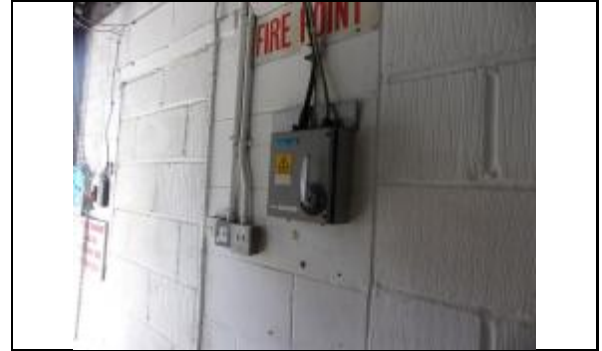
Location ID:	79392
Location Ref:	Visual ID
Product:	Fuse & Switchgear
Area:	32
Floor:	Ground floor
Room:	Garage
Surveyor Name:	Jake Lyons
Drawing Ref:	32
Asbestos ?	Yes
Date:	07 September 2023

Priority Assessment Algorithm			
Assessment factor	Variable(s) selected	Score for each variable	Overall score
Normal Occupant Activity:			
Main type of activity in area:	Low disturbance	1	average
Secondary activities for area:	Low disturbance	1	1
Likelihood Of Disturbance:			
Location:	Rooms up to 100 m2	2	
Accessibility:	Usually inaccessible or unlikely to be disturbed	0	average
Extent/Amount:	<=10 m ² or <=10 m pipe run	1	1
Human Exposure Potential:			
Number of occupants:	None	0	
Frequency of use of area:	Daily	3	average
Average time area is in use:	>1 to <3 hours	1	1
Maintenance Activity:			
Type of maintenance activity:	Minor disturbance	0	average
Frequency of maintenance activity:	Unlikely to be disturbed	0	0

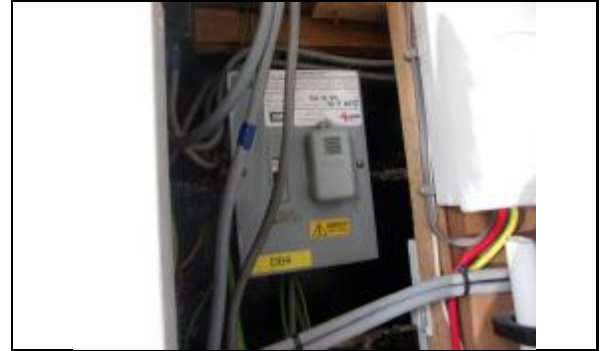
Location ID:	79404
Location Ref:	Visual ID
Product:	Fuse & Switchgear
Area:	33
Floor:	Ground floor
Room:	Mazda Showroom
Surveyor Name:	Jake Lyons
Drawing Ref:	33
Asbestos ?	Yes
Date:	07 September 2023

Priority Assessment Algorithm			
Assessment factor	Variable(s) selected	Score for each variable	Overall score
Normal Occupant Activity:			
Main type of activity in area:	Low disturbance	1	average
Secondary activities for area:	Low disturbance	1	1
Likelihood Of Disturbance:			
Location:	Rooms up to 100 m2	2	average 1
Accessibility:	Usually inaccessible or unlikely to be disturbed	0	
Extent/Amount:	<=10 m ² or <=10 m pipe run	1	
Human Exposure Potential:			
Number of occupants:	None	0	average 2
Frequency of use of area:	Daily	3	
Average time area is in use:	>3 to <6 hours	2	
Maintenance Activity:			
Type of maintenance activity:	Minor disturbance	0	average
Frequency of maintenance activity:	Unlikely to be disturbed	0	0

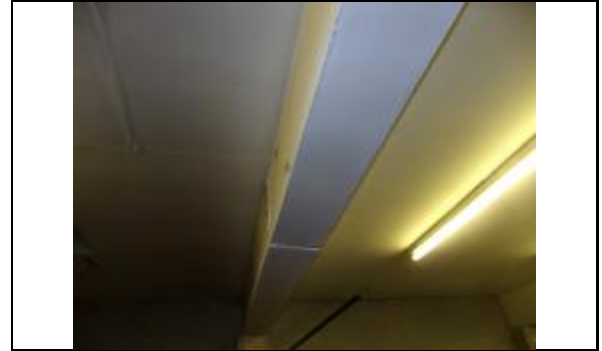
Location ID:	79406
Location Ref:	Sample 5
Product:	Insulating Board
Area:	37
Floor:	First floor
Room:	Store
Surveyor Name:	Jake Lyons
Drawing Ref:	37
Asbestos ?	Yes
Date:	07 September 2023

Priority Assessment Algorithm			
Assessment factor	Variable(s) selected	Score for each variable	Overall score
Normal Occupant Activity:			
Main type of activity in area:	Rare disturbance	0	average
Secondary activities for area:	Rare disturbance	0	0
Likelihood Of Disturbance:			
Location:	Rooms up to 100 m2	2	average 2
Accessibility:	Occasionally likely to be disturbed	1	
Extent/Amount:	>10 to <=50 (m ² or pipe run)	2	
Human Exposure Potential:			
Number of occupants:	None	0	average 0
Frequency of use of area:	Monthly	1	
Average time area is in use:	<1 hour	0	
Maintenance Activity:			
Type of maintenance activity:	Minor disturbance	0	average
Frequency of maintenance activity:	Unlikely to be disturbed	0	0

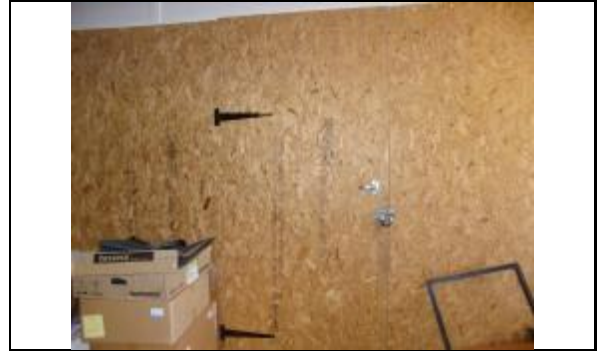
Location ID:	79408
Location Ref:	Visual ID To Sample 5
Product:	Insulating Board
Area:	38
Floor:	First floor
Room:	Store
Surveyor Name:	Jake Lyons
Drawing Ref:	38
Asbestos ?	Yes
Date:	07 September 2023

Priority Assessment Algorithm			
Assessment factor	Variable(s) selected	Score for each variable	Overall score
Normal Occupant Activity:			
Main type of activity in area:	Rare disturbance	0	average
Secondary activities for area:	Rare disturbance	0	0
Likelihood Of Disturbance:			
Location:	Rooms up to 100 m2	2	average 2
Accessibility:	Occasionally likely to be disturbed	1	
Extent/Amount:	>10 to <=50 (m ² or pipe run)	2	
Human Exposure Potential:			
Number of occupants:	None	0	average 0
Frequency of use of area:	Monthly	1	
Average time area is in use:	<1 hour	0	
Maintenance Activity:			
Type of maintenance activity:	Minor disturbance	0	average
Frequency of maintenance activity:	Unlikely to be disturbed	0	0

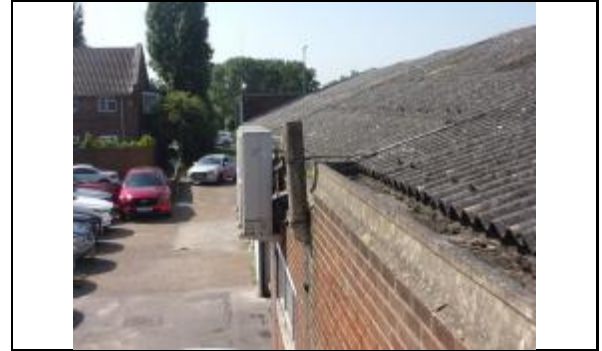
Location ID:	79414
Location Ref:	Visual ID
Product:	Cement flue pipe
Area:	39
Floor:	External
Room:	External
Surveyor Name:	Jake Lyons
Drawing Ref:	39
Asbestos ?	Yes
Date:	07 September 2023

Priority Assessment Algorithm			
Assessment factor	Variable(s) selected	Score for each variable	Overall score
Normal Occupant Activity:			
Main type of activity in area:	Low disturbance	1	average
Secondary activities for area:	Low disturbance	1	1
Likelihood Of Disturbance:			
Location:	Rooms up to 100 m2	2	average 1
Accessibility:	Usually inaccessible or unlikely to be disturbed	0	
Extent/Amount:	<=10 m ² or <=10 m pipe run	1	
Human Exposure Potential:			
Number of occupants:	None	0	average 1
Frequency of use of area:	Daily	3	
Average time area is in use:	<1 hour	0	
Maintenance Activity:			
Type of maintenance activity:	Minor disturbance	0	average
Frequency of maintenance activity:	Unlikely to be disturbed	0	0

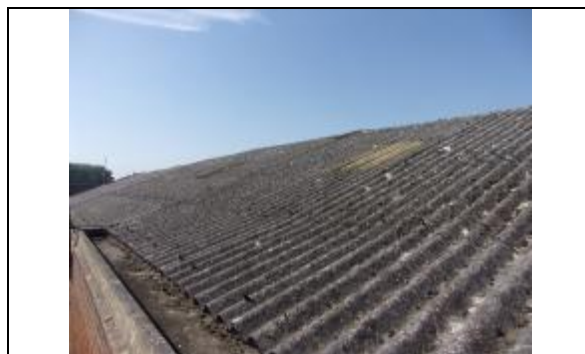
Location ID:	79411
Location Ref:	Sample 6
Product:	Cement Roof Sheets
Area:	39
Floor:	External
Room:	External
Surveyor Name:	Jake Lyons
Drawing Ref:	39
Asbestos ?	Yes
Date:	07 September 2023

Priority Assessment Algorithm			
Assessment factor	Variable(s) selected	Score for each variable	Overall score
Normal Occupant Activity:			
Main type of activity in area:	Low disturbance	1	average
Secondary activities for area:	Low disturbance	1	1
Likelihood Of Disturbance:			
Location:	Rooms up to 100 m2	2	average 2
Accessibility:	Occasionally likely to be disturbed	1	
Extent/Amount:	>50 m ² or >50 m pipe run	3	
Human Exposure Potential:			
Number of occupants:	None	0	average 1
Frequency of use of area:	Daily	3	
Average time area is in use:	<1 hour	0	
Maintenance Activity:			
Type of maintenance activity:	Minor disturbance	0	average
Frequency of maintenance activity:	<=1 per year	1	1
