STARK Re-inspection with Priority Assessments

SURVEY LOCATION: Jewson & Graham (Bexhill-on-Sea 471 & 365), Beeching Road, Bexhill-on-Sea, TN39 3LG

PROJECT NUMBER: M-162757

SURVEY DATE: 26 March 2025

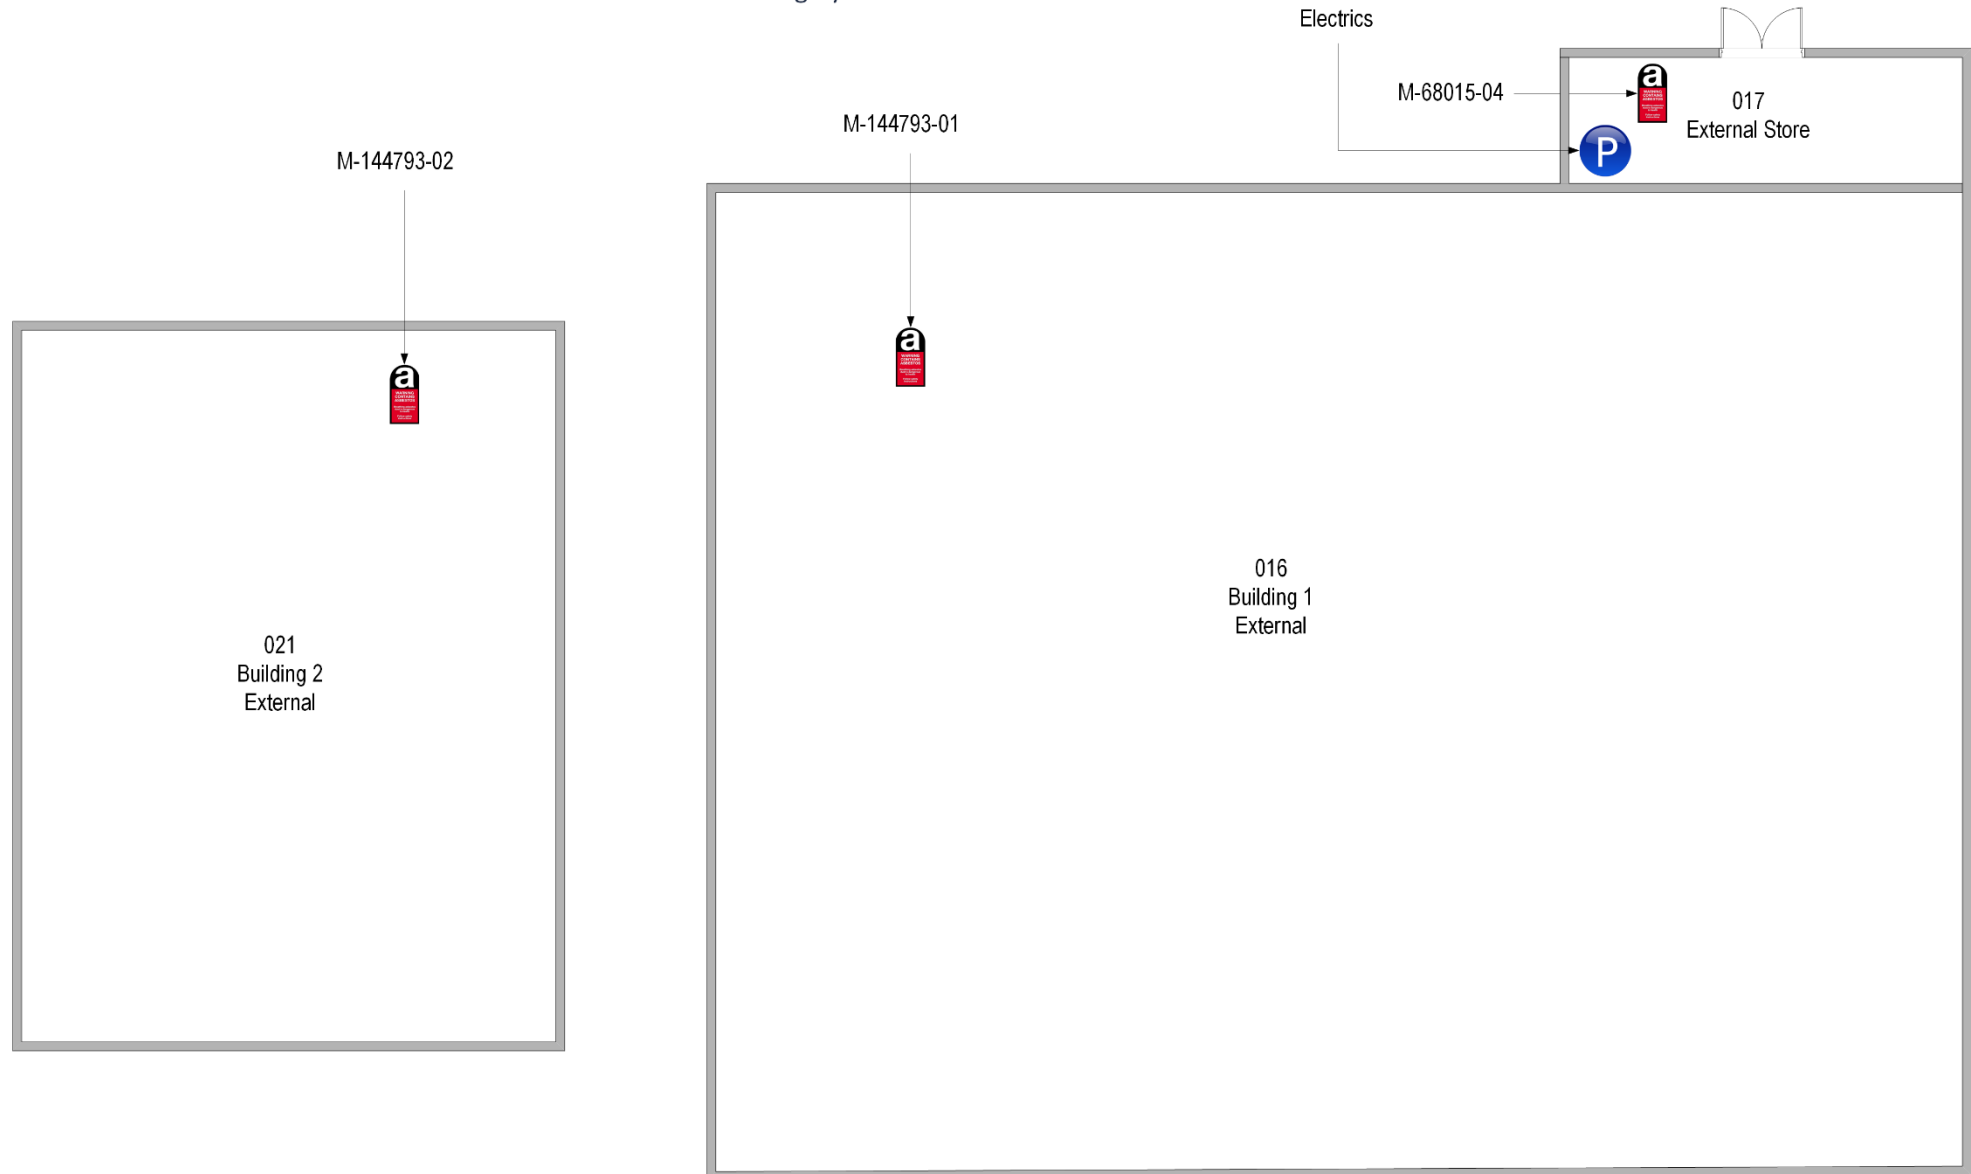
Client: STARK
Survey Address: Jewson, Beeching Road, Bexhill, East Sussex, TN39 3LG
Floor Level: External
Drawing By: Jordan Leedham

Woven Product within
Electrics

Jewsons 017 Ground Floor External Store	Presumed Woven product to Within electrics	10no	Asbestos insulating board, millboards, gaskets & ropes etc. (2)	Low damage (1)	Enclosed sprays & lagging, sealed AIB, textiles, gaskets & cement products (1)	Chrysotile (1)	5	2	7	Further Inspection Required
Jewsons 017 Ground Floor External Store	Previously Sampled M-68015-04 Asbestos Insulating Board to Ceiling panels	4m ²	Asbestos insulating board, millboards, gaskets & ropes etc. (2)	Good (0)	Enclosed sprays & lagging, sealed AIB, textiles, gaskets & cement products (1)	Amosite, Chrysotile (2)	5	2	7	Manage
