Refurbishment Survey

Site: Meads End, Dukes Drive, Eastbourne, BN20 6XL
UPRN: N/A
Client: Bede's School Trust (Prep School)
Report No: J025905
Survey Date: 11th September 2023 to 12th September 2023
Report Date: 15th September 2023
Surveyors: Wayne Clarke
Report Produced By: Report Reviewed By:

Type of Survey: Refurbishment

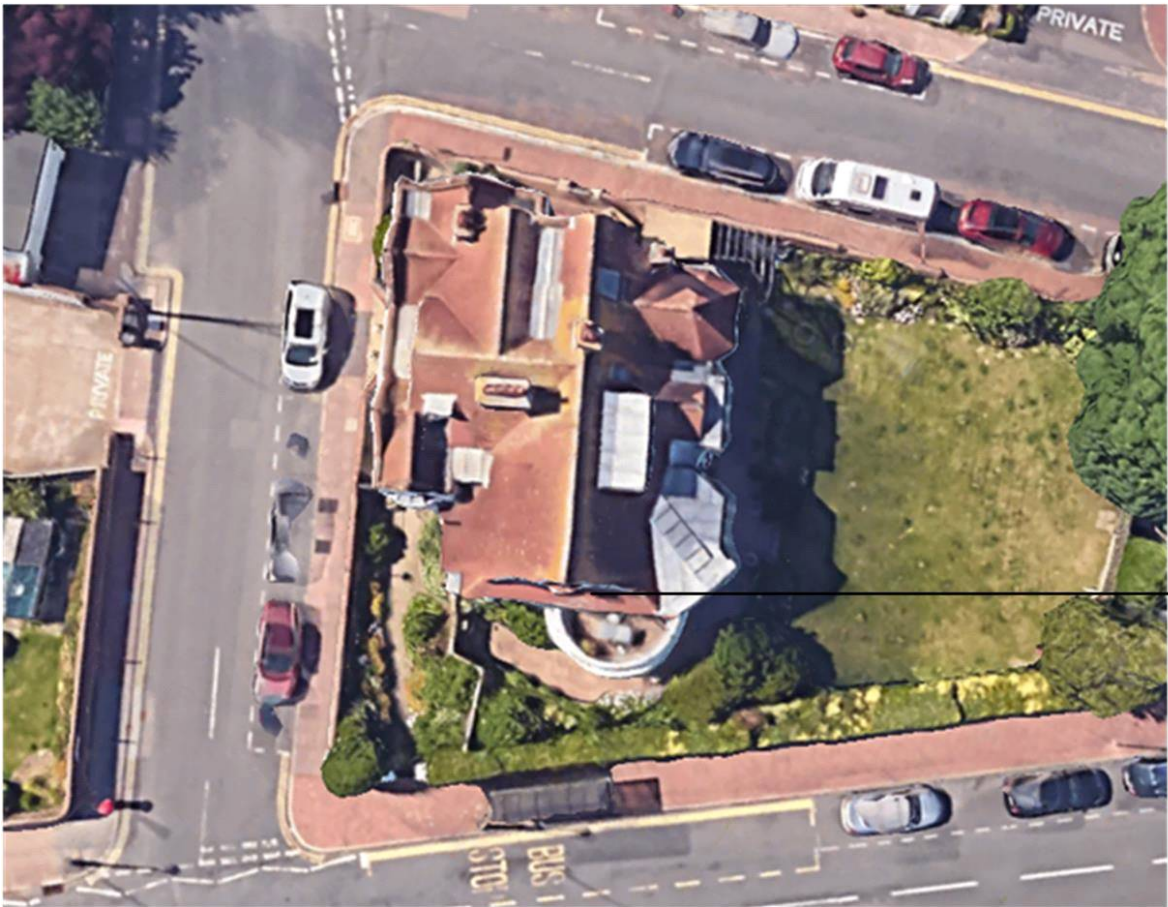
Client: Bede's School Trust (Prep School)
Site Address Meads End, Dukes Drive,Eastbourne
Position: External
Not to Scale

DA006712
Cement
Undercloaking
Throughout
NADIS

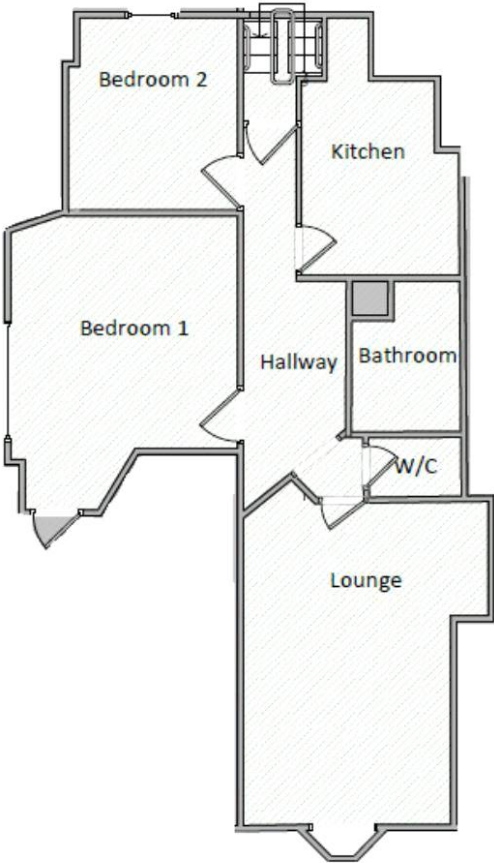
Client:	Bede's School Trust (Prep School)
Site Address	Meads End, Dukes Drive,Eastbourne
Position:	2nd Floor
Not to Scale

No Samples
Taken To This
Floor
